**MARINE ARCHAEOLOGICAL ASSESSMENT  
OF WRECKAGE FOUND ALONG  
POINT CLARK BEACH  
LAKE HURON**

**Licence No. 2021-08**

**Licence Holder: Scarlett Janusas**

**May 8, 2024**

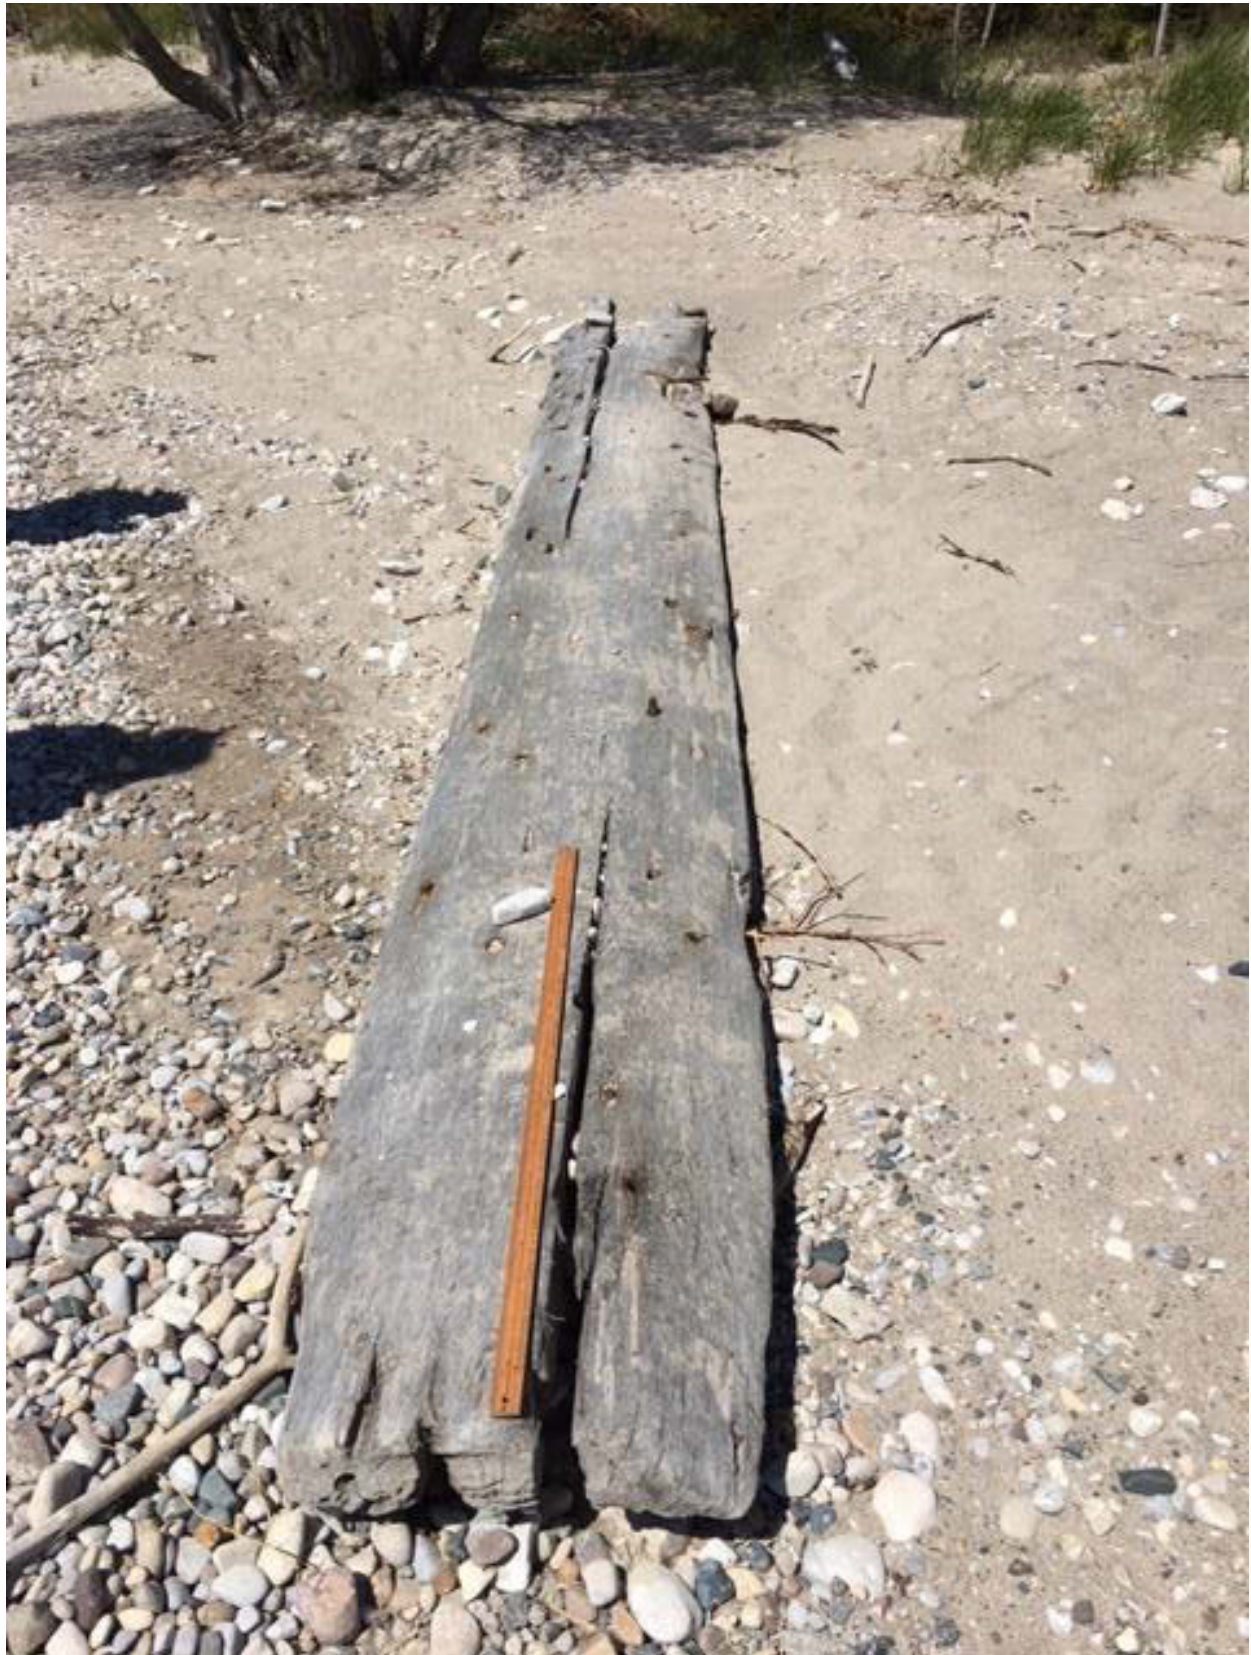
Image 2: Piece 1

Image 2 shows **piece 1** with a metre stick on the lower end for scale. The piece is highest in elevation in the middle and tapers off from this height on either side. The piece has multiple iron fasteners in place. The piece is broken at both ends, suggesting that is longer than the provided measurement of 19'. The piece is one solid piece of wood, probably white oak.

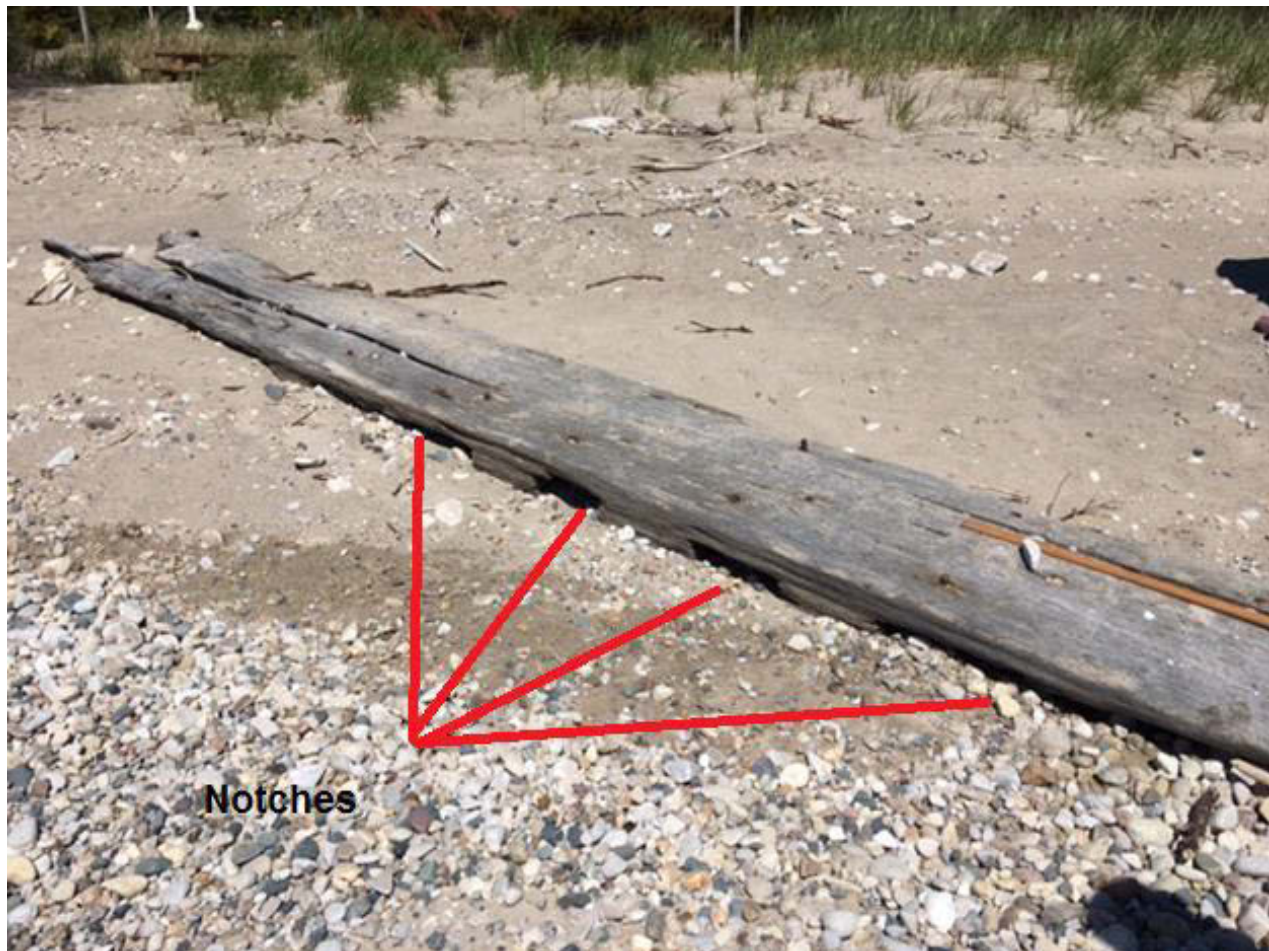
**Image 3: Piece 1 from Side showing Underlying Notches**

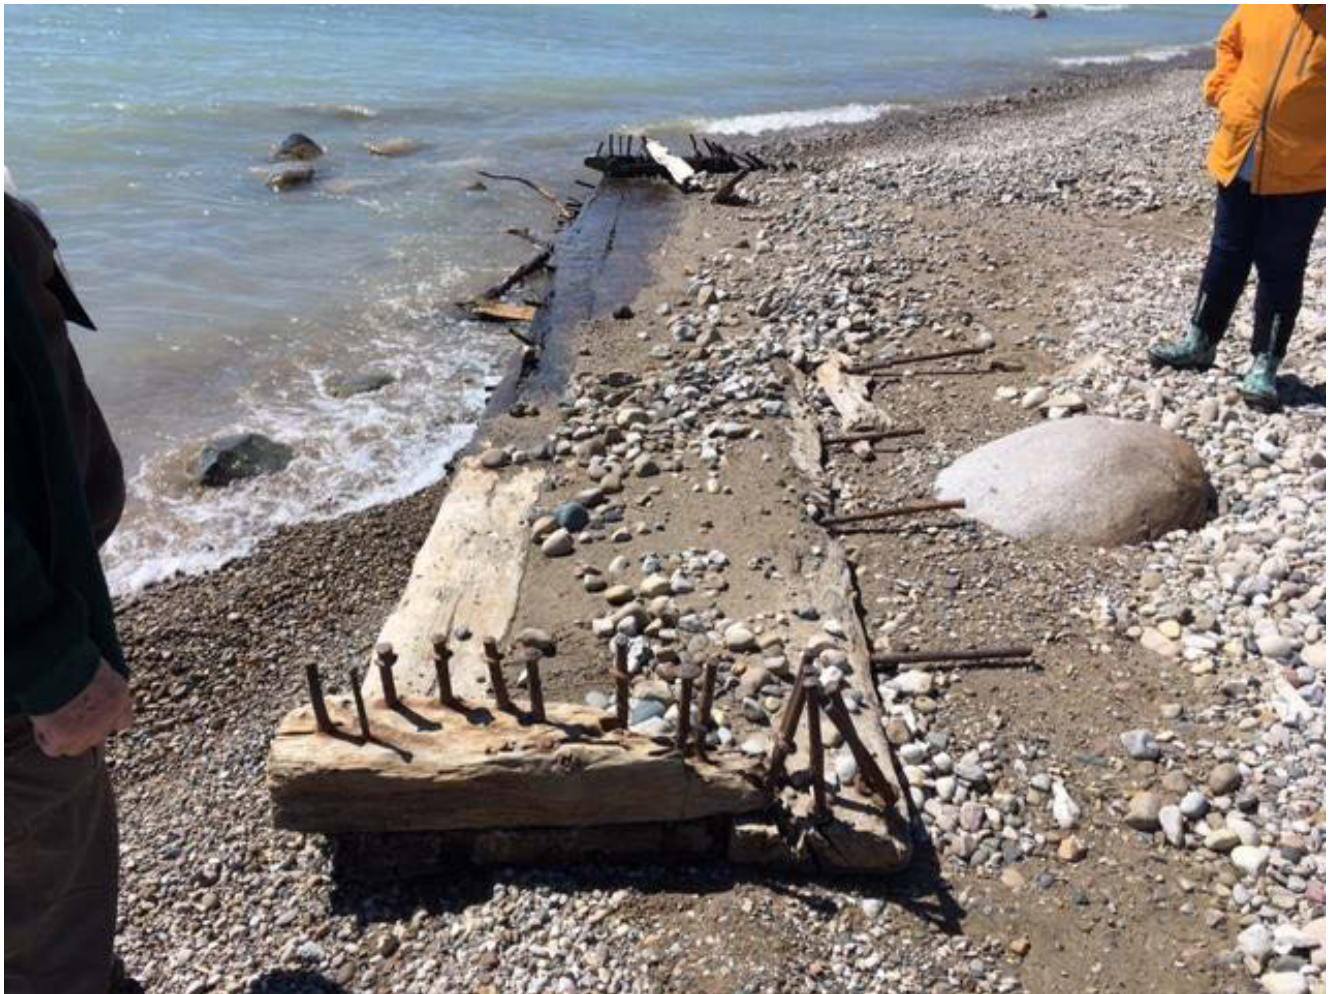
Image 4 shows that Piece 2 was originally partially covered with sand and beach gravel/stones (informants say it was once clear of sediments/rocks) by storm wave action. Image 4 shows the three large planks and on the right side of the image illustrates the iron bolts that have been driven through the planks. Image 5 illustrates the iron bolts, suggesting that there was at least one more plank forming part of this piece. On either end of the planking are perpendicular pieces of wood that have been affixed to the planking with multiple iron bolts (Images 4-11). The abundance of these fasteners suggests a possible refit, and/or a need to ensure that the pieces would not shift therefore requiring additional fasteners to ensure the pieces would not separate. The latter, if this is the case, suggests that this piece was subject to heavy use or heavy vibrations that would tend to separate the pieces. Image 6 illustrates one end with the heavy use of fasteners, but also of notable interest is the presence of one wooden trenail (a trenail is a wooden peg that has been driven through a hole drilled by hand with an auger) or possibly a spile (covering for a metal fastener). Image 6 is also paired with a drawing overlaid on the image showing the position of each of the bolt holes. There is no specific configuration of the bolt holes, such as spacing or position relative to other bolts. Image 7 illustrates more of fasteners and their configuration. The spacing of the fasteners does

**Image 4: Piece 2 facing NW – Centreboard Box Casing (May 2021)**

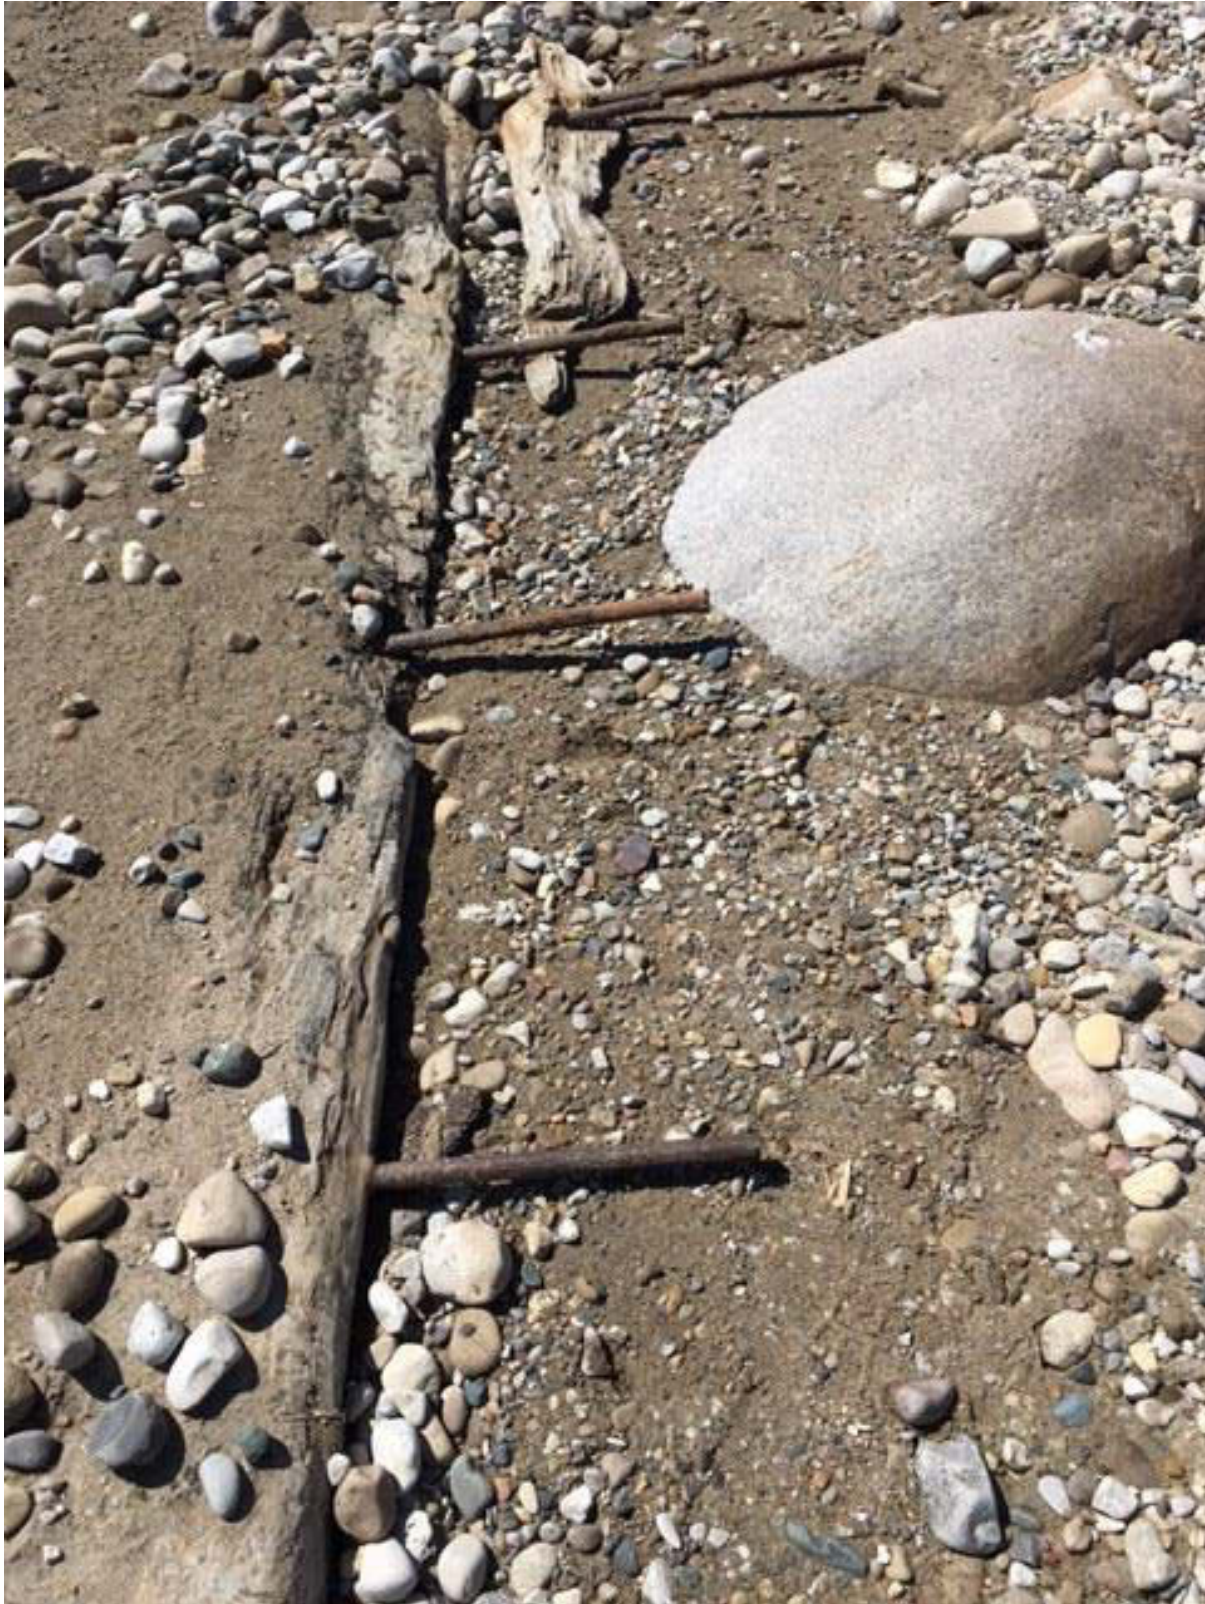
**Photograph 5: Extension of Iron Through Bolts Suggesting Another Plank (May 2021)**

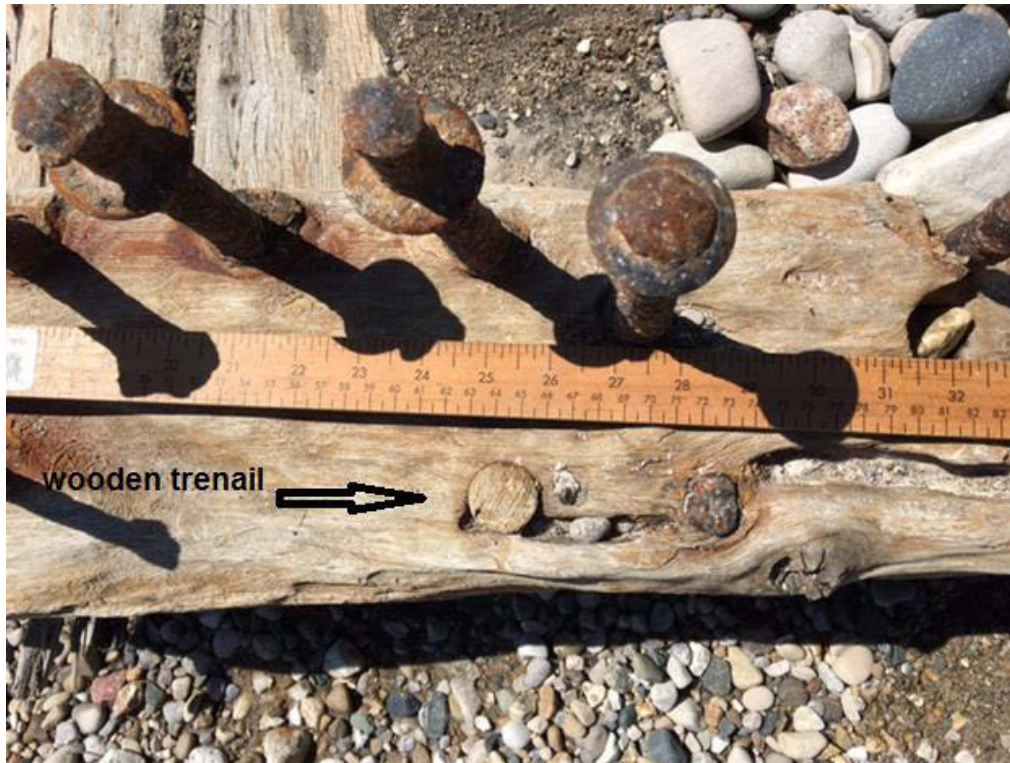
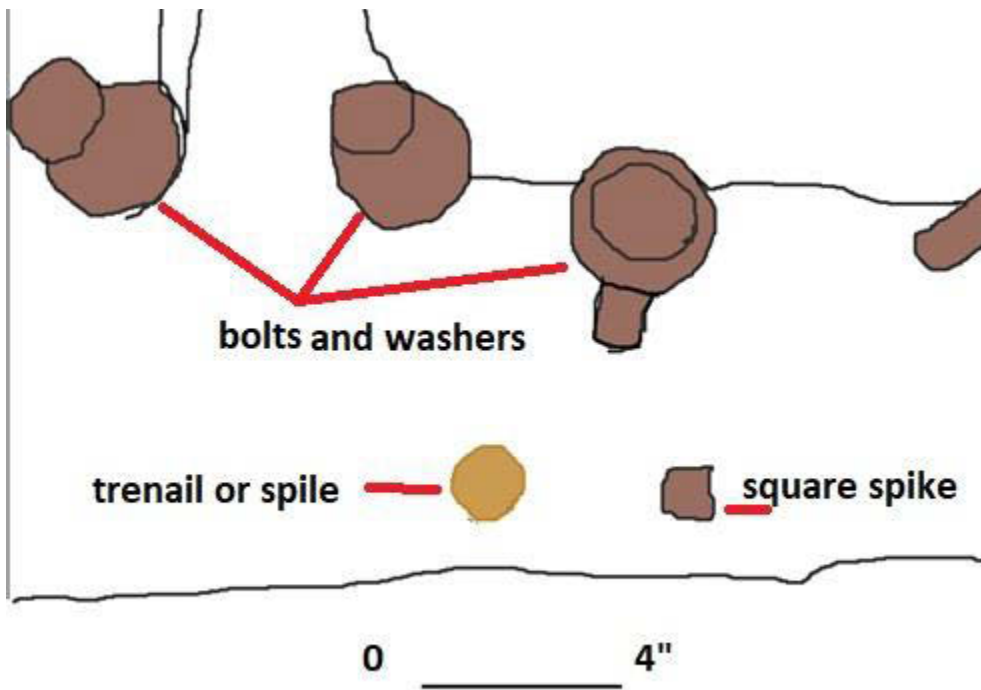
Photograph 6: Fasteners, Washers and Wooden Trenail or Spile (May 2021)

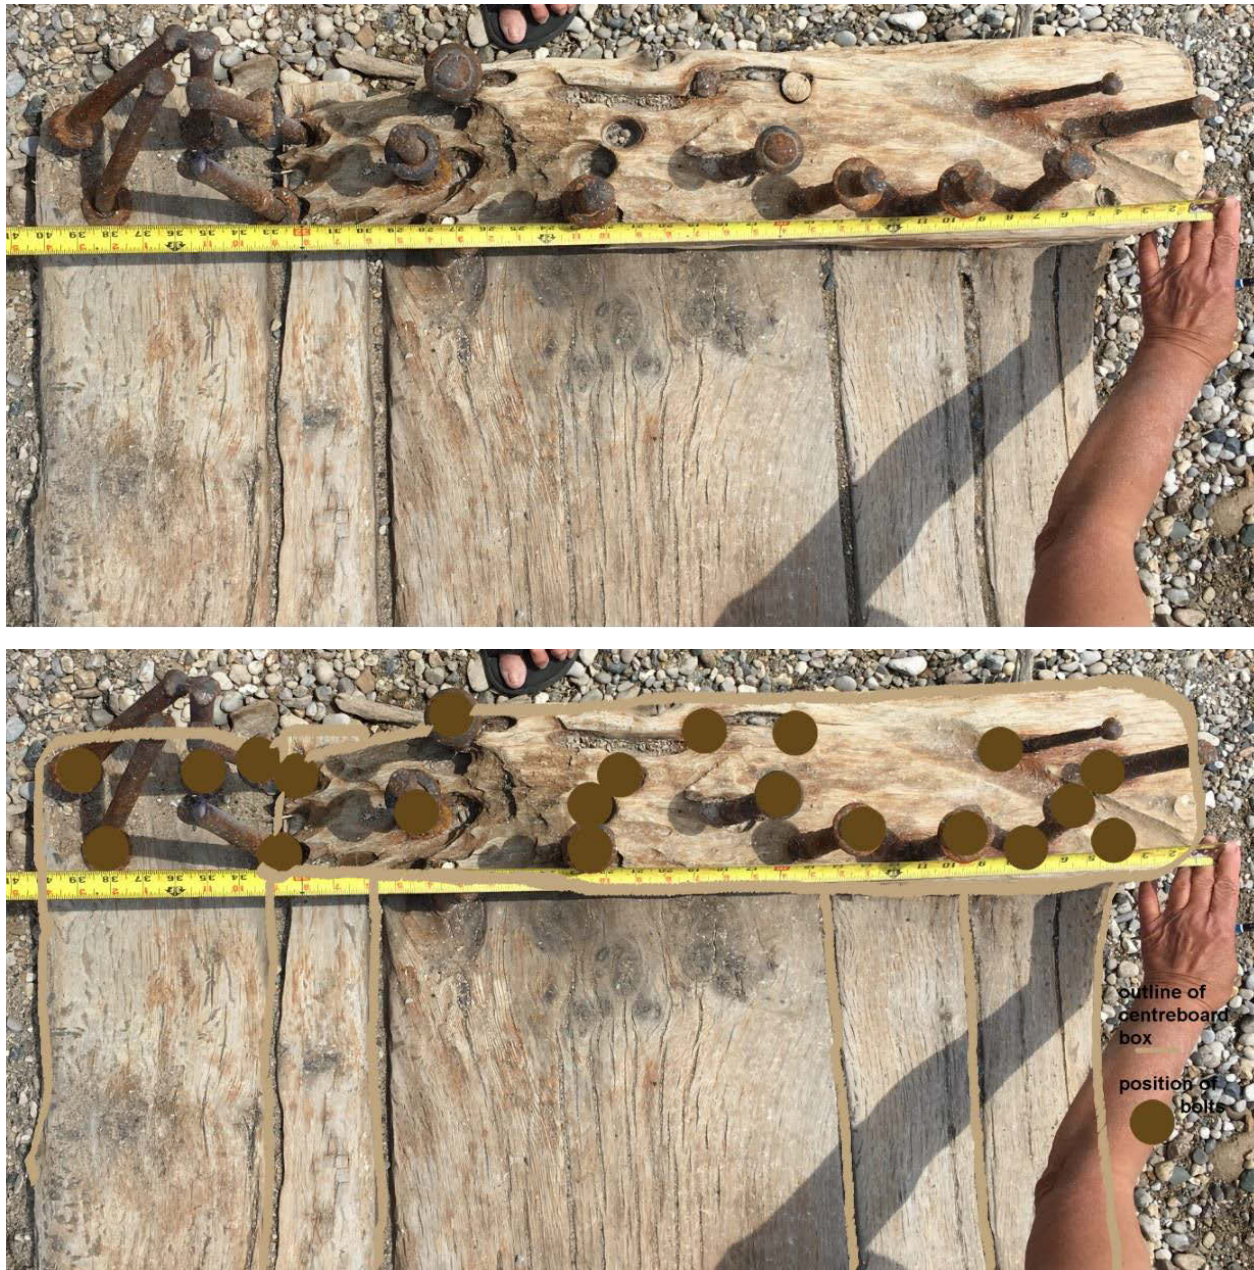
not appear to have any purposeful pattern, again suggesting some refit activity for the piece, possibly to reinforce the piece. Image 8 illustrates the planks underlying the wooden piece attached with fasteners. Image 9 shows the lakeside end of **piece 2**. Image 10 shows a piece of wood that is still attached to one of the fasteners at the lake end of the piece, showing that these pieces would have lain in alignment with the underlying planks, but aside from this small fragmentary remnant, there are no other remnant pieces attached to **piece 2**. Image 10 also indicates that the space between the planks on the bottom and the top wooden pieces did not allow for a great deal of space (width wise) between the two areas. This supports the identification of piece 2 being part of a centerboard box. Image 11 shows a piece of metal coming up through the planking at the lake side of the piece. This is part of the pivot pin, supported by its position near the end of the "box".

Photograph 7: Metal Fasteners and Base Placement (May 2021)

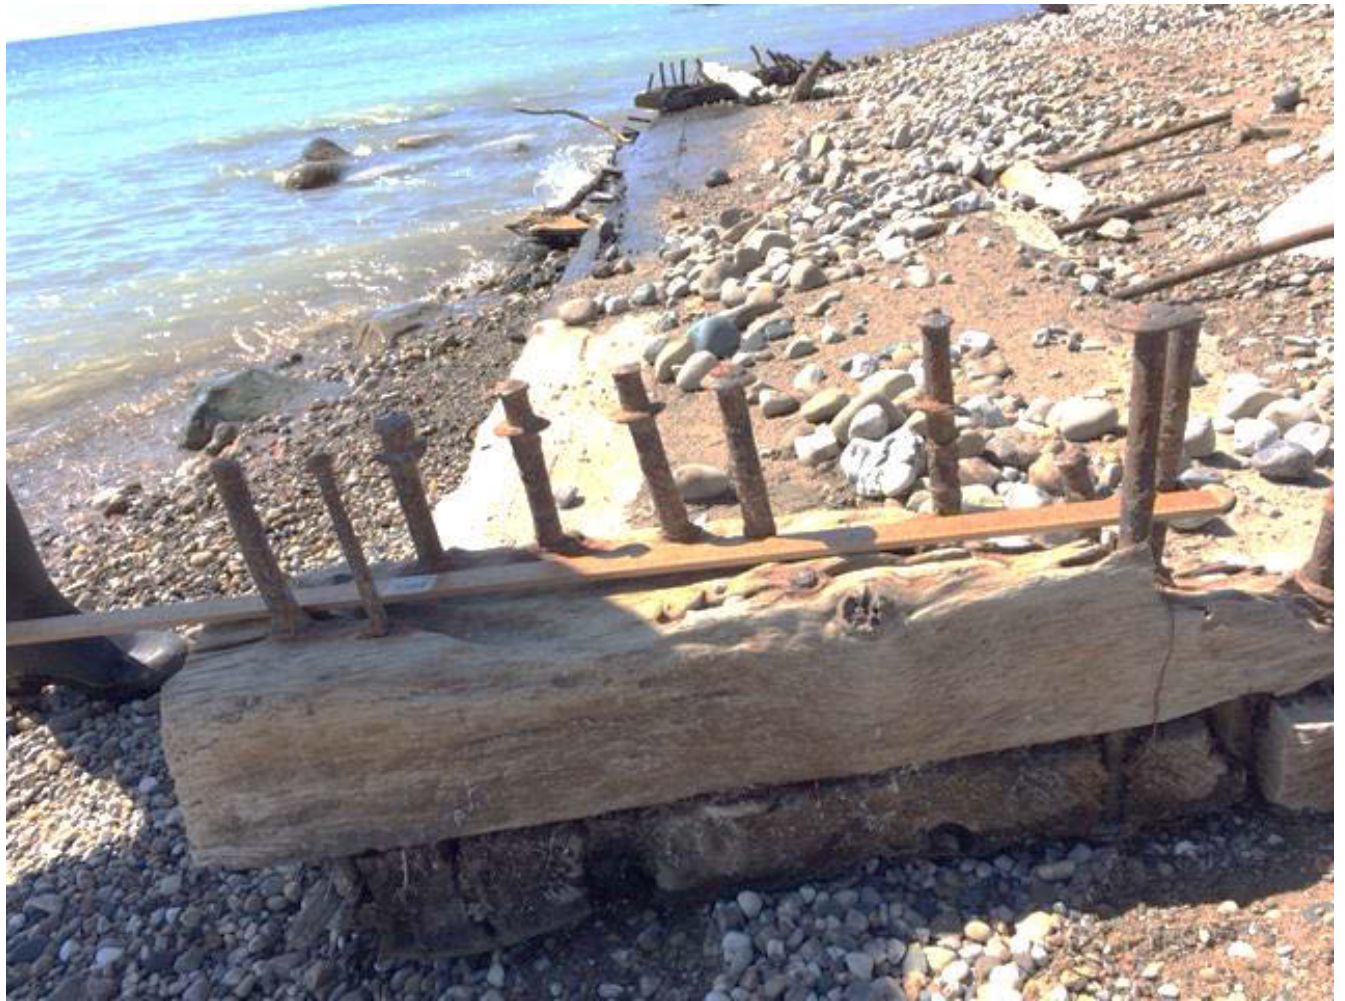
**Photograph 8: View of Underlying Planks (May 2021)**

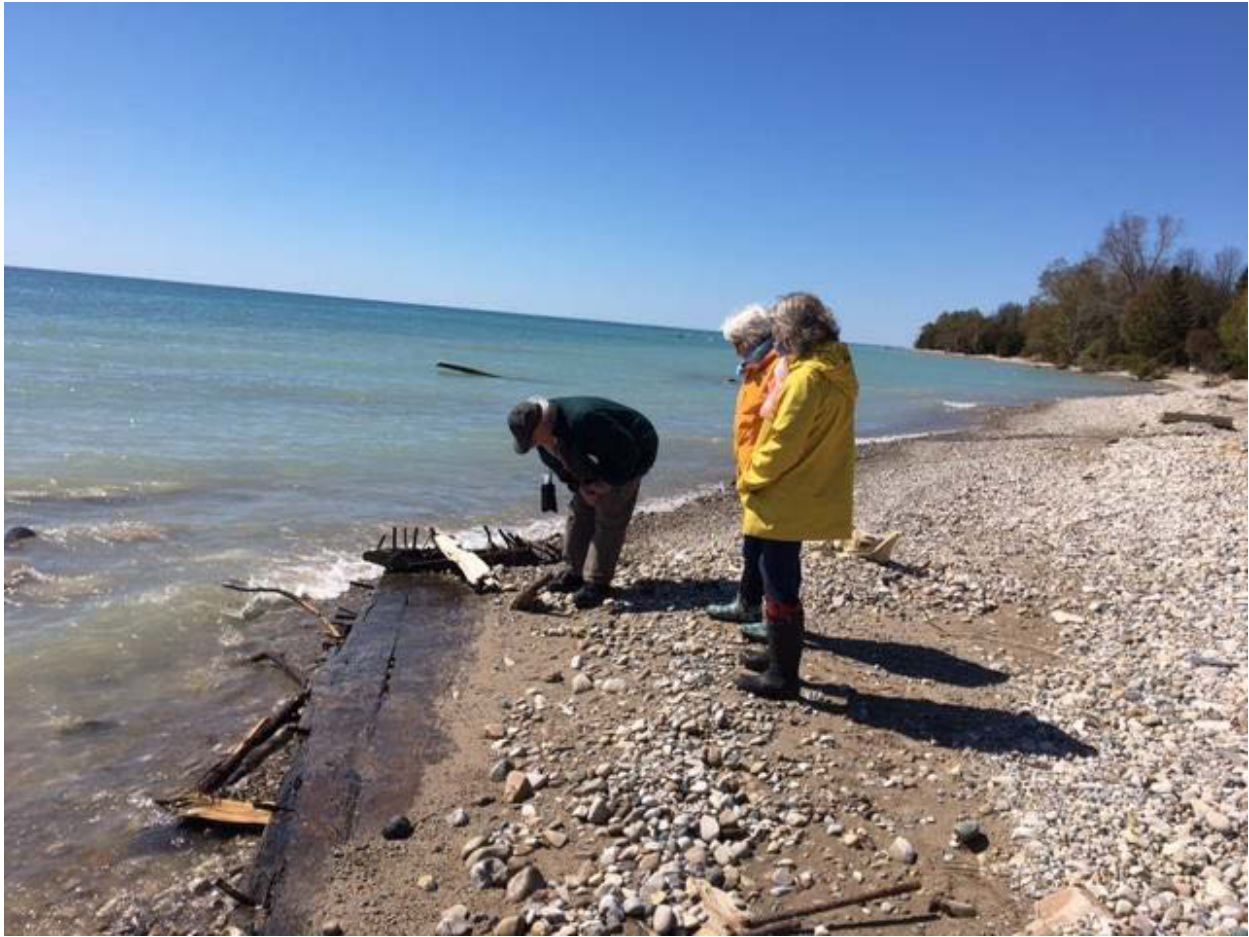
**Photograph 9: Lake Side End of Piece 2 (May 2021)**

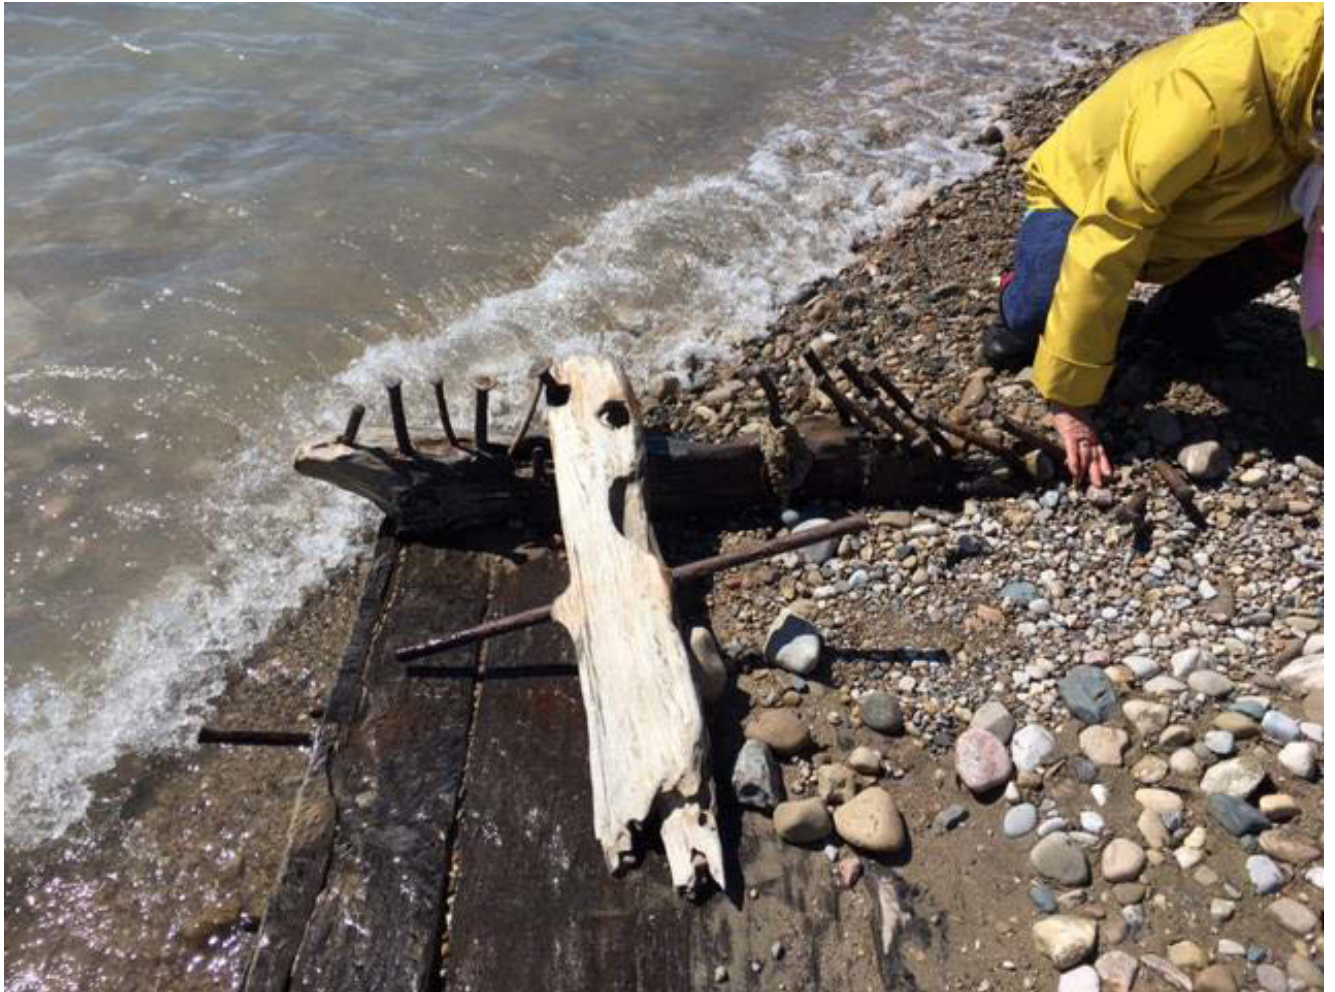
**Photograph 10: Remnant Wood in Alignment with Planking (May 2021)**

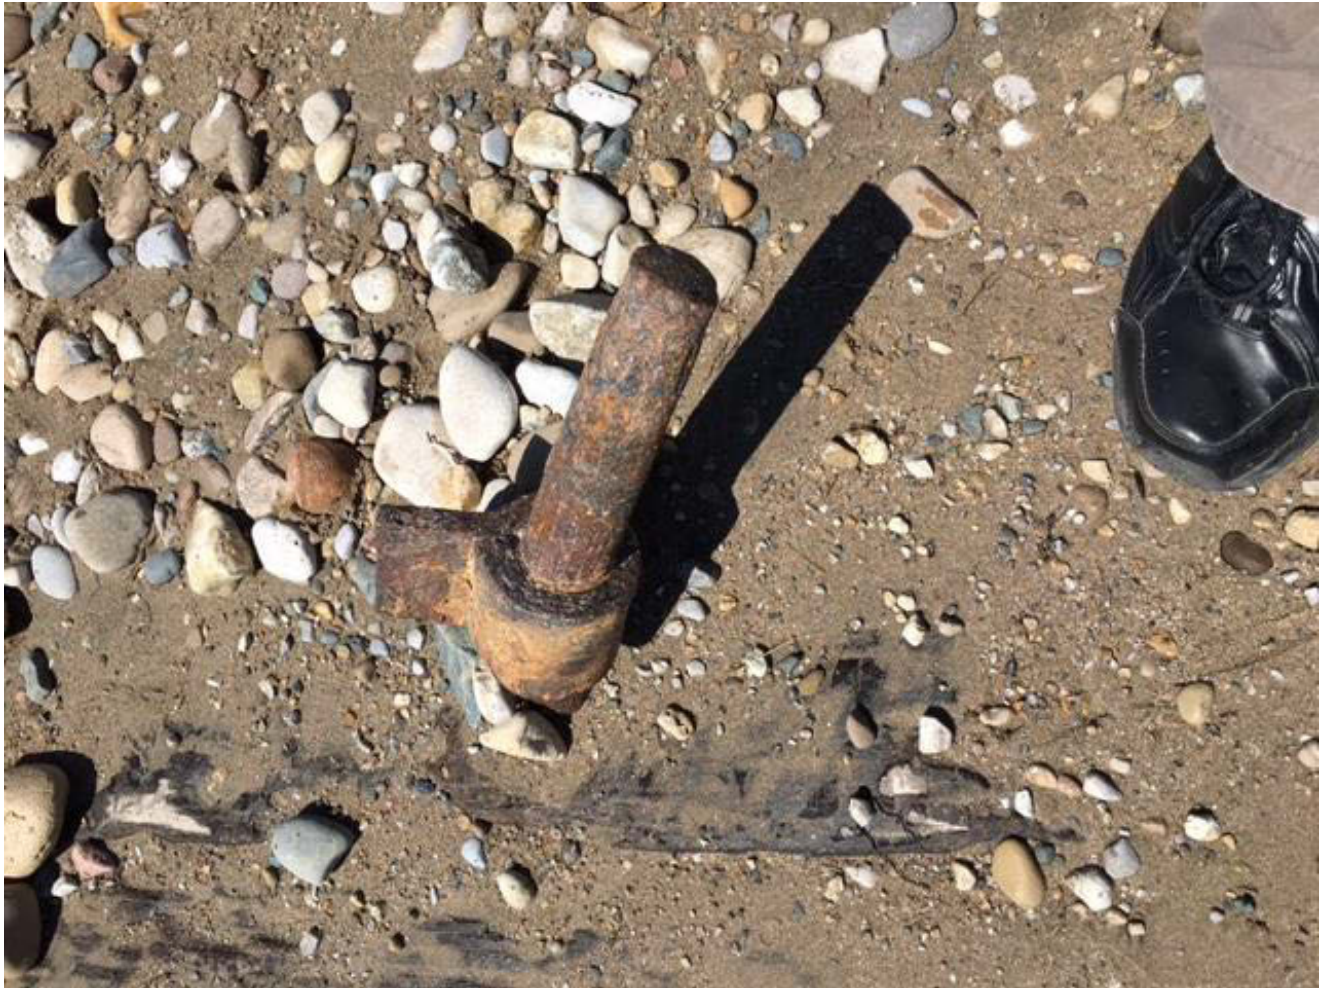
**Photograph 11: Pivot Pin Coming Through Planking (May 2021)**

Centerboards are derived from leeboards and sliding keels. They were used generally in vessels that were more flat-bottomed. The sliding keels were present in some early ships on the Great Lakes; however, this was quickly replaced in favour of the pivoted centerboard. The pivot bolt is, in fact, the key element of the centerboard and is present on this centerboard box casing (Image 11 and 15) labelled **Piece 2** in this report.

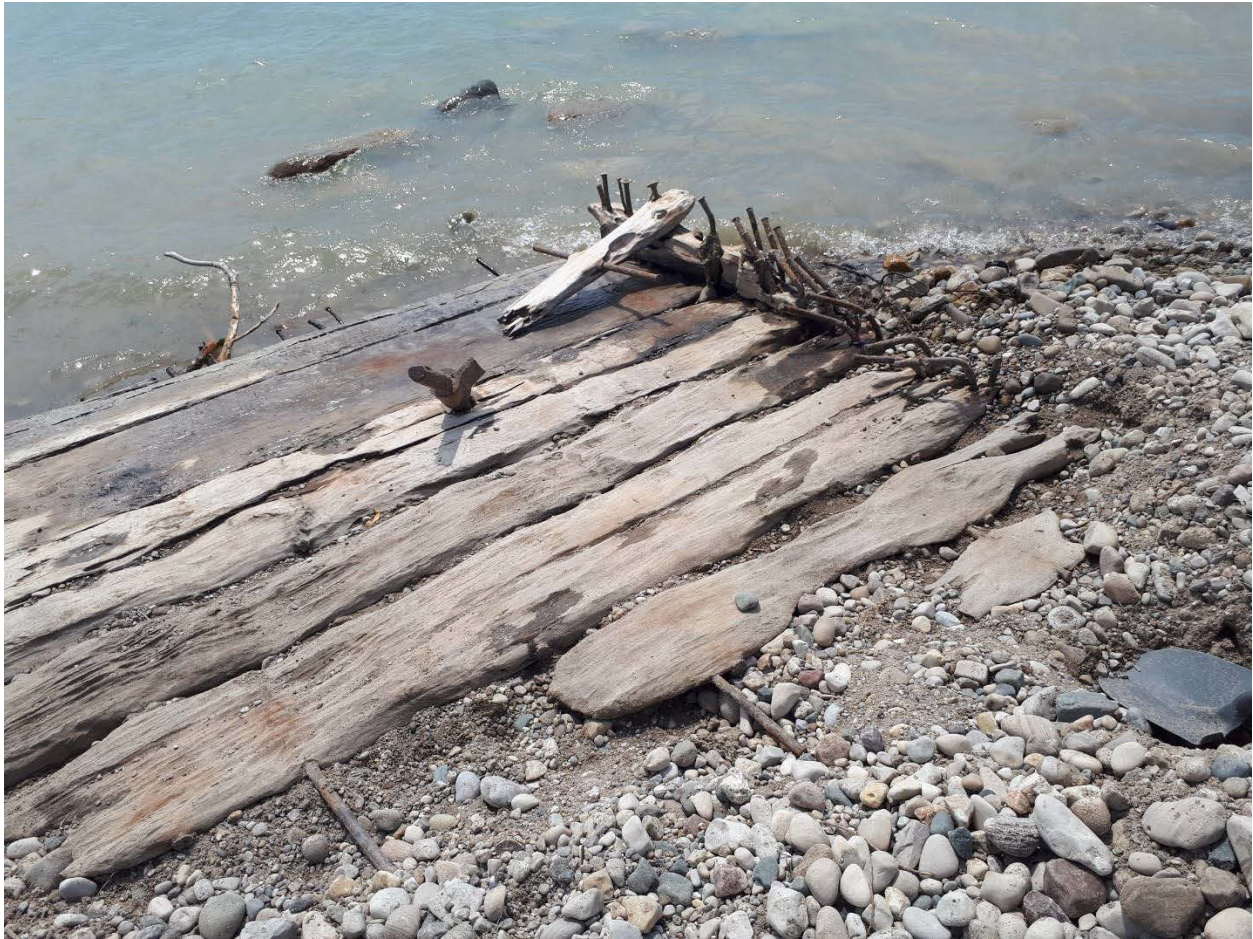
**Image 15: North End of Piece 2 with Pivot Pin (June 2021)**

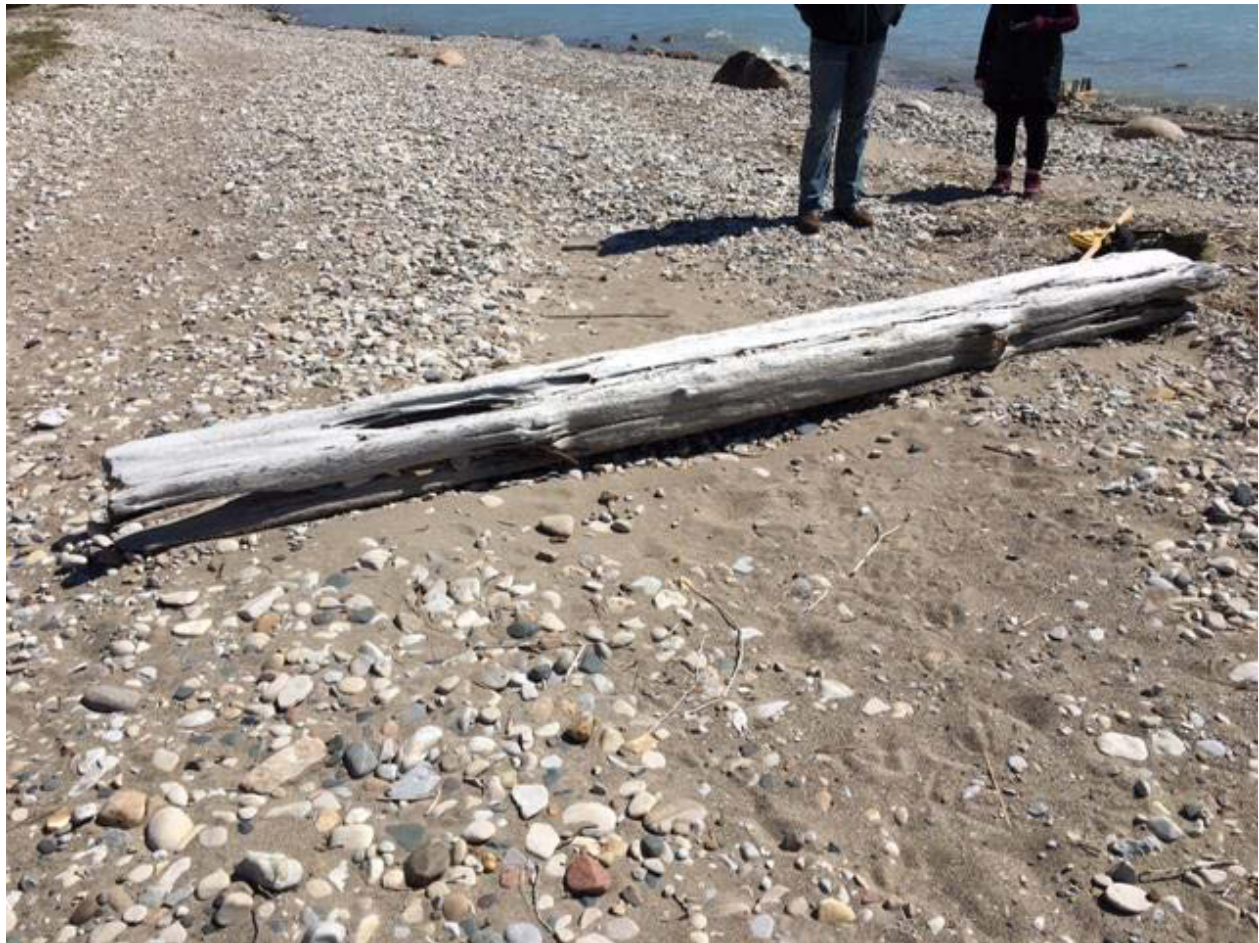
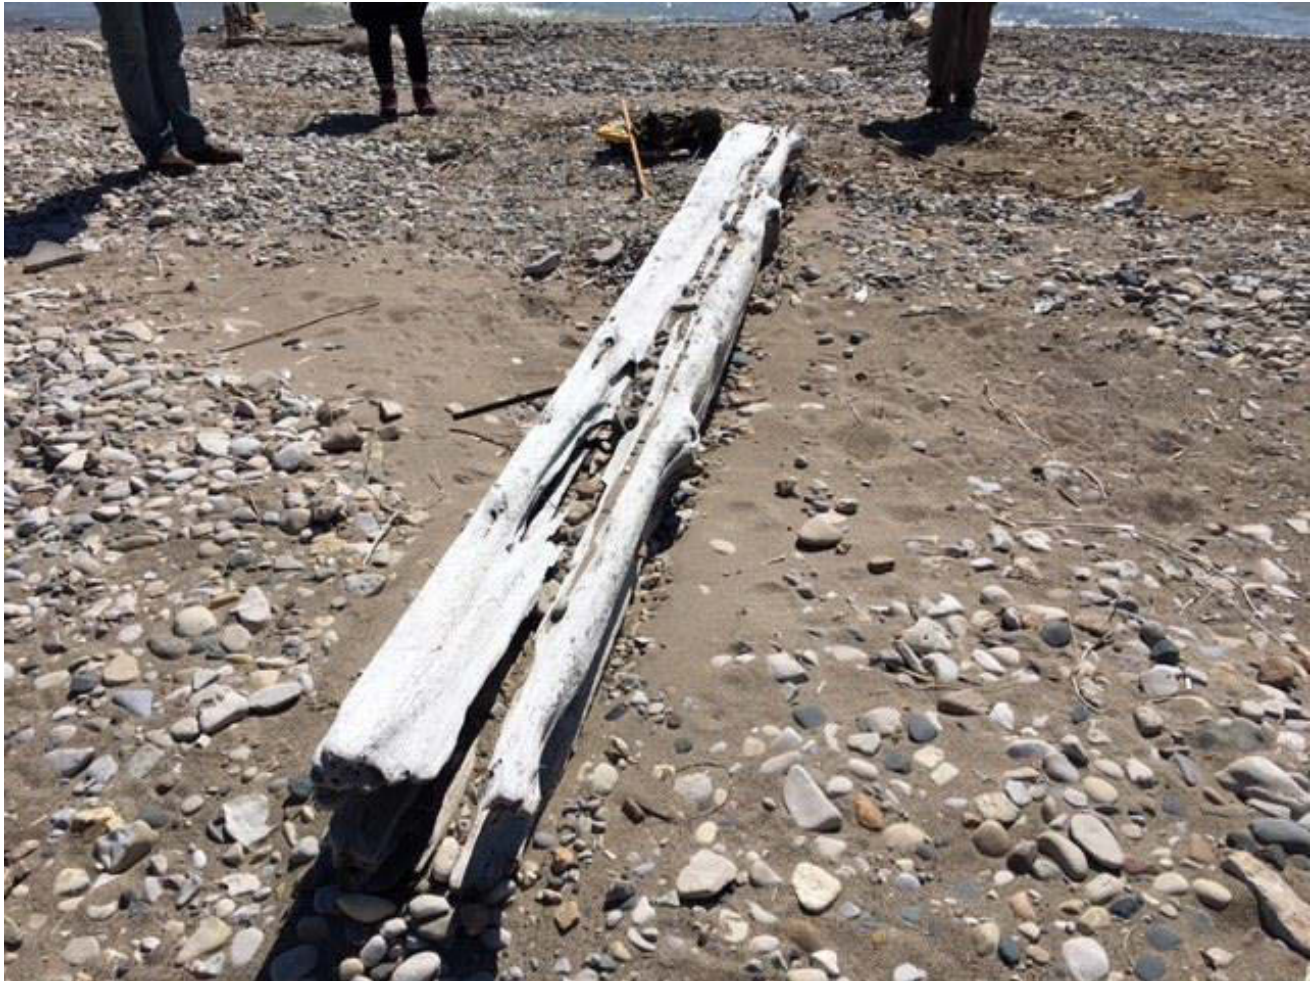
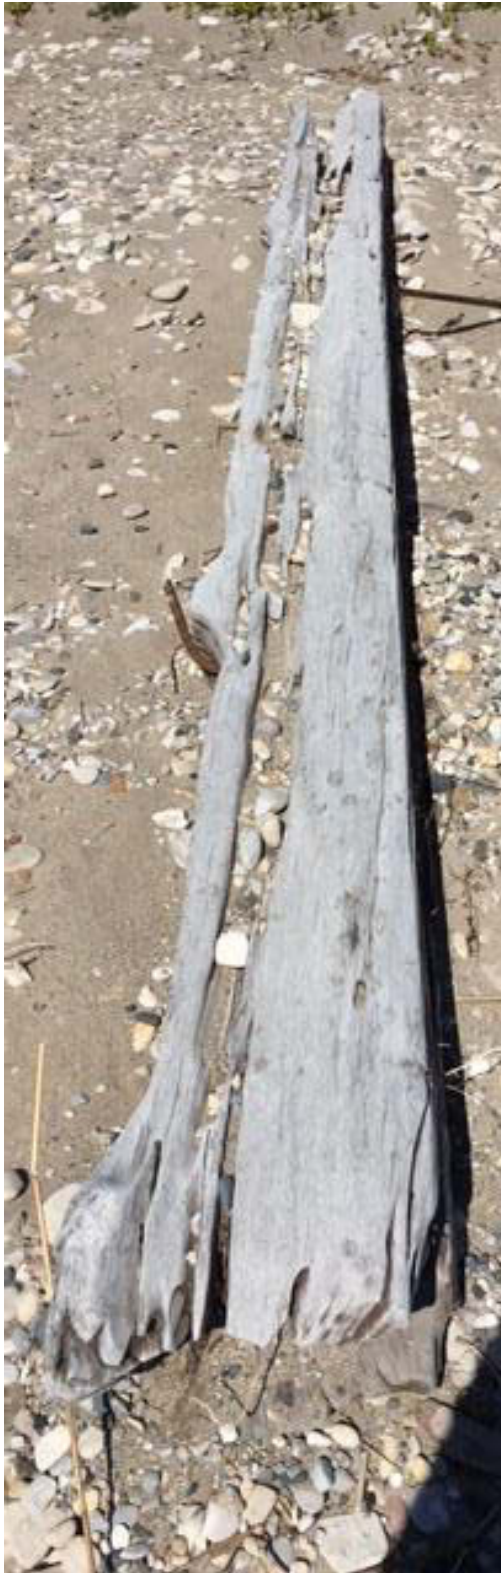
**Piece 3** is a single piece of planking. The wood appears different from Piece 1 and 2. The piece may be from another wreck, however, shipbuilding routinely used many different types of wood for construction, so it is more likely from the same wreck. The piece measures 13' 6" (4.14528m) in length with a width of 11' (.033528m). **Piece 3** (Photographs 17 to 19) shows two (possibly 3) slight projections along one side. There are also iron fasteners on the piece. Function of the piece is unknown at this time. Piece 3 is located about five metres east of Piece 2.

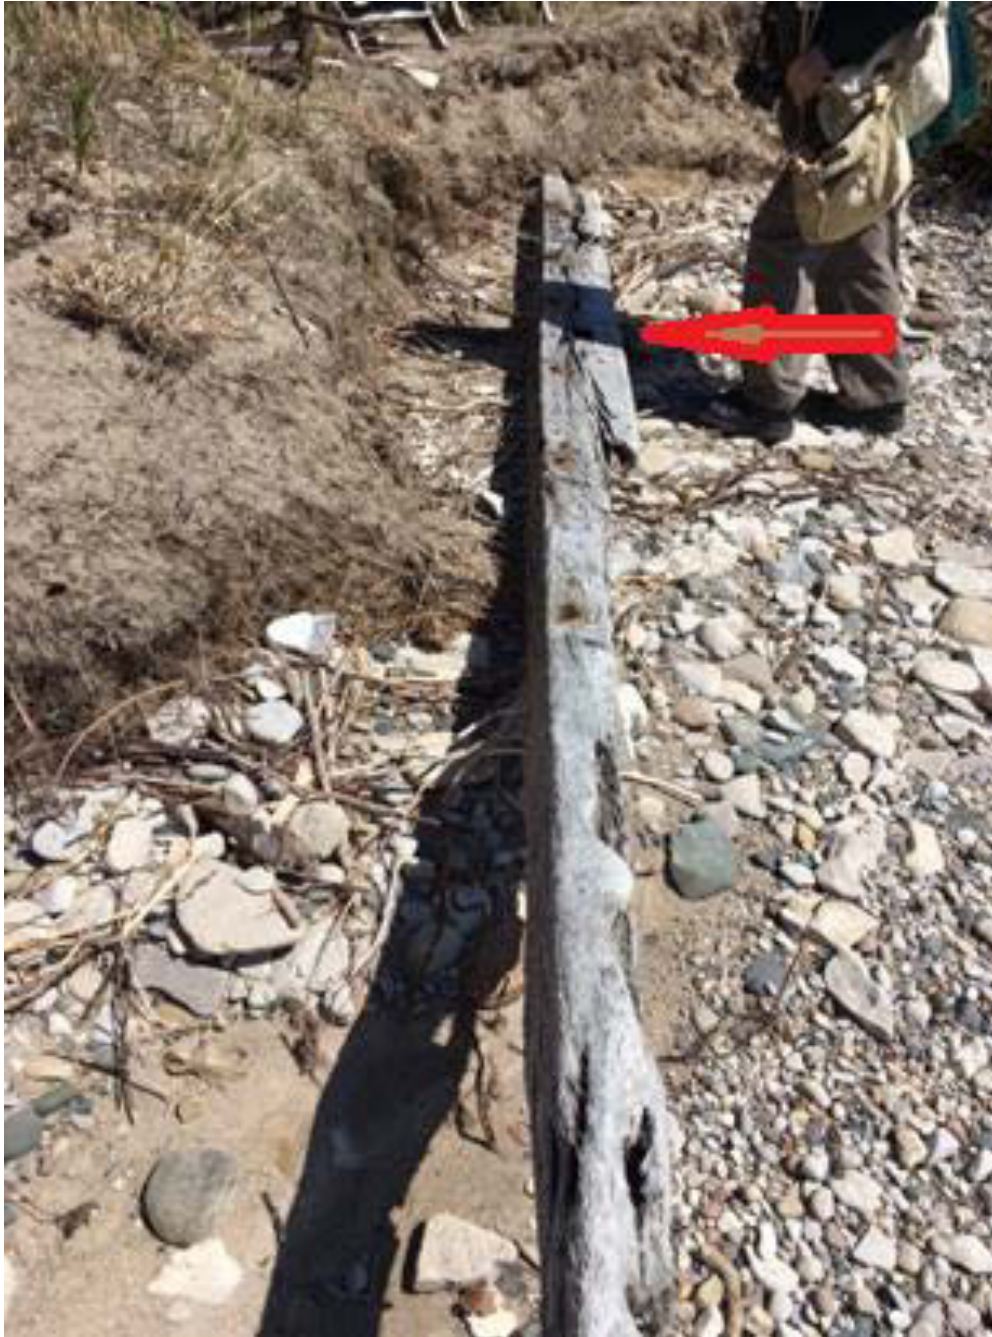
**Piece 4** is a single piece of wood with a small rectangular indentation. The indentation appears too small for mast step but may possibly be a step for an interior support. The piece was located at: 44.060560 latitude, -81.750812 longitude, near 143 Huron Road.

**Image 20: Piece 4 showing Rectangular Small "Step"**
