**MARINE ARCHAEOLOGICAL ASSESSMENT  
OF WRECKAGE FOUND ALONG  
POINT CLARK BEACH  
LAKE HURON**

**Licence No. 2021-08**

**Licence Holder: Scarlett Janusas**

**May 8, 2024**

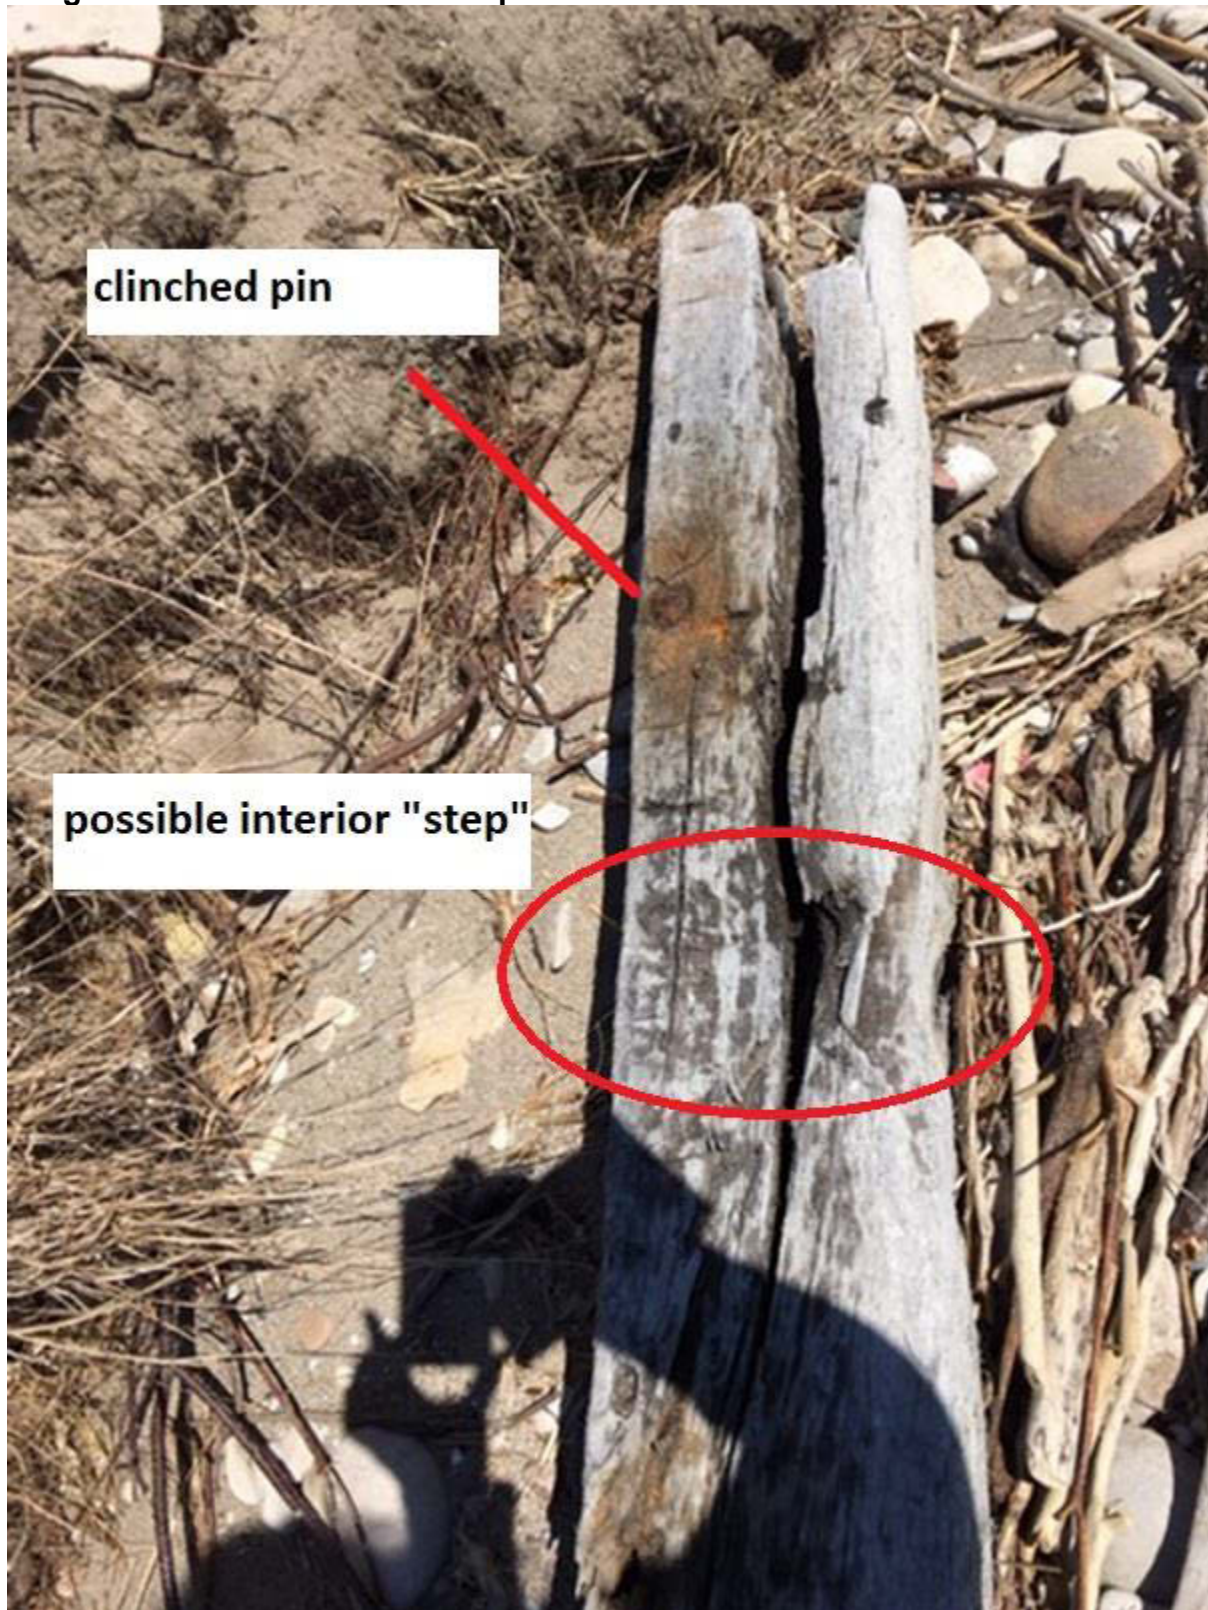
This piece also had iron bolts, one of which was clinched. There are what appears to be adze marks on one end of the piece. The piece measures 17' 3" long by 9" wide. The small indentation measures 3.5" by 3" with a depth of 1". Images 20 and 21 illustrate the above.

Image 21: Clinched Pin and "Step"

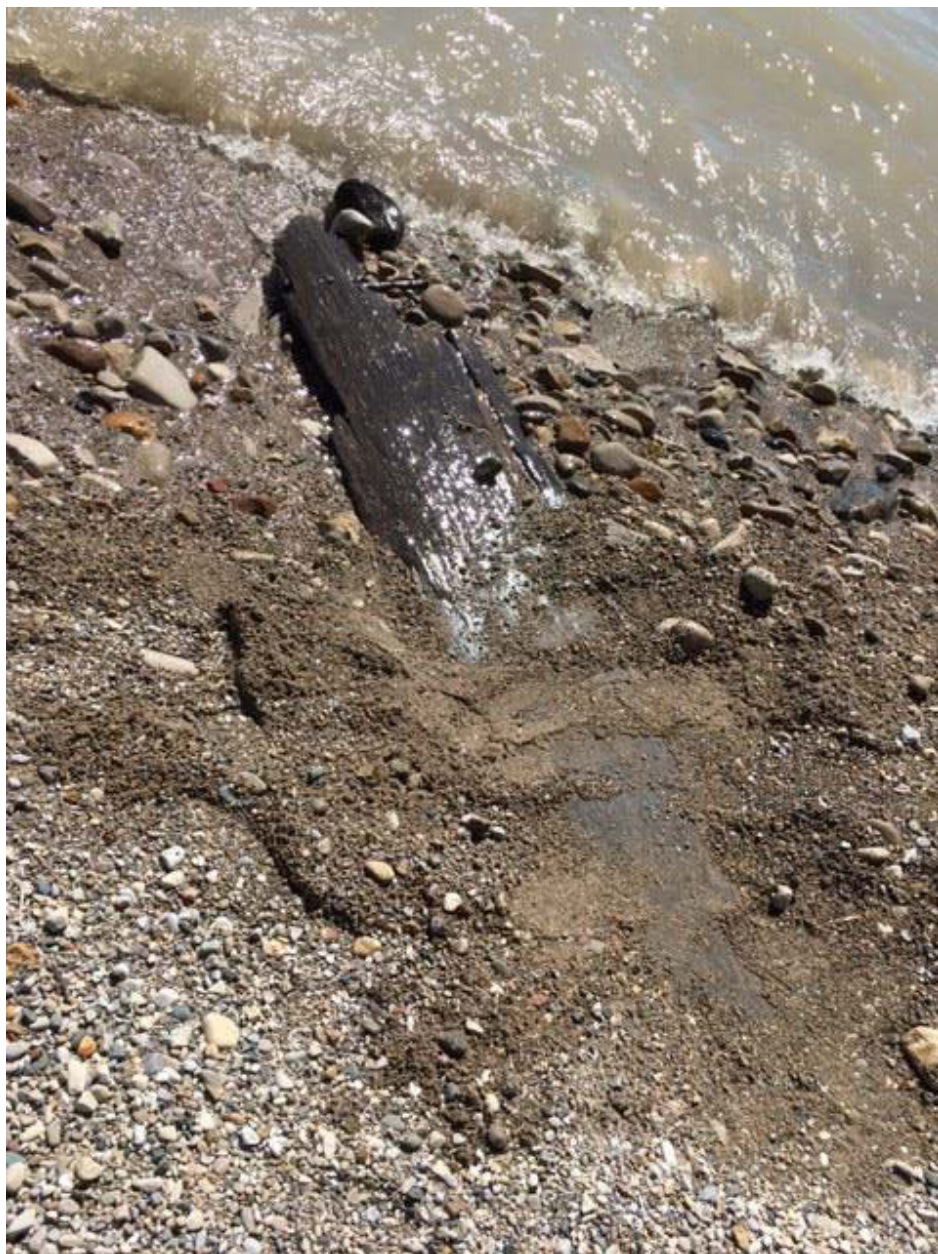
**Piece 5** is similar to **piece 1** having a similar curvature. It is partially buried in the sediment/sand. It was located at 44.061009 latitude, -81.75129 longitude.

Length could not be obtained because of the burial of the piece, but width is 15”.

**Image 22: Partially Buried Piece 5**

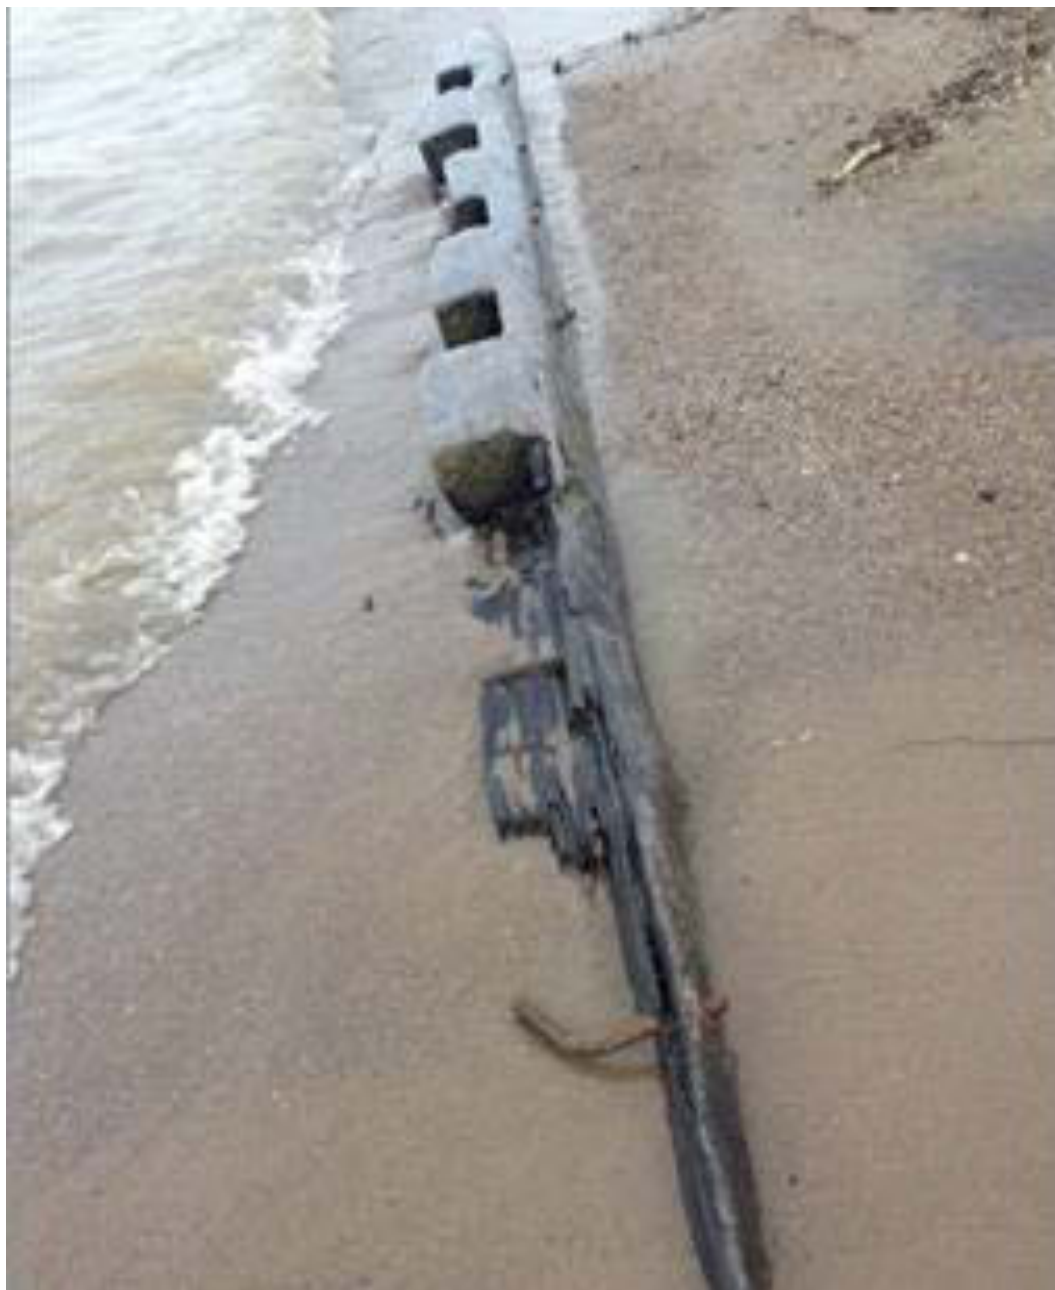
recorded the piece as being 14' in length at that time. OMHC records it as 15'6". Despite the differences in measurements and not knowing how Guasden measured the piece, they are most definitively the same piece. The main difference is the condition of the piece. In 2016 it presents still as a solid piece of wreckage, whereas in 2021, the deterioration of the piece is also clearly evident. She also informed OMHC members that "Cottages in the 60's pushed rocks into long fingers stretching out into the water in order to build docks to launch their boats."

**Image 23: Piece 6 "Discovered" in 2016**

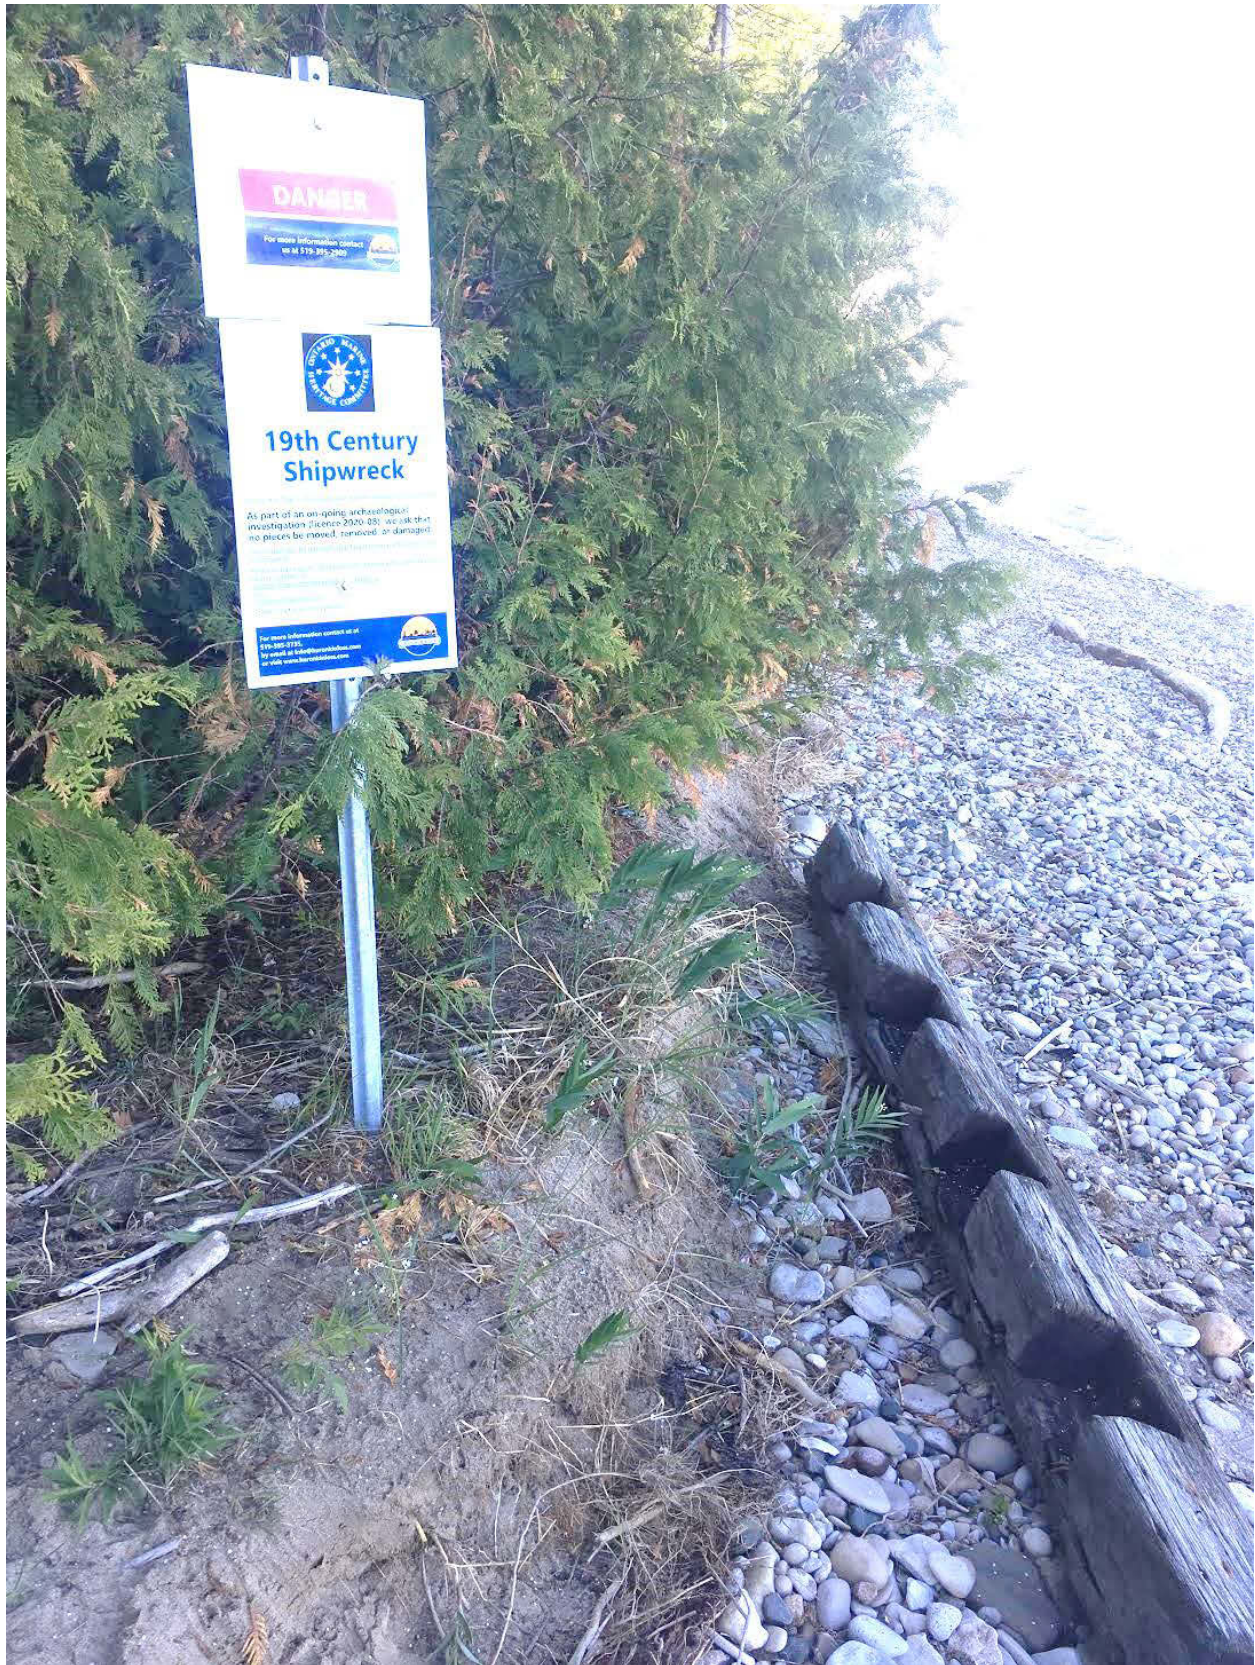
**Piece 6:** is a possible a "pocket piece" and possibly associated with **Piece 2**. There were at least six (6) notches and the length of the entire piece is 15' 6". No width was obtained. The notches were approximately 8" in length with a depth of 4.5", separated by a runner of 5". This piece was located at: 44.061606 latitude, -81.751834 longitude.

Image 24: Piece 6 “rediscovered” in 2021

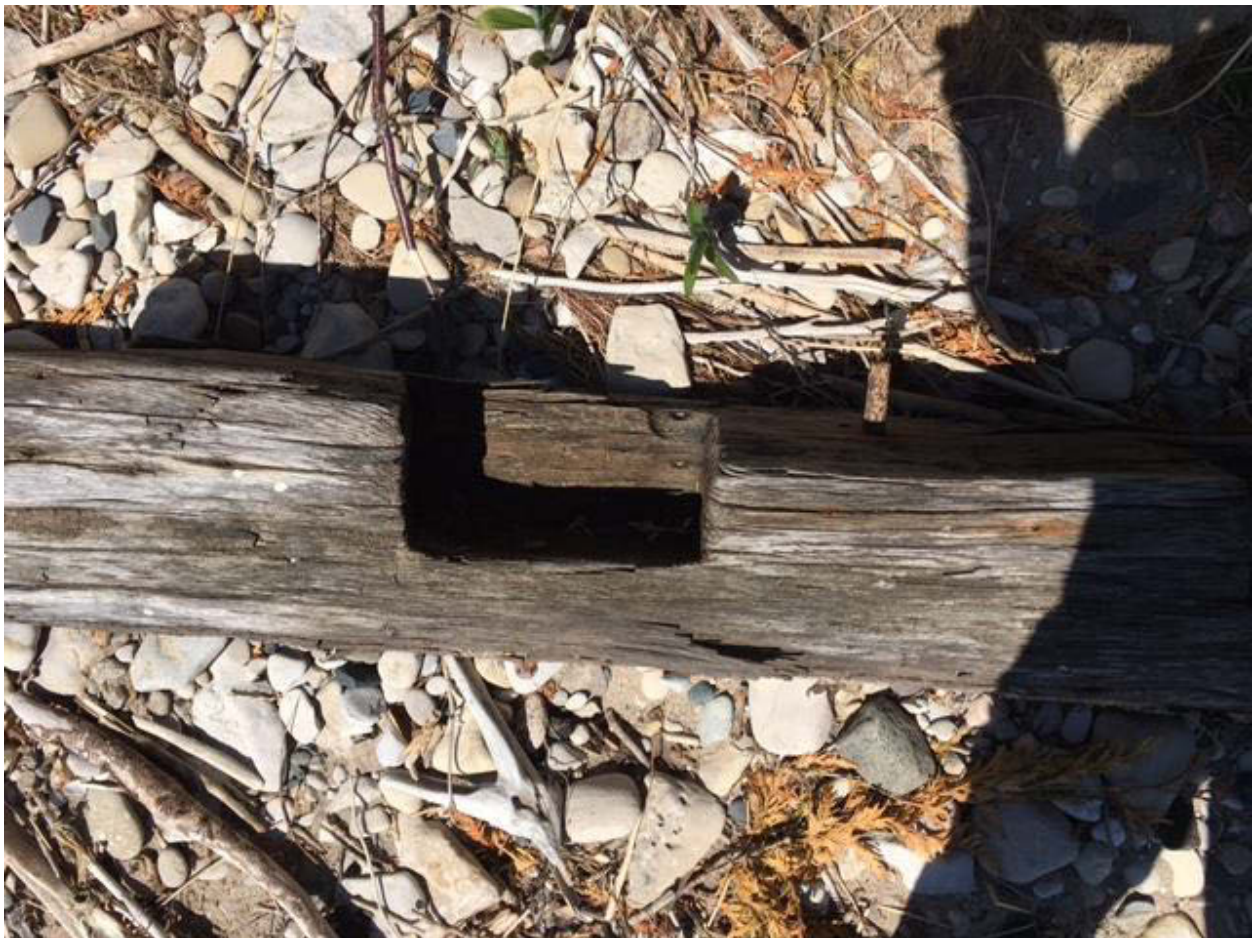
**Image 26: Notching on Piece 6**

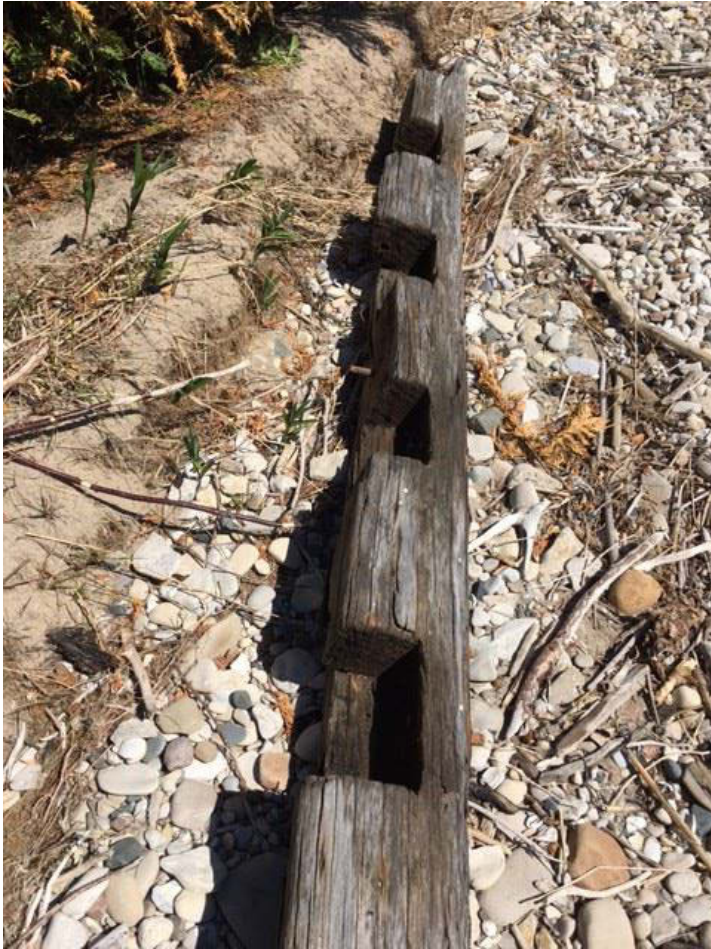
**Image 27: Piece 6 with Notching**

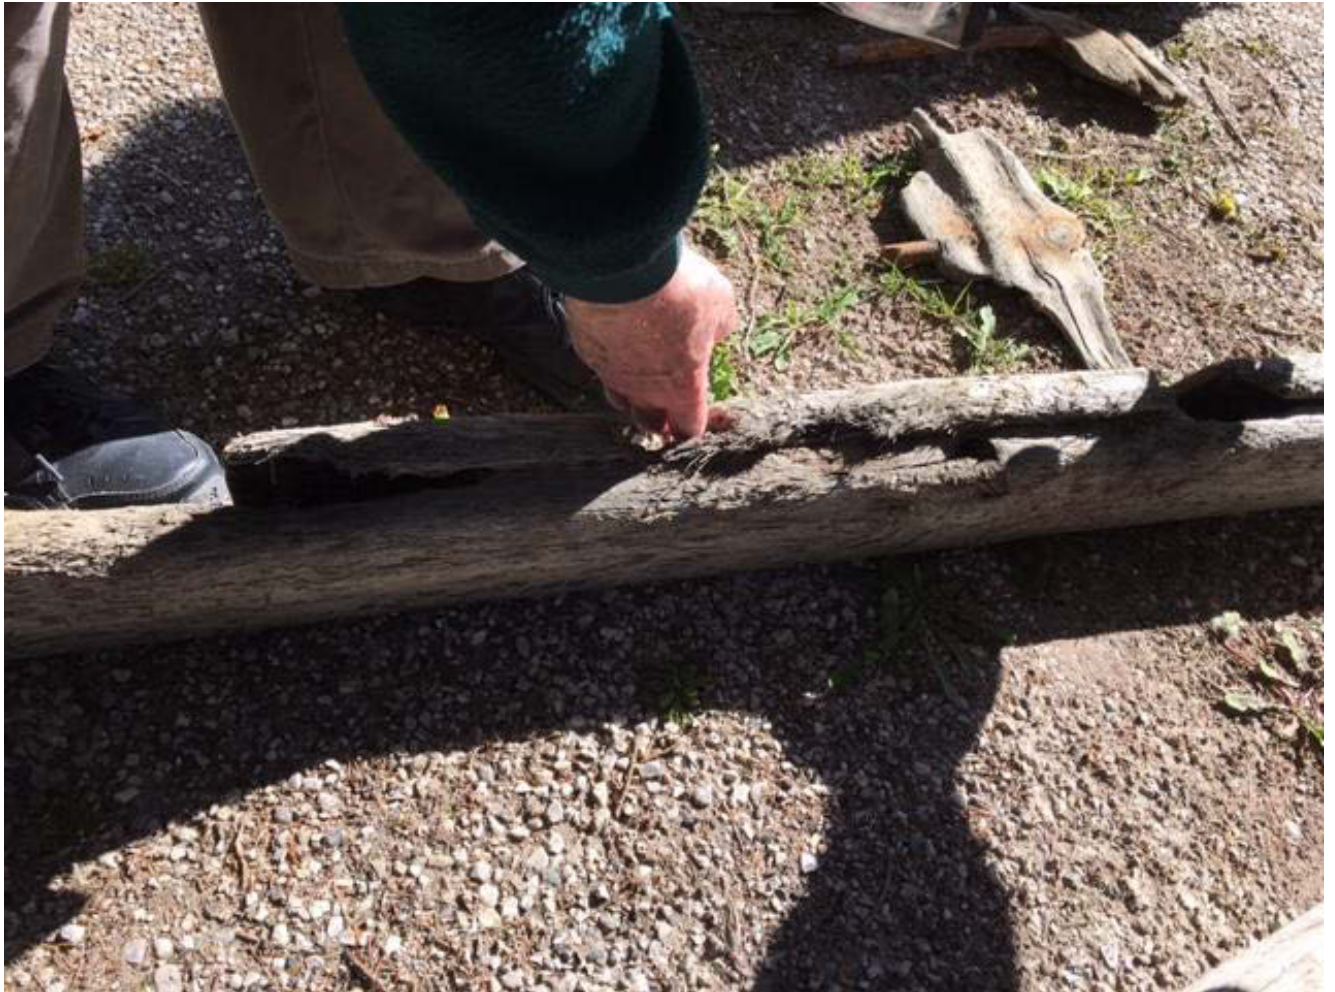
**Image 30: Lip along Edge of Long Piece**

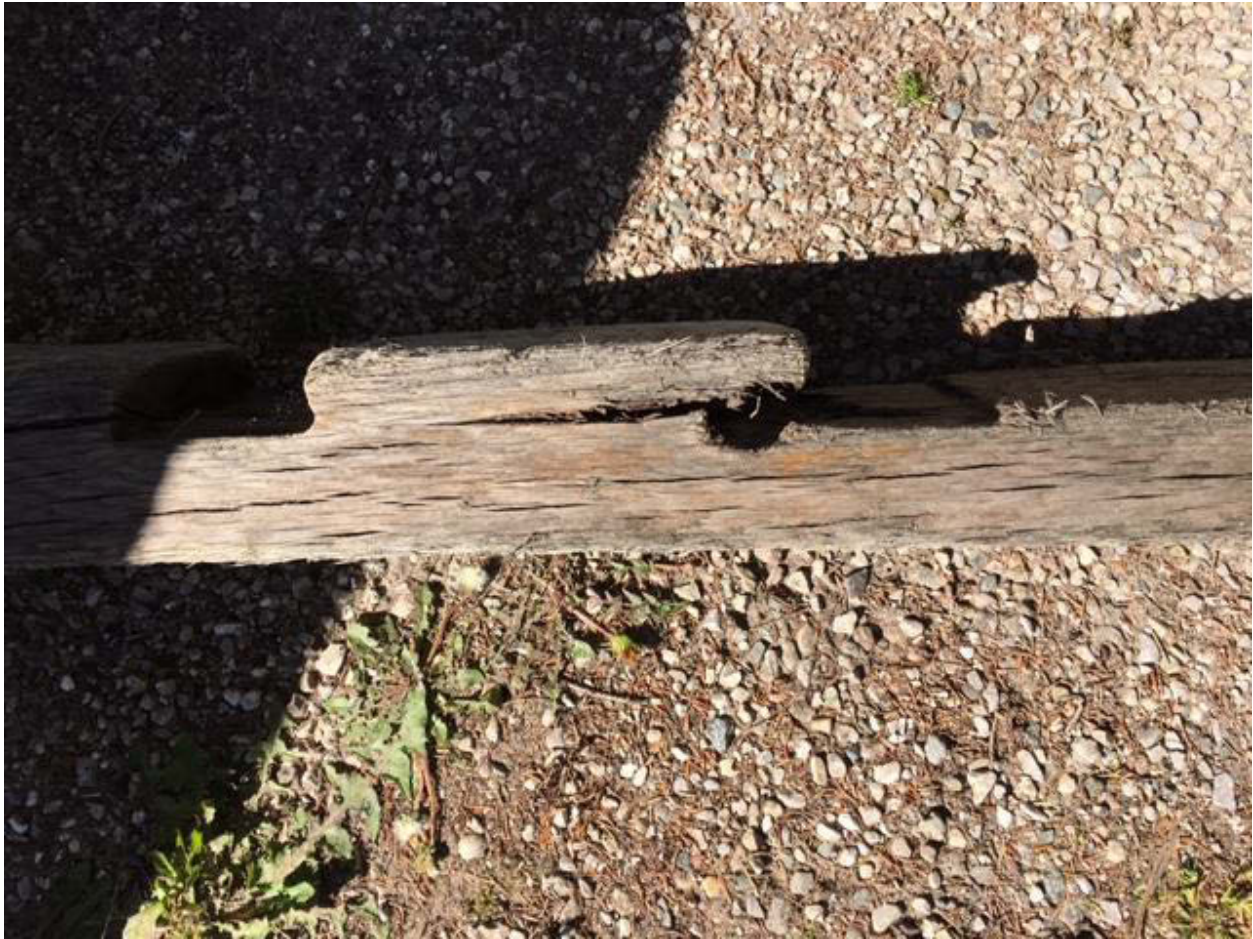
Image 31: Beveled Notching

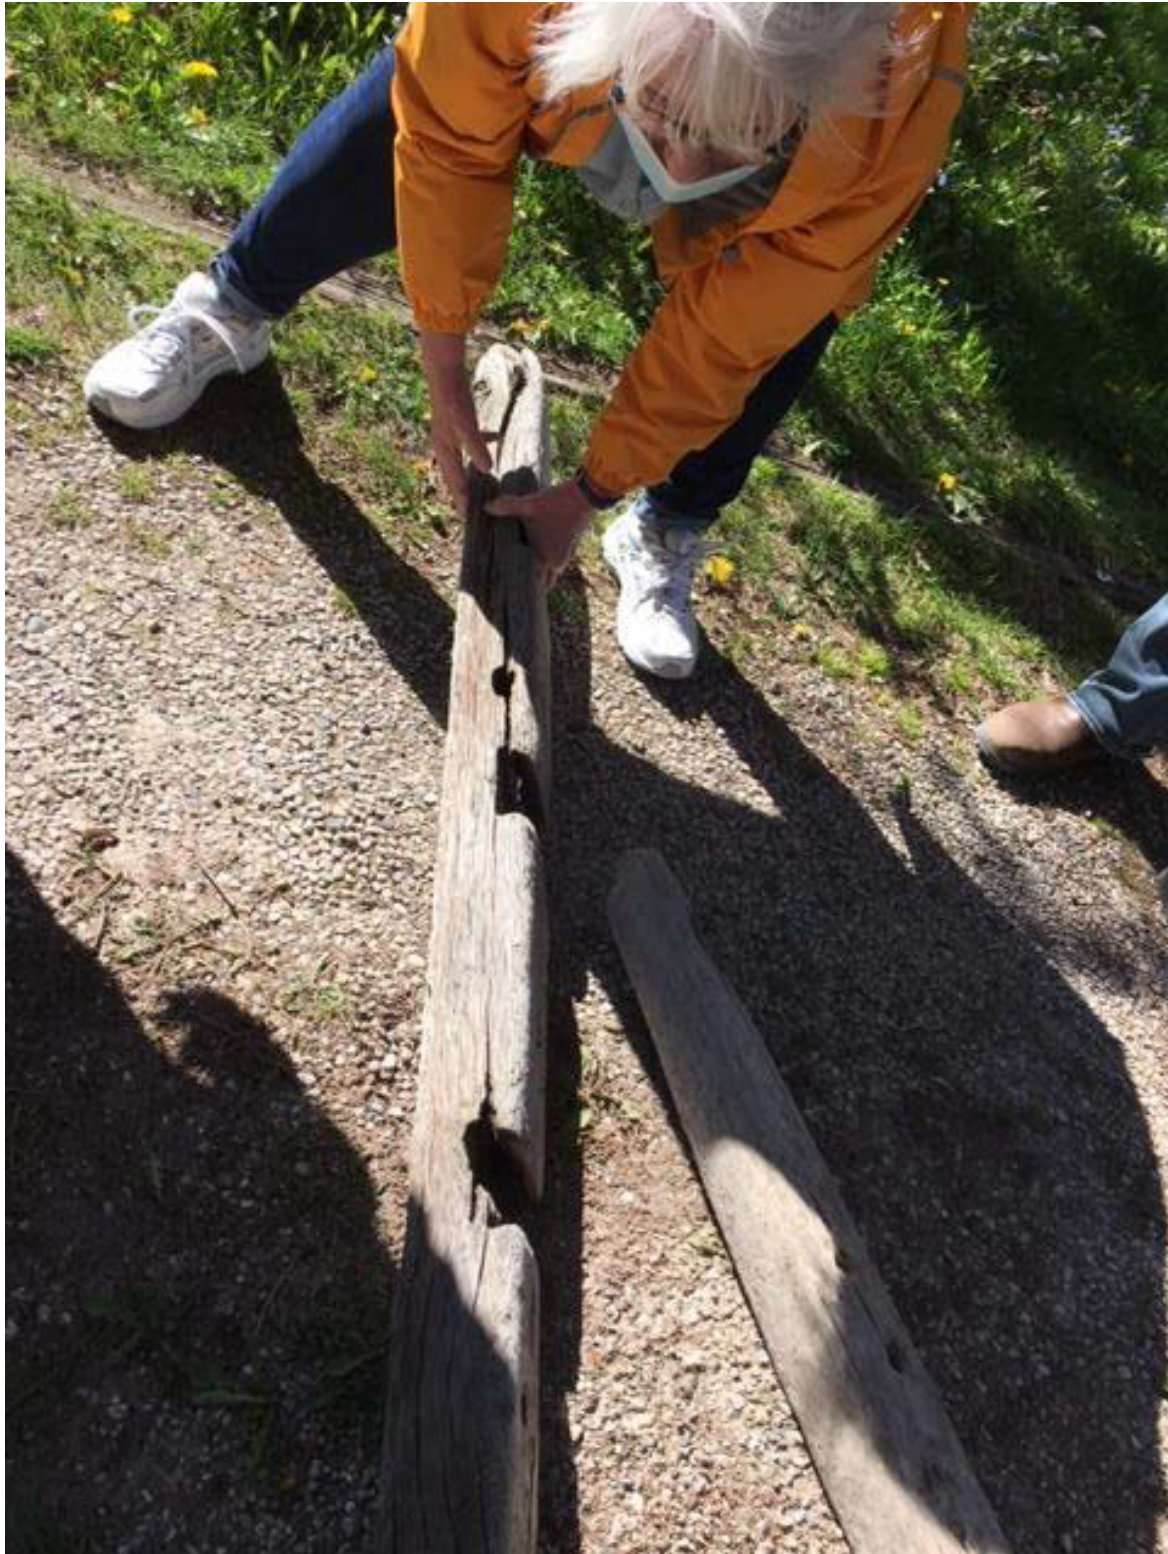
**Image 32: Fastener Hole on Bottom Side of the Piece**

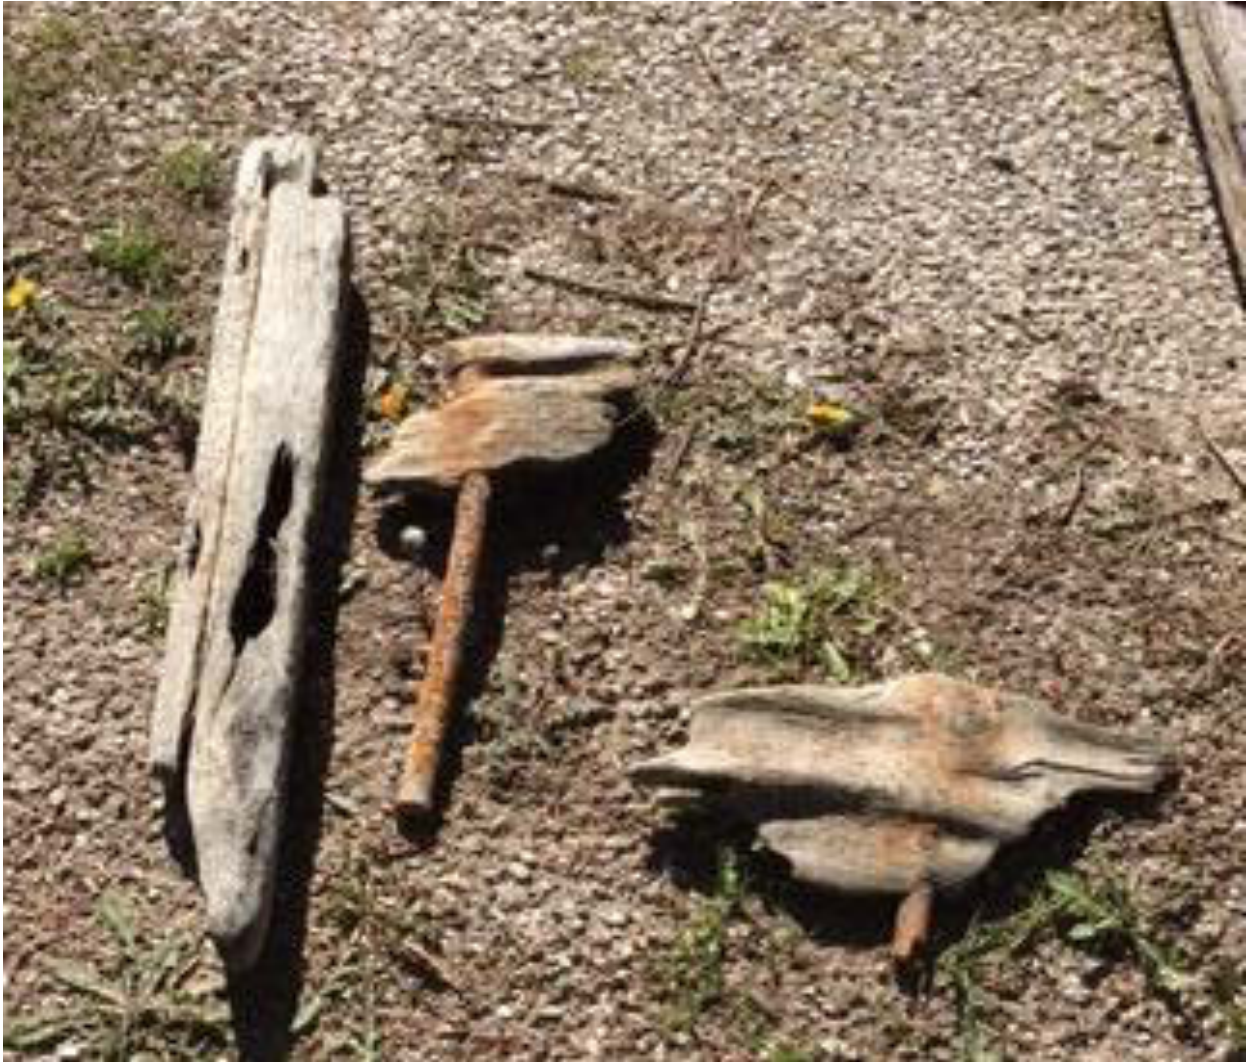
The remaining four other salvaged pieces were very warped and aside from identifying them as wreckage, they could not be assigned clear functionality. Two had iron fasteners running through them. Three are seen in Image 33 and the fourth piece is seen beside the large, notched piece above in Image 32.

**Image 33: Pieces salvaged from Burn Pile**

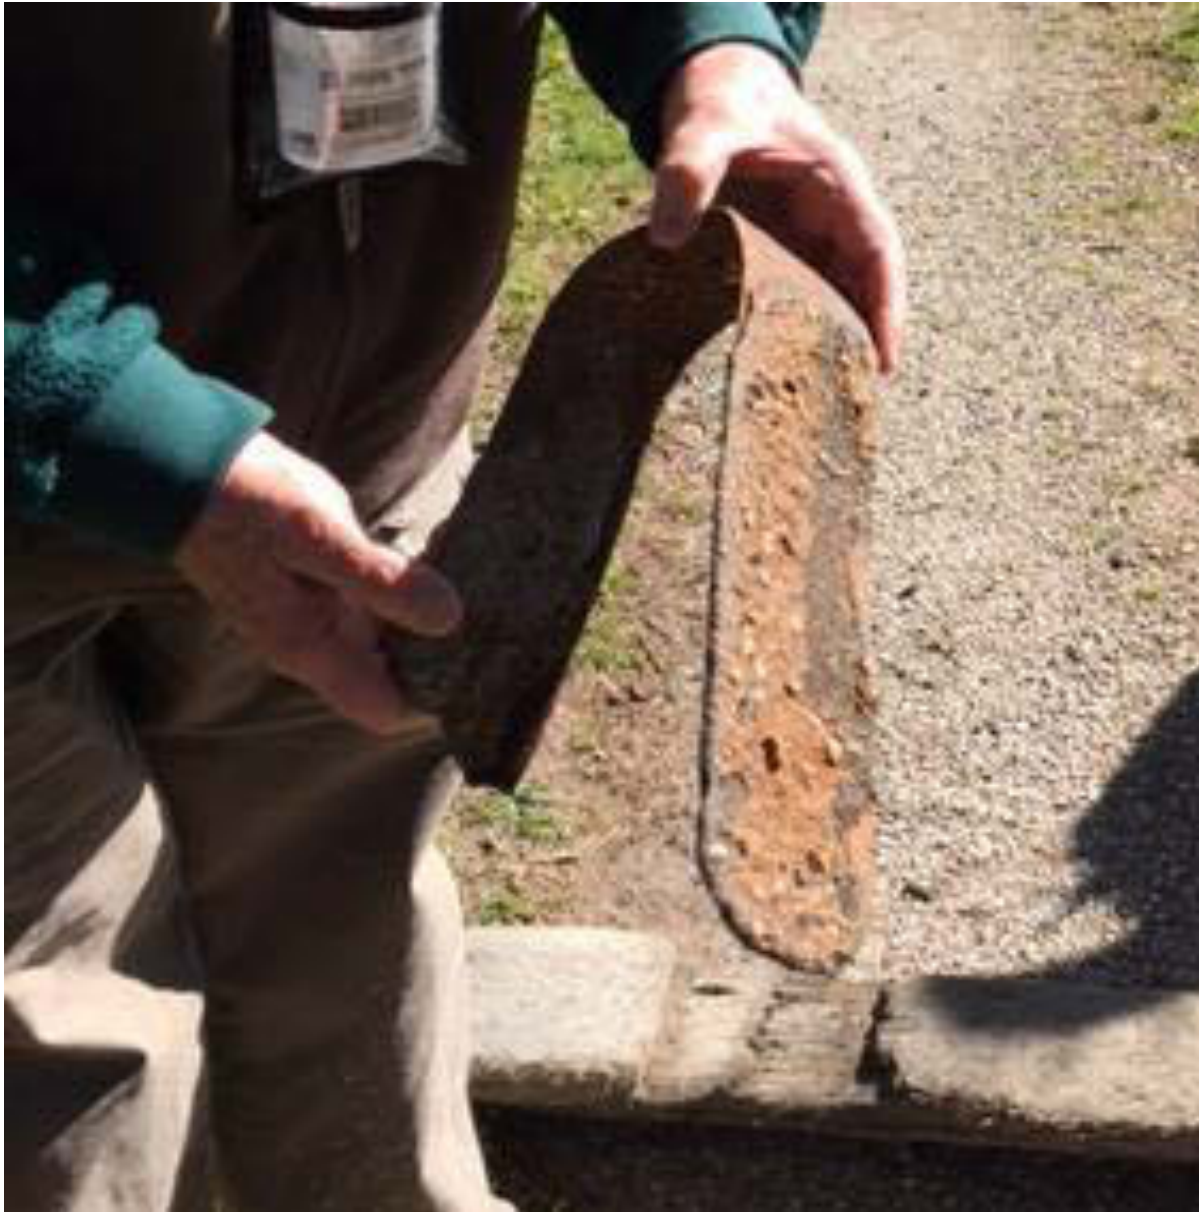
Another piece was a flat band of metal that was curved. It is not known if this was its original configuration or if wave action and wreckage process contributed to its shape, but it is likely to have been some strapping material (Image 34).

**Image 34: Flat Metal Strapping**

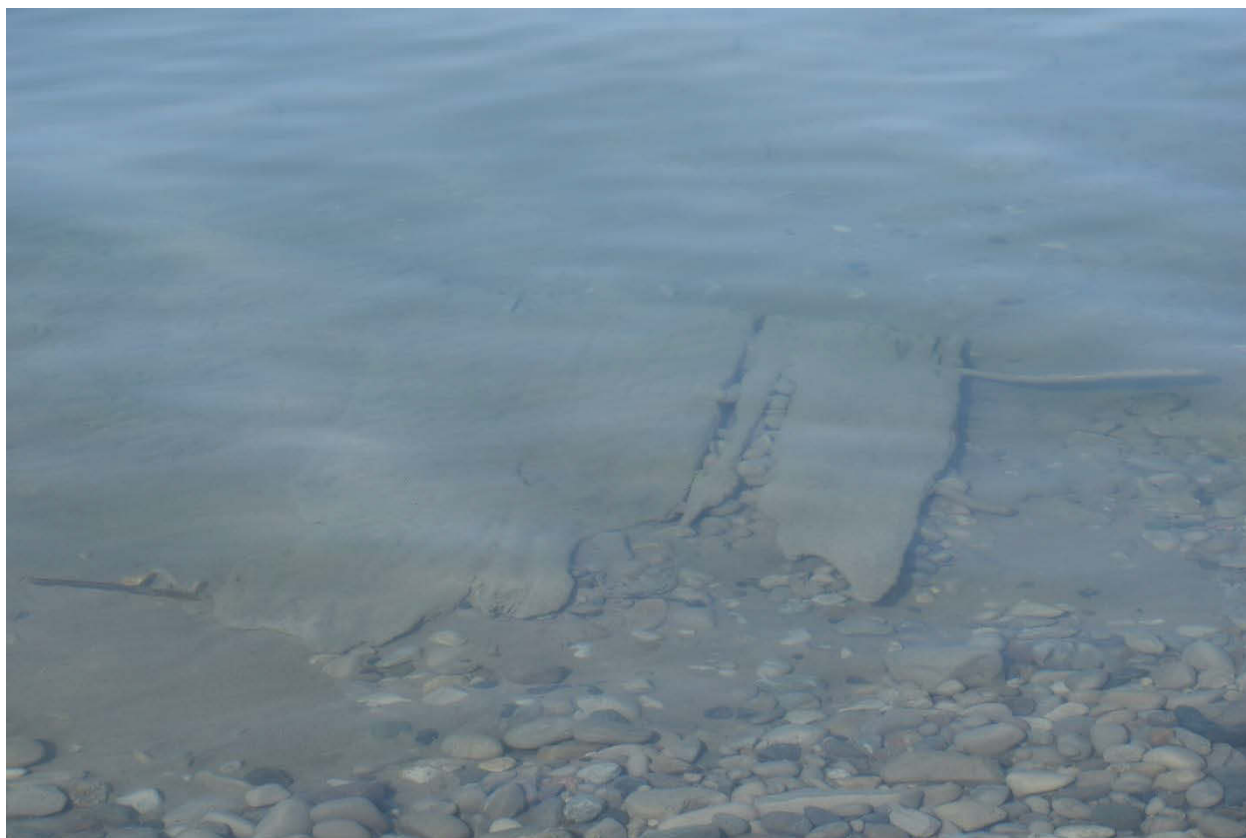
**Image 35: Part of Centreboard Box (Piece 9)**

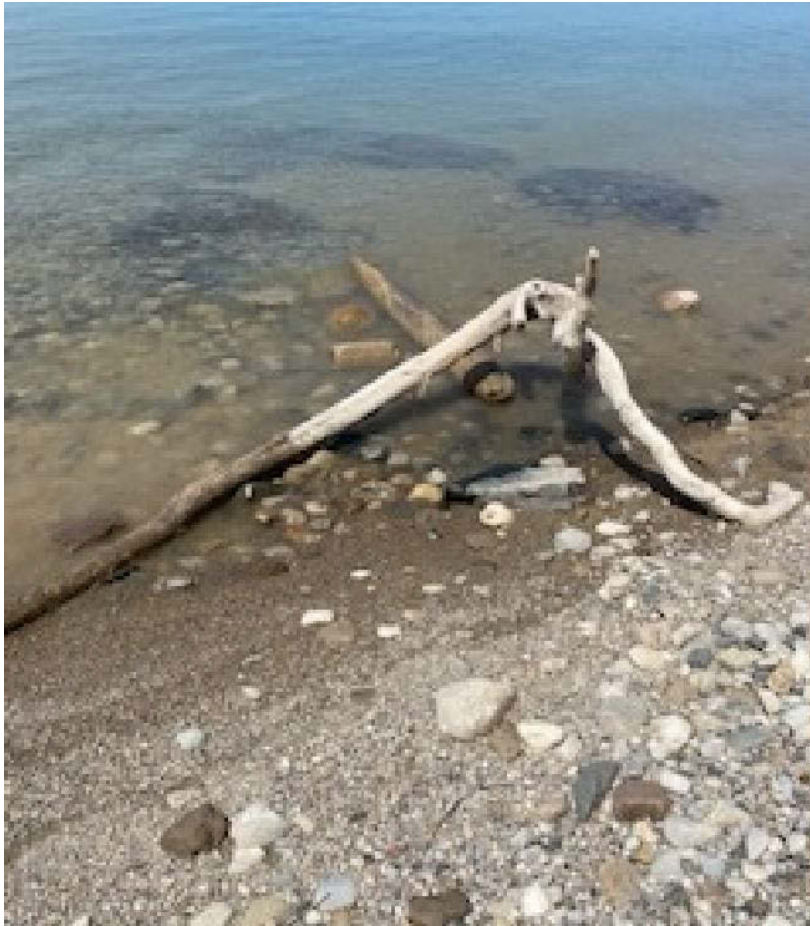
Virginia Elliott reported wreckage south of the lighthouse off Cedar Trail. These were investigated and determined to be remnants of docks/piers rather than a shipwreck. Images 36 – 38 illustrate these finds and Figure 3 shows the location of these pieces.

**Image 36: Round logs – possibly part of pier/wharf**

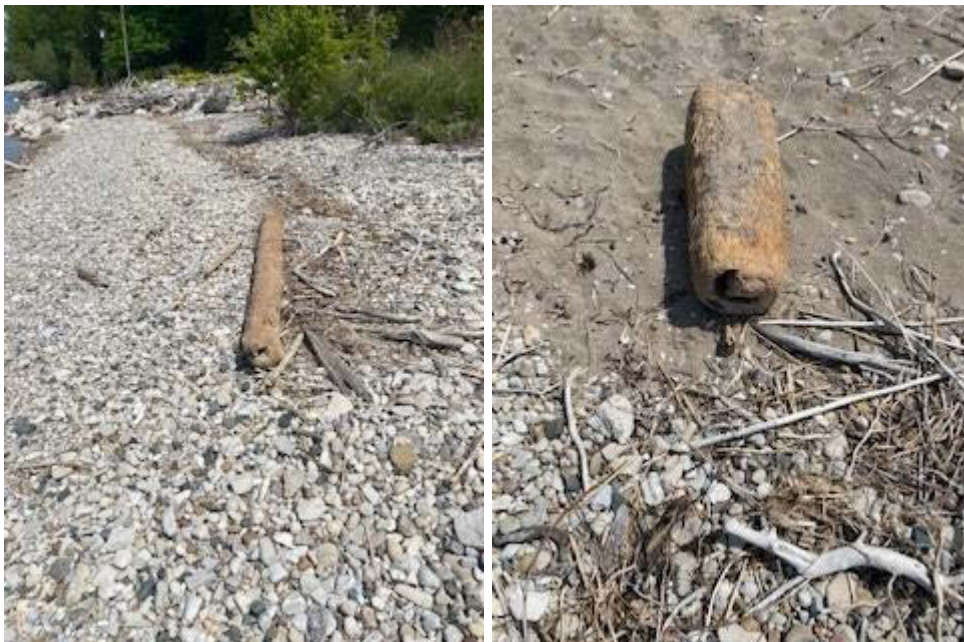
**Image 37: Round logs – possibly part of wharf or pier/crib**

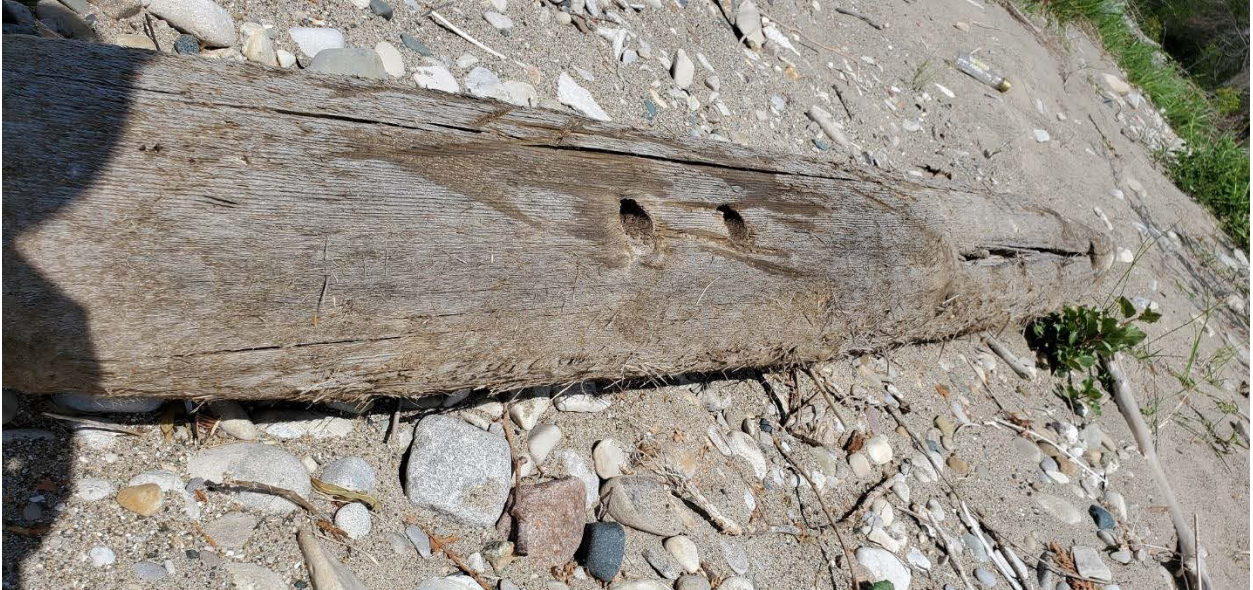
Greg Ernest reported a piece in the water and provided a general location and photographs but the find was not verified by OMHC members. Based on the rounded timber, it is also not likely to be part of a shipwreck, but more likely part of a pier/wharf construction.

**Image 38: Rounded timber with bolt holes**

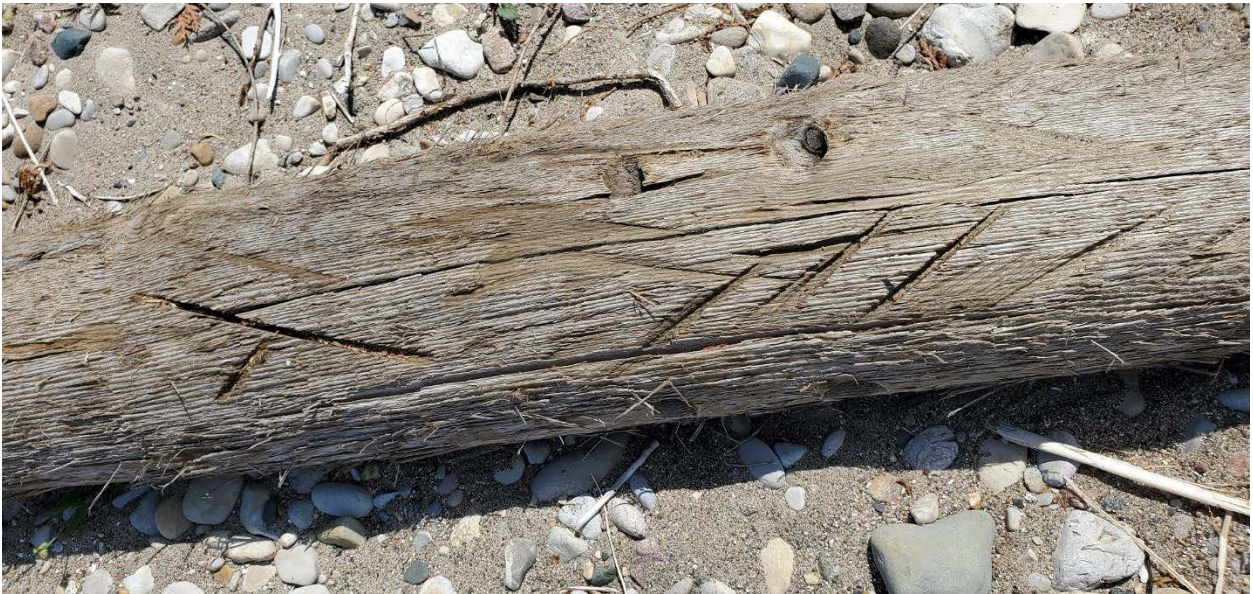
**Image 39: Rounded log with bolt holes and recent axe marks**

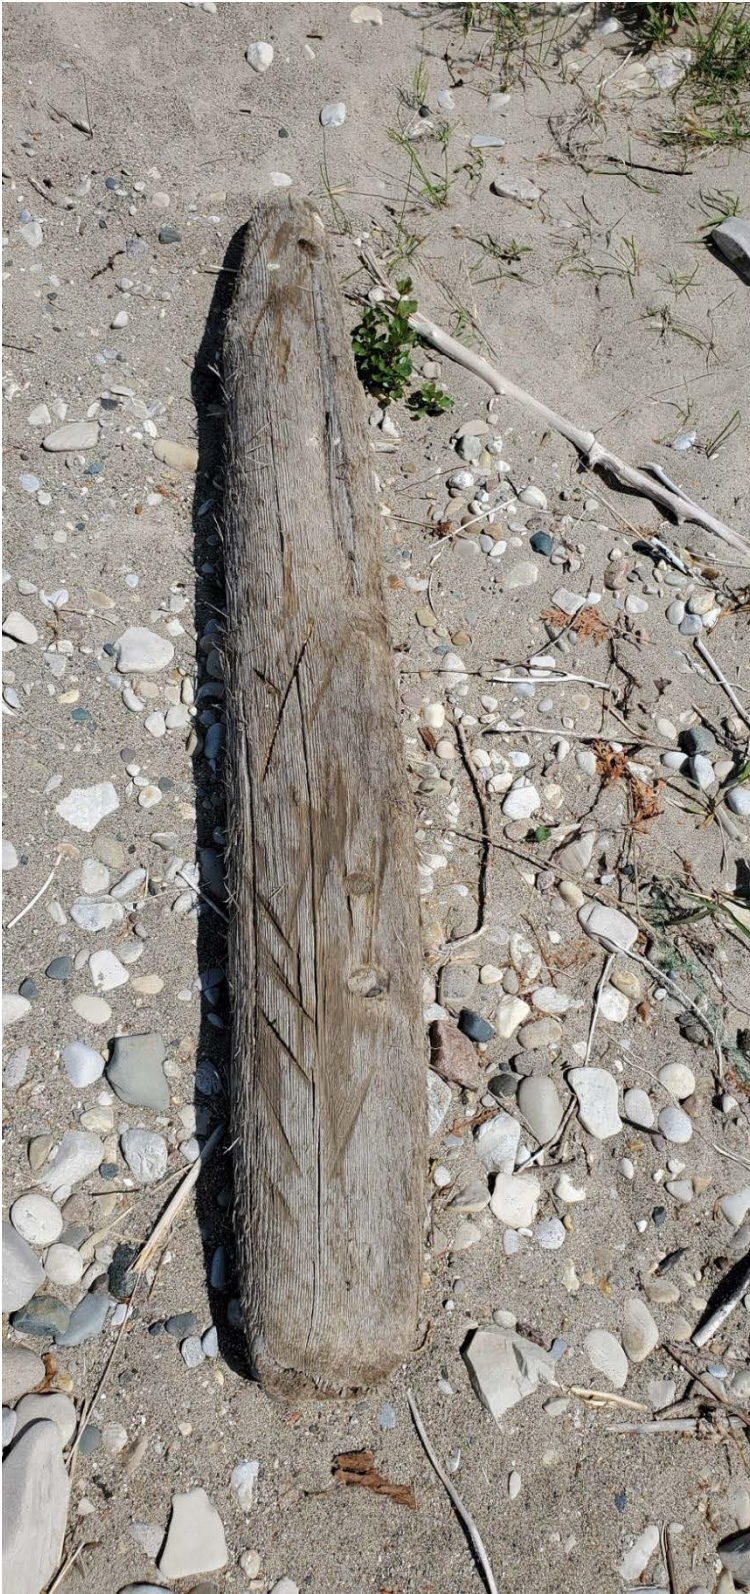
**Image 40: Opposite side of rounded log showing bolts were through bolts**

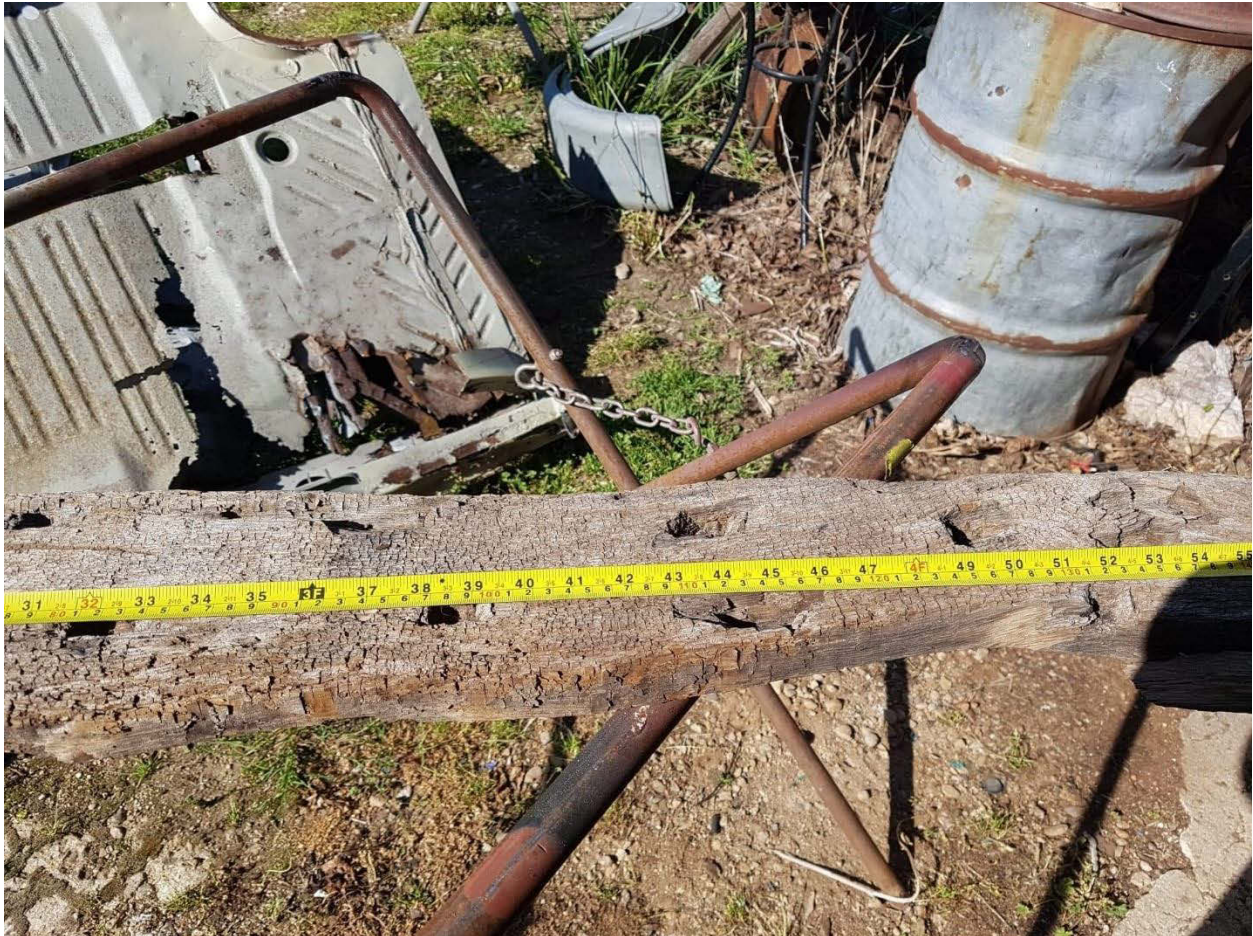
Other pieces were reported to the team but recovered and no longer in situ (that is, they have been moved from the beach on which they were washed ashore). One was reported by Carol Phillips (Image 41) and is a plank with many holes for fasteners that appear to have a uniform placement on the plank, - pairs of holes for fasteners run along the entire board. The piece has been subject to extreme deterioration from lack of conservation.

**Image 41: Plank with fastener holes**
