**MARINE ARCHAEOLOGICAL ASSESSMENT  
OF WRECKAGE FOUND ALONG  
POINT CLARK BEACH  
LAKE HURON**

**Licence No. 2021-08**

**Licence Holder: Scarlett Janusas**

**May 8, 2024**

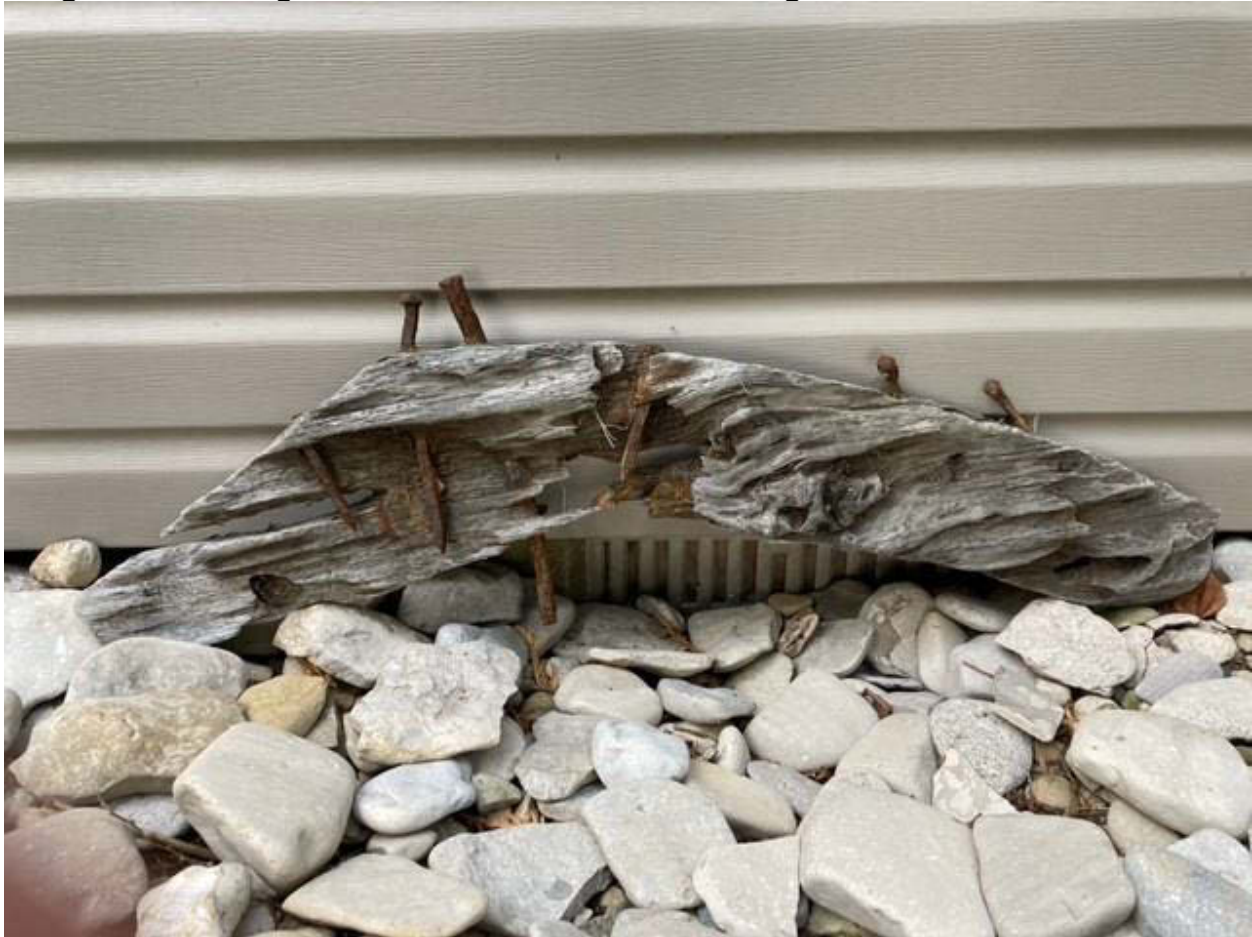
Another piece is located at a cottage fronting the lake (133 Huron). The piece may be a knee, although investigation of the piece was not possible, other than a quick photograph (Image 42).

**Image 42: Wreckage recovered and located at cottage**

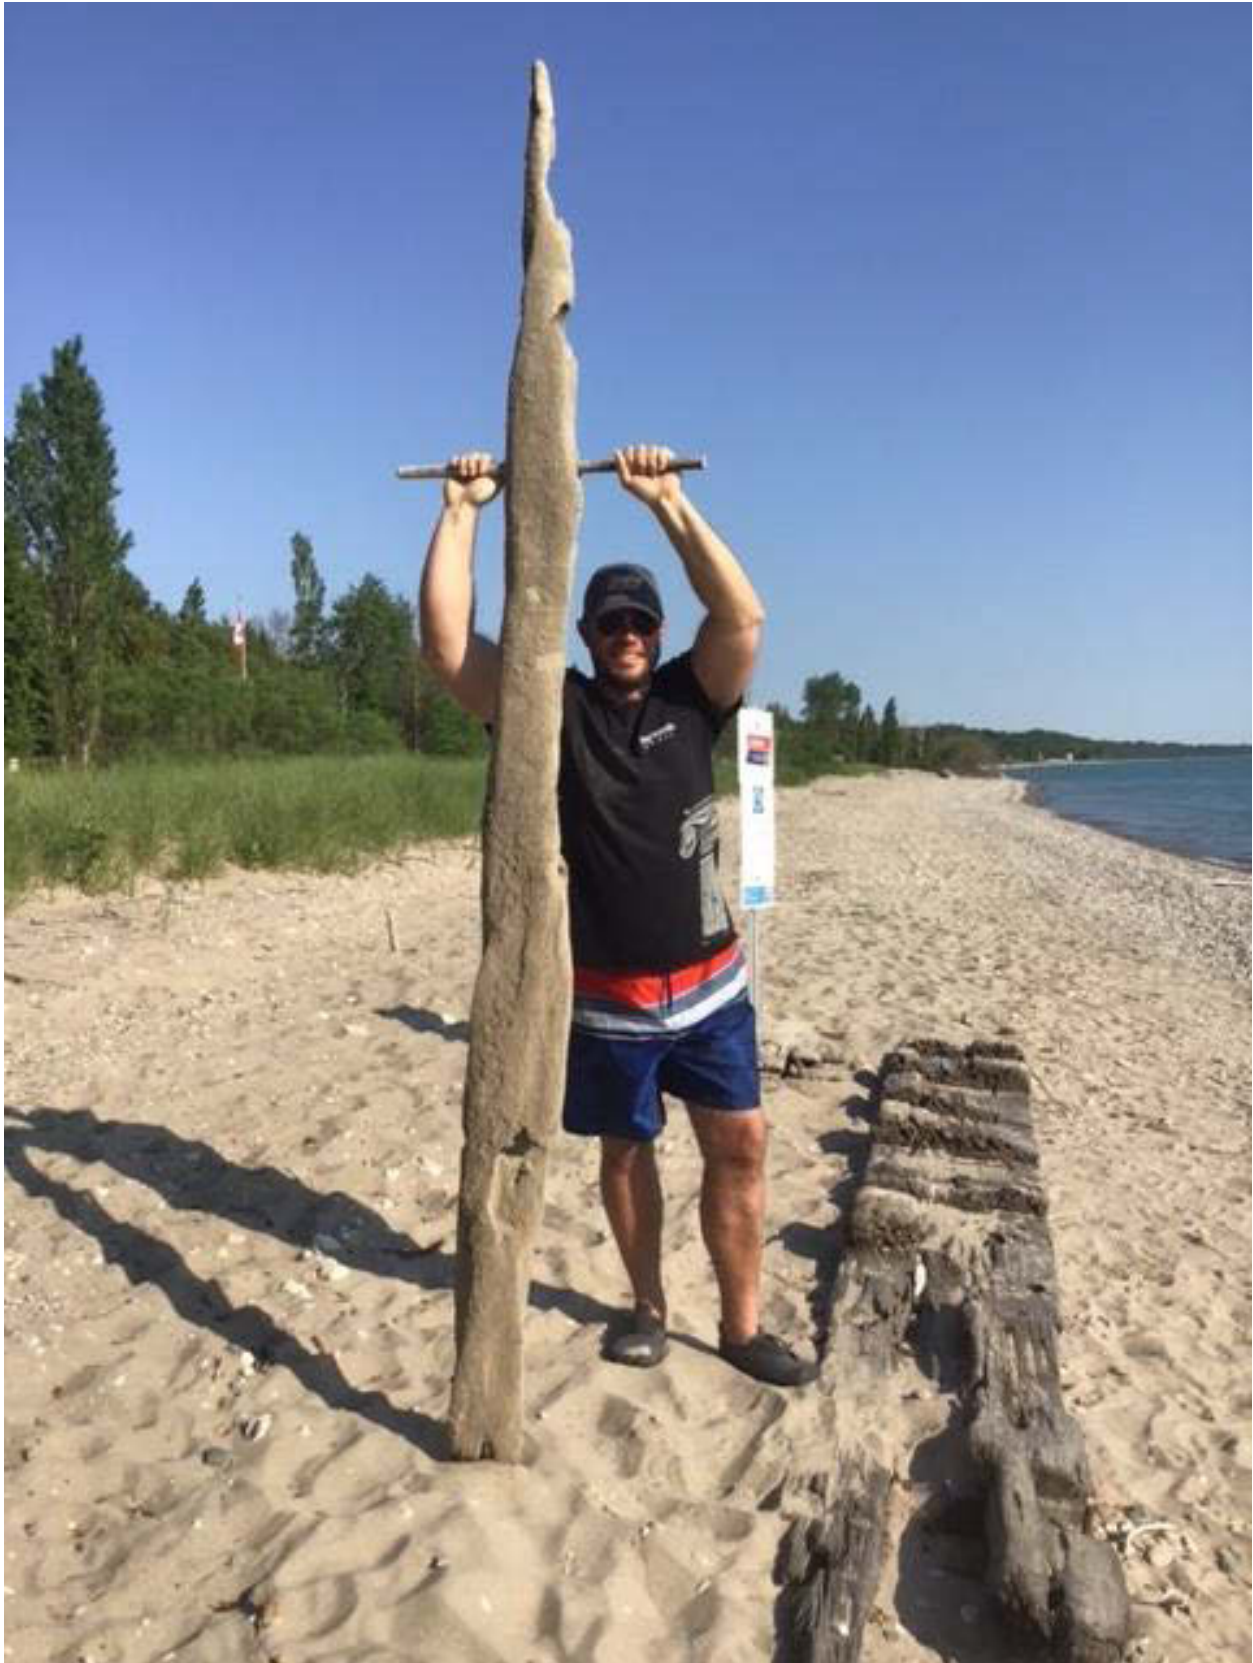
Another two pieces of wreckage were found in the proximity of Piece 1 (Image 43 and 44). The first piece, referred to as **Piece 7**, does not provide much information other than it is wreckage with a large bolt (Image 43). The second piece, referred to as **Piece 8** (Image 44) was found by volunteers and dragged out of the water. After documenting the piece by photograph, the volunteers were asked to put it back in the water to avoid deterioration due to drying. The piece is part of the centerboard box and has two sides still intact. There are three wooden planks of varying widths that are affixed to three other wooden planks on the opposite side. Through bolts are readily apparent.

**Image 43: Piece 7 found near Piece 1 with large bolt**

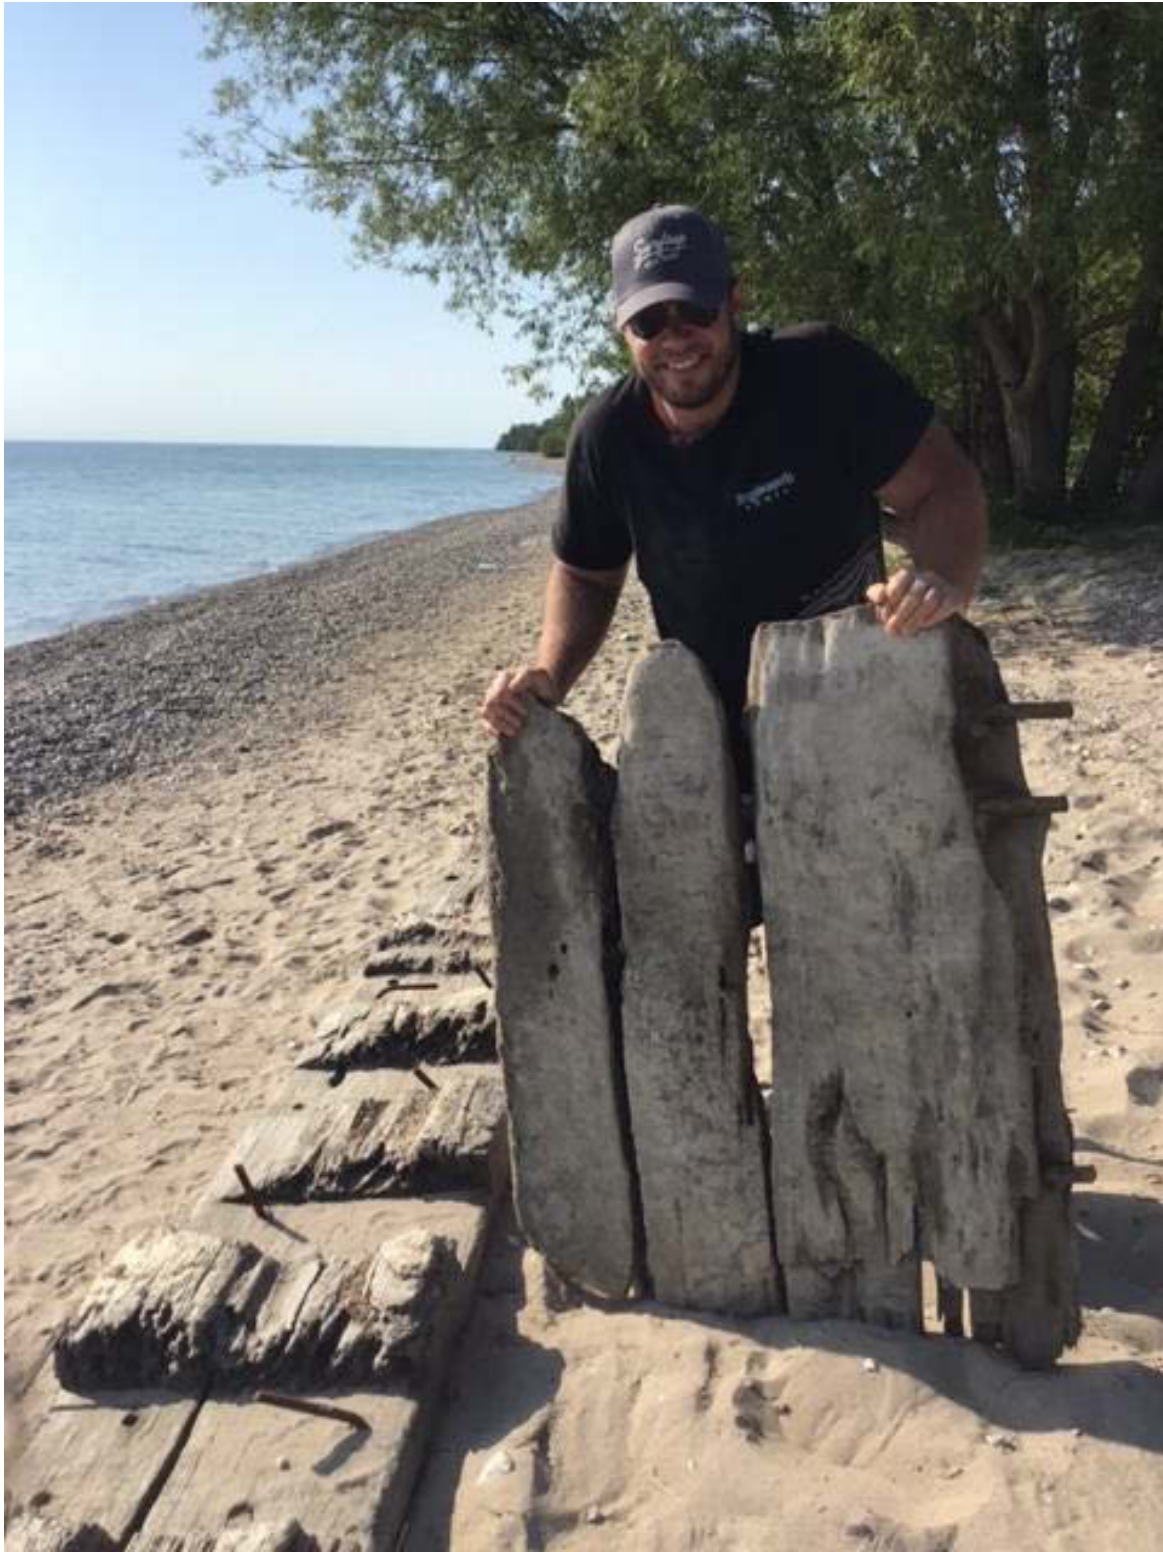
**Image 44: Piece 8 - Centreboard box section**
