## Staff Report

**Report Title: Victoria Road Flooding**

**Report Number: PW-2021-06-39**

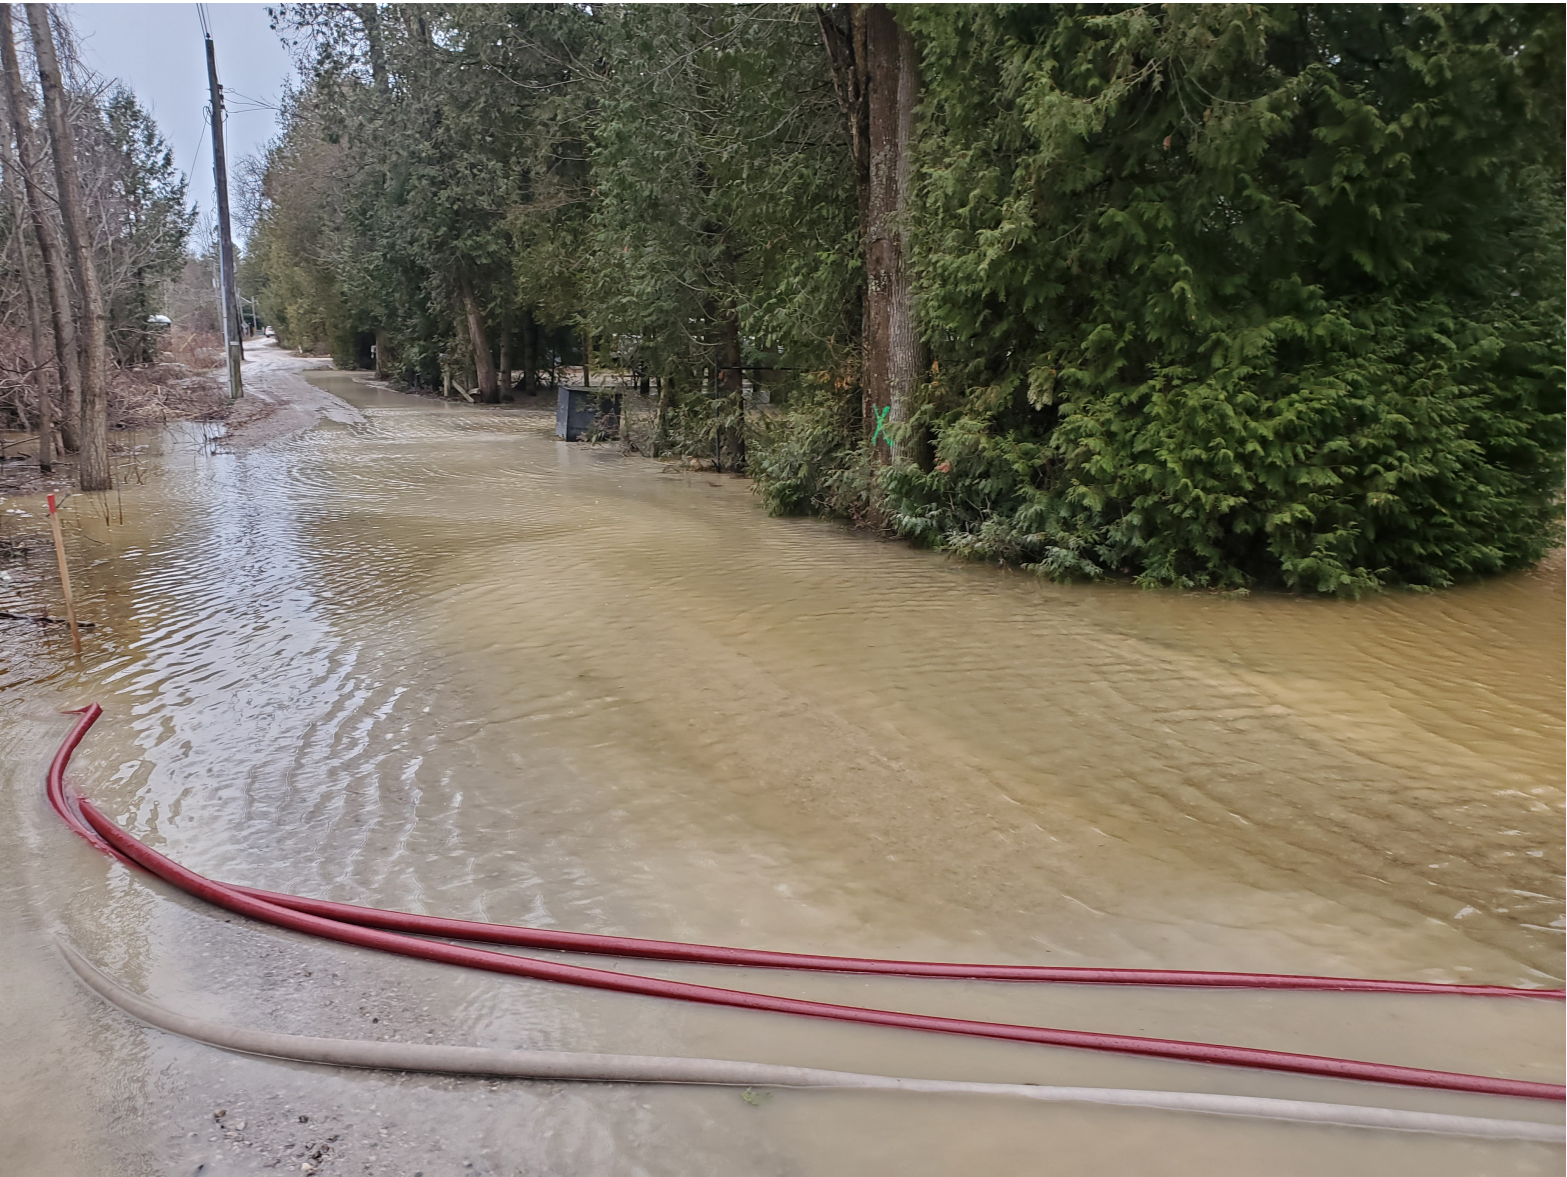
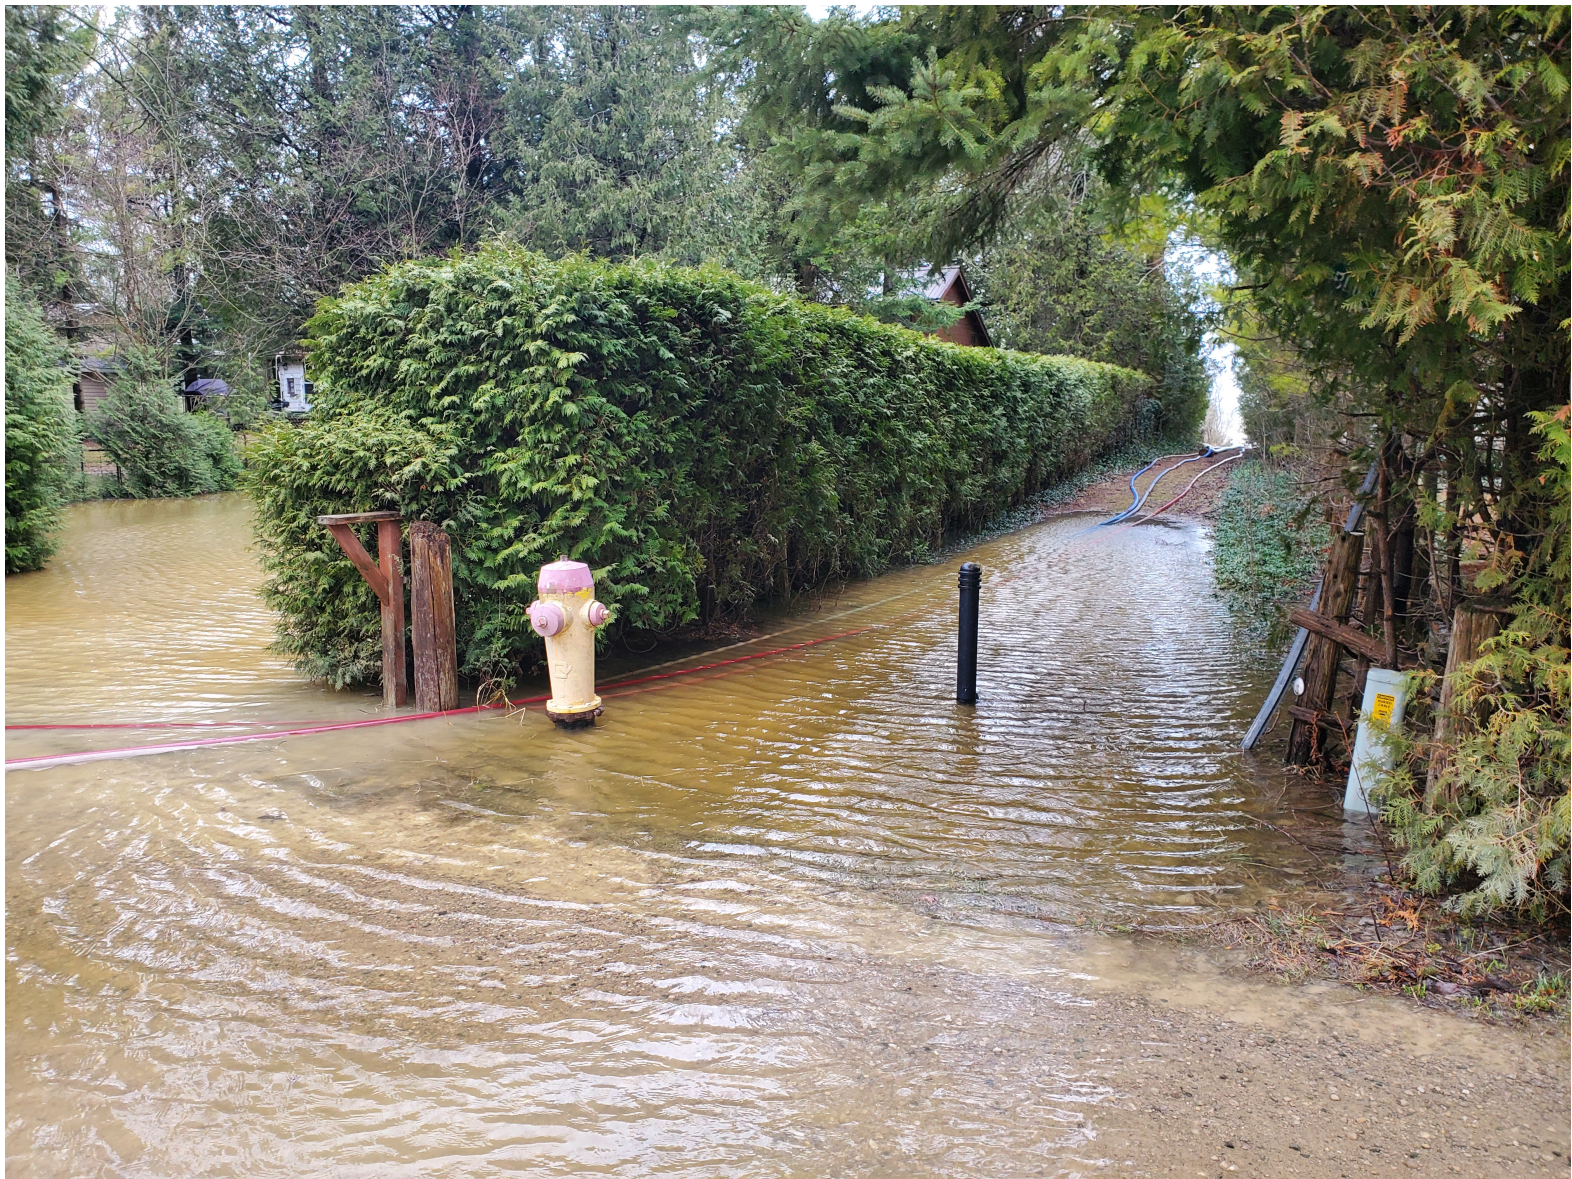
On March 17, 2021, Public Works observed flooding on Victoria Road in the geographic area of Point Clark (see attached Photo 1 and Photo 2). The cause of the flooding appeared to be a blocked culvert located near the public beach access at 795A Victoria Road. Not only did this incident cause significant flooding on the road, but Township staff also received reports of significant damage to private properties in this area (see attached Photo 3 and Photo 4).

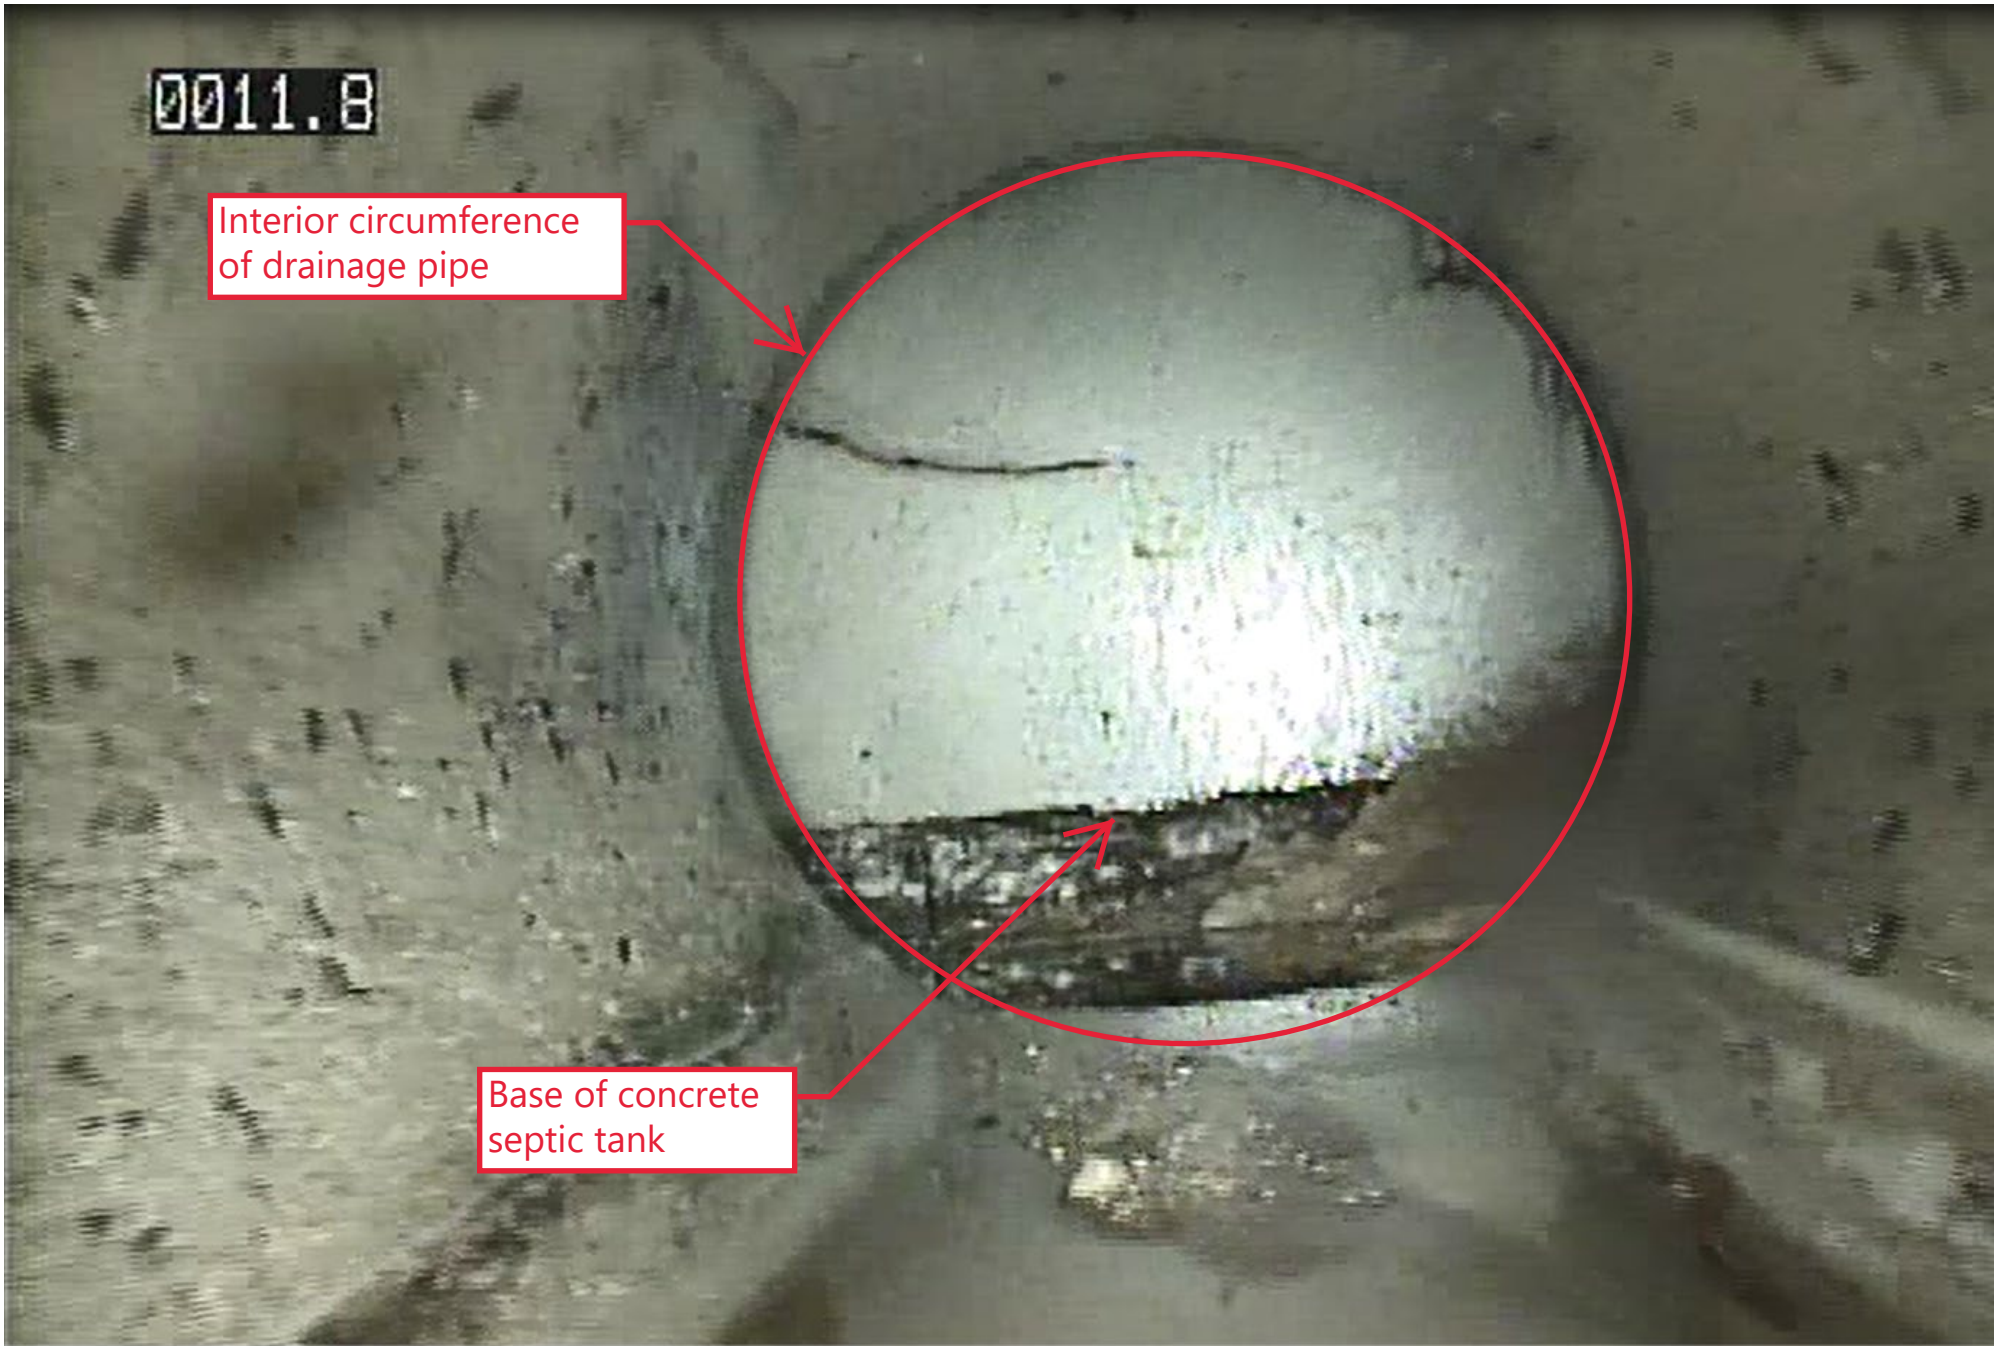
On May 17<sup>th</sup>, Township staff enlisted the services of a sewer inspection contractor to inspect the existing drainage system on the west side of Victoria Road to try to determine the source of the blockage. The contractor was able to inspect the enclosed system starting at #787 and discovered that the existing pipe was blocked by a septic tank chamber located at #789 (see attached Photo 5) that was installed in September 2020.

Interior circumference  
of drainage pipe

Base of concrete  
septic tank

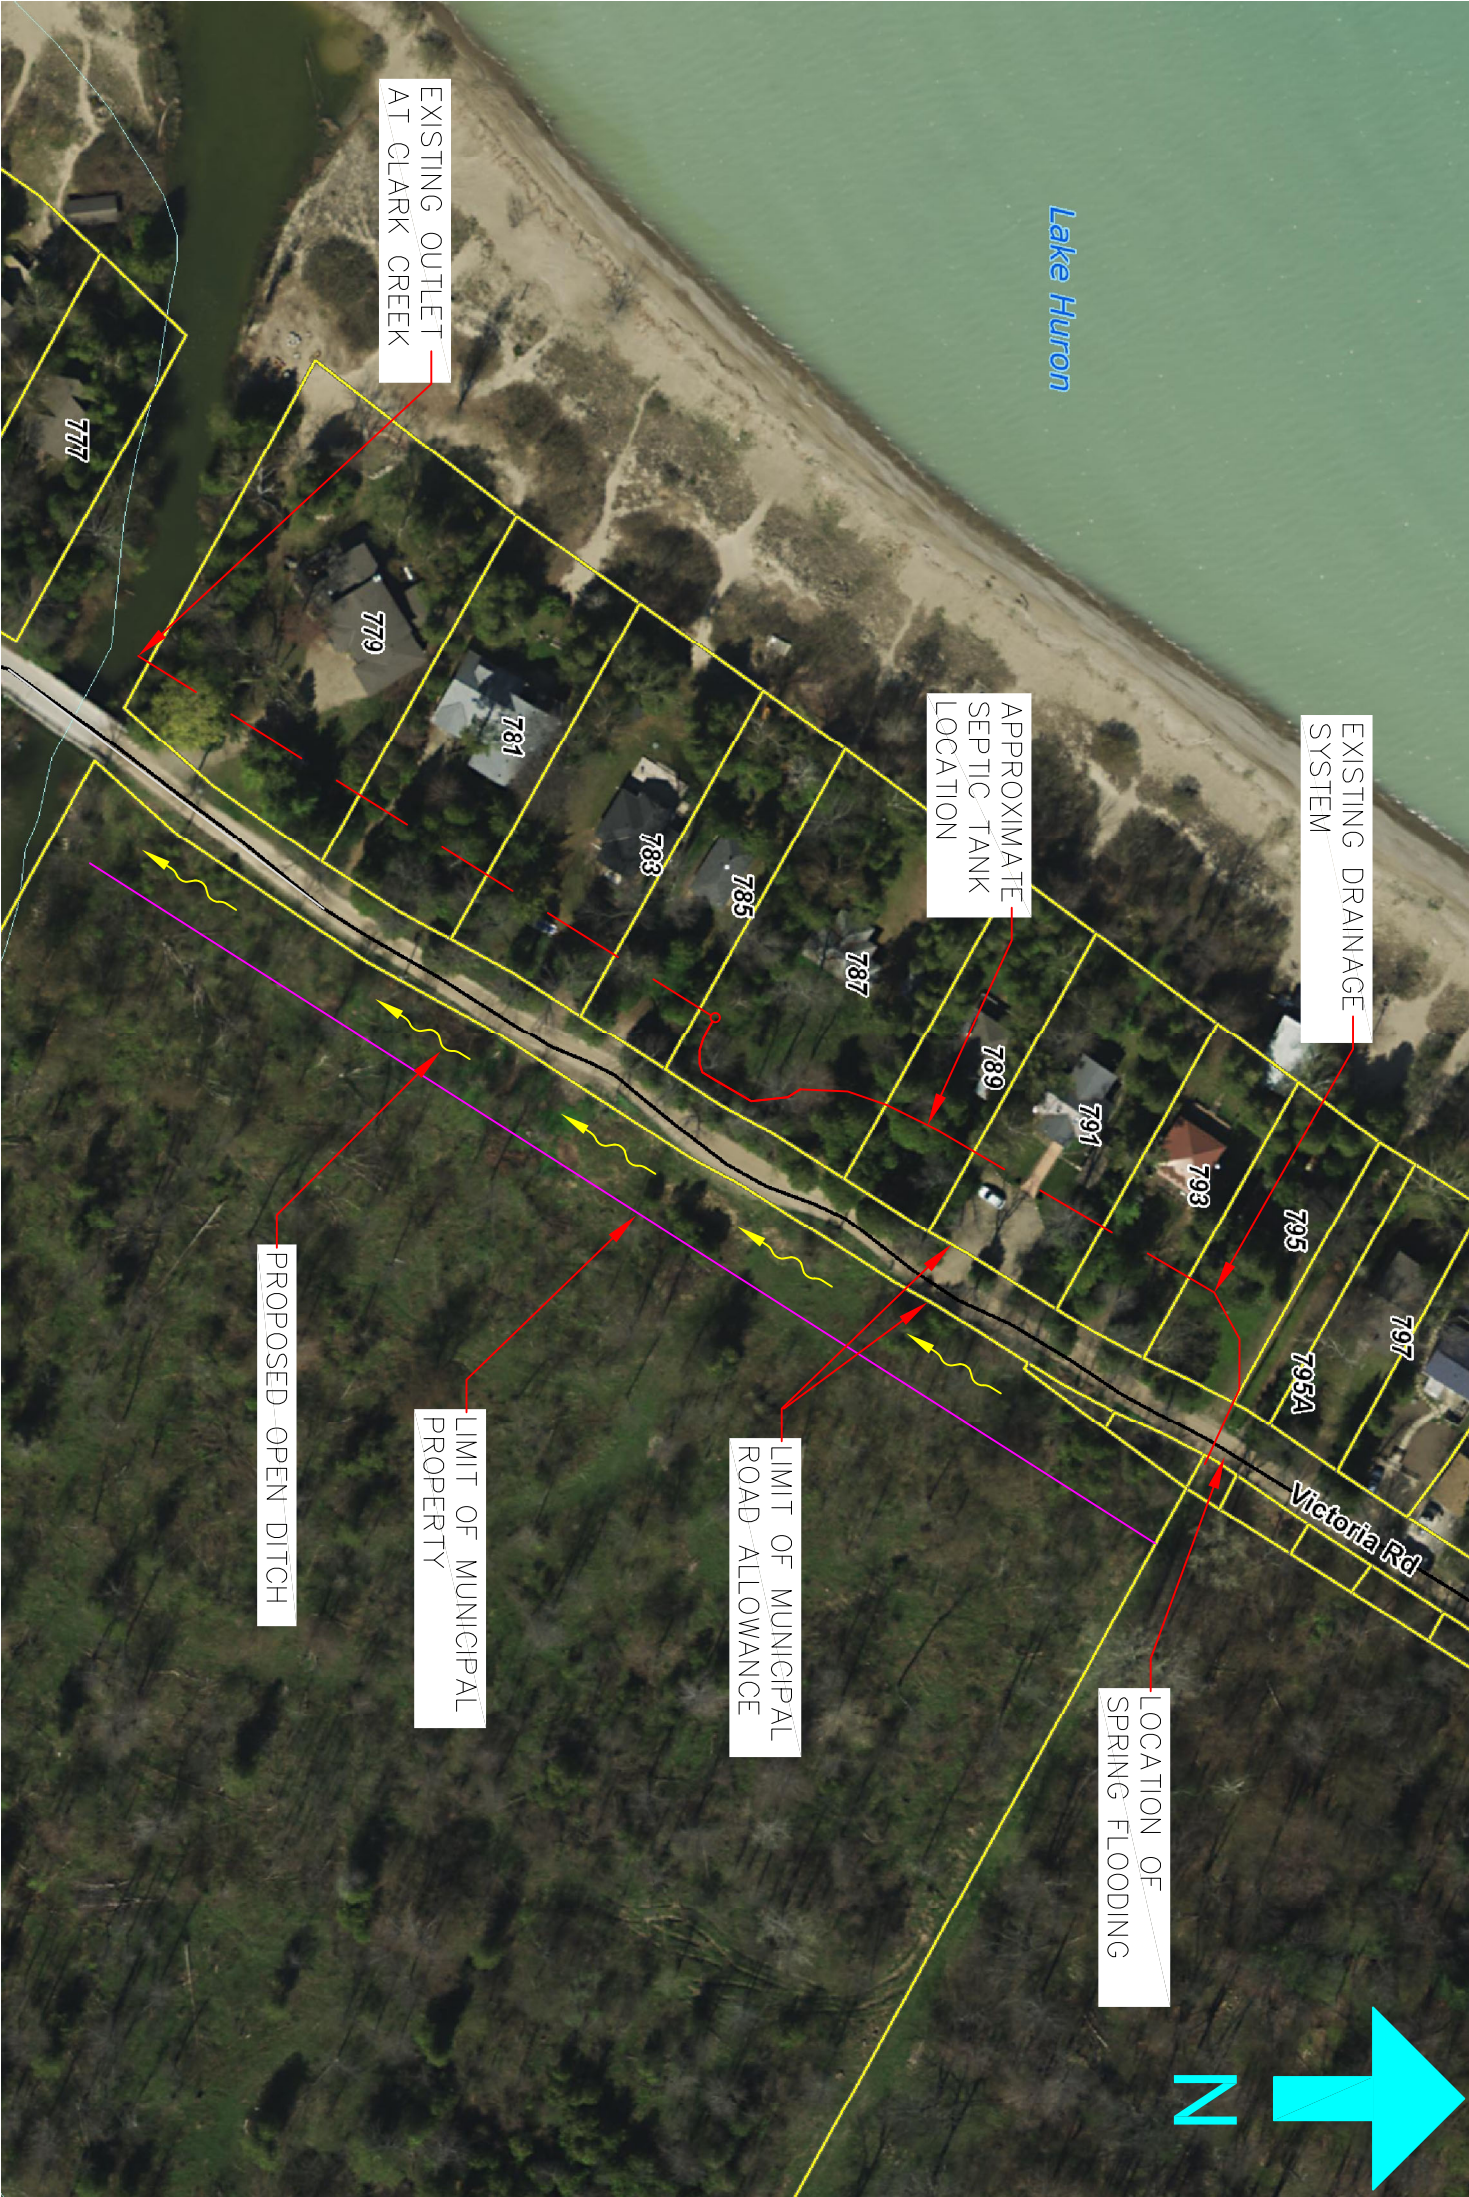
APPROXIMATE SEPTIC TANK LOCATION

LOCATION OF SPRING FLOODING

Option 4: Construct an open ditch along the east side of Victoria Road from #796 to Clark Creek within a parcel of land that was previously transferred to the Township (see attached Site Plan).

Option 4 was chosen because the open ditch is estimated to cost less than \$5,000 to construct and it will be considerably less expensive to maintain in the future. The new ditch is also offset from the roadway which will reduce any safety issues for road users.

PROPOSED OPEN DITCH
