# Township of Huron-Kinloss Bridge Needs Assessment 2021

PRESENTATION TO COUNCIL ON: April 4, 2022 By: Ken Logtenberg, P.Eng.

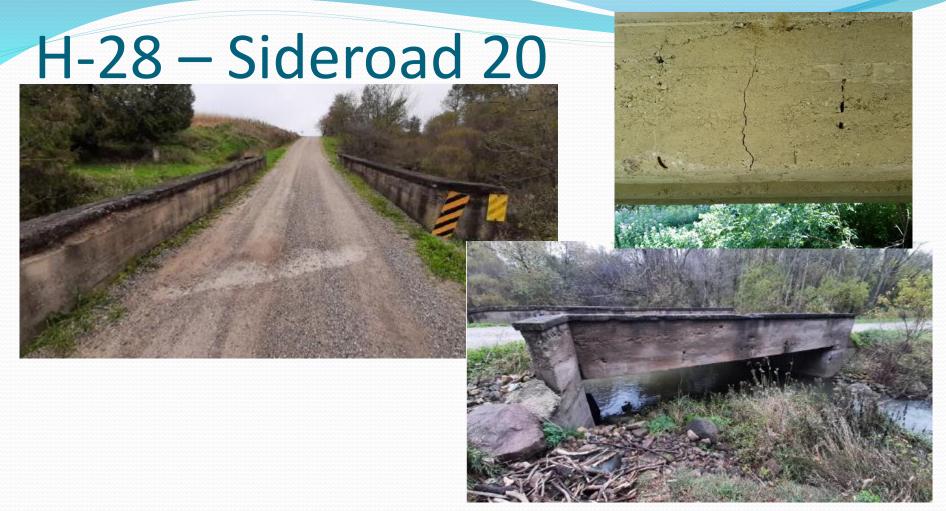
Structure has 10.7m span but structure downstream has 6.1m span, therefore, may be oversize. If able to replace with a concrete culvert or single lane bridge, we may determine that the budget price of \$720,000 is excessive.

Recommending replacement vs. repairing, load limit reduction proposed now and decision to close or repair within 5 years
