Glass Fused to Steel

Complete Inspection Report

PROJECT NAME Township of Huron
LOCATION 3405 Concession Rd 2, Ripley ON
INSPECTION DATE May 5, 2021
INSPECTOR Josh Rodrigues

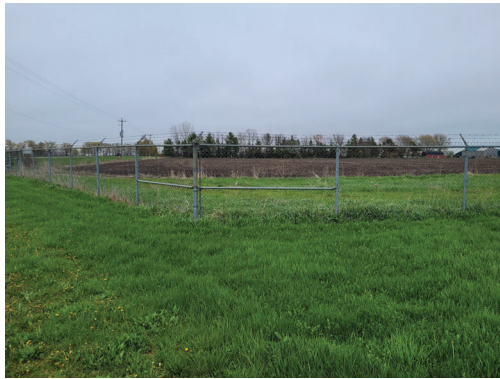
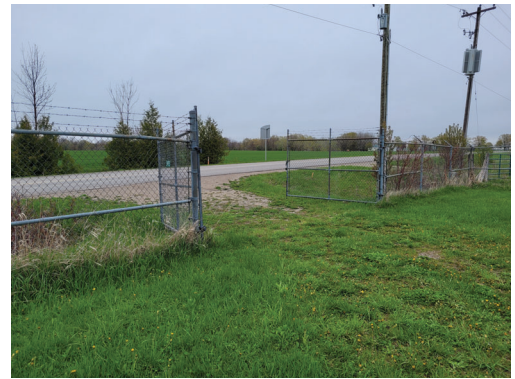
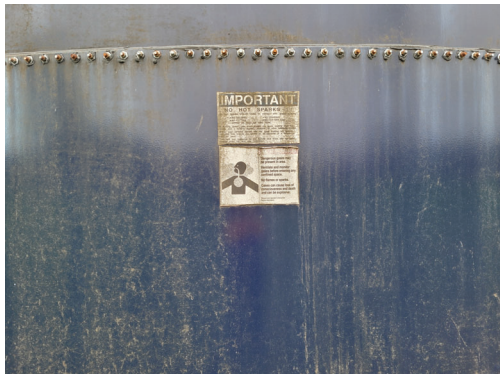
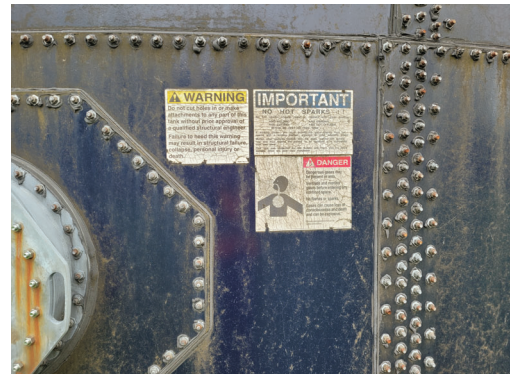
Tank is surrounded by barbed wire, chain link fencing with locked access gate. There are no signs of trespassing or vandalism. All safety placards are in place and are legible.

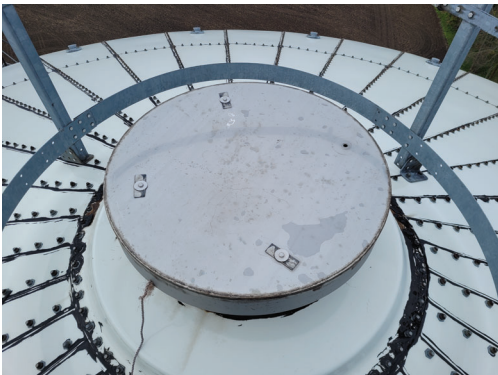
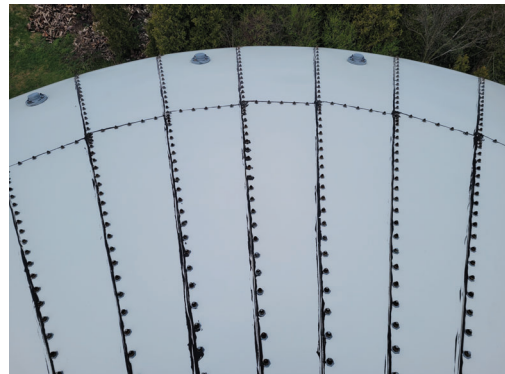
Type:	Bolted Knuckle
Panels:	Good
Panel Coating:	Good
Sealer/Silicon Condition:	Poor
Overall Condition:	Fair

Exterior of bolted steel knuckle style roof is in fair overall condition. Roof panels and glass coating is in good condition however sealer on sheet edges is in poor condition due to age with bare steel exposed on sheet edges throughout. Roof vent is in fair overall condition. Non manufacturer supplied vent hood has been previously installed, there is no fines mesh insect screen installed.

Expanded Metal Screen:	Good
Insect Screen:	Poor
Hardware Condition:	Fair
Overall Condition	Fair

- 1) Complete interior and exterior tank rehabilitation including;
 - exterior tank cleaning
 - removal of sediment and tank floor cleaning
 - removal of all remaining sealer on sheet edges and bolt heads
 - installation of new sealer fillets on all interior and exterior sheet edges
 - prepare all bolts on tank exterior and install sealed, protective bolt caps
- 2) Install screen or valve at open end of overflow pipe
- 3) Re-coat both sidewall access manway door plates
- 4) Install additional anodes if required

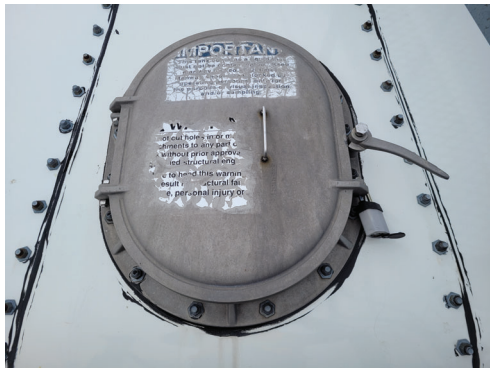
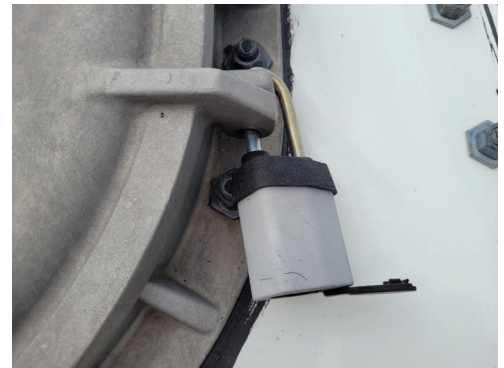
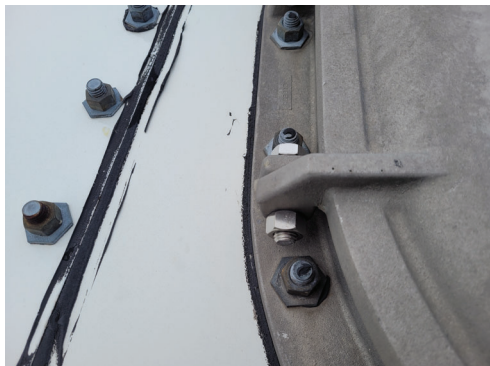
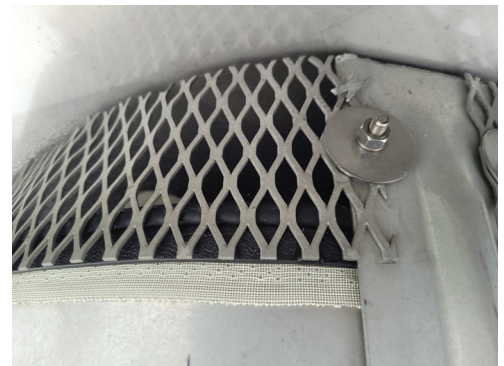
Quantity:	1
Hinges/Hardware:	Good
Size:	18"x24"
Overall Condition:	Good
Pad Lock Installed:	Yes

One 18"x24" roof access manway is installed at top ladder platform location and is in good overall condition. All hardware is in place, hinges move freely and door is unobstructed when opening. There are no roof flanges installed.

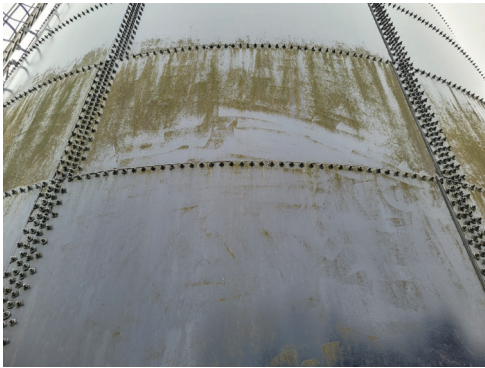
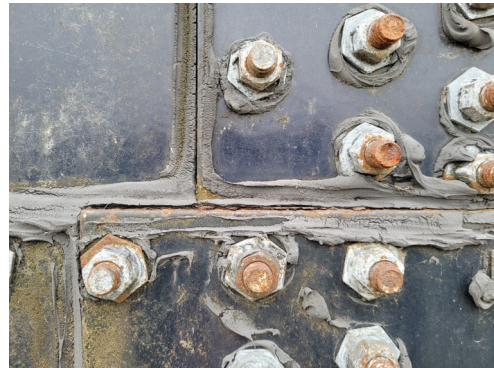
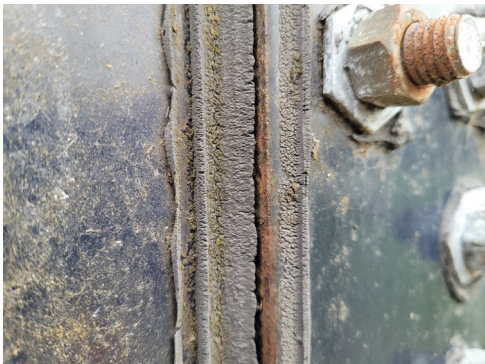
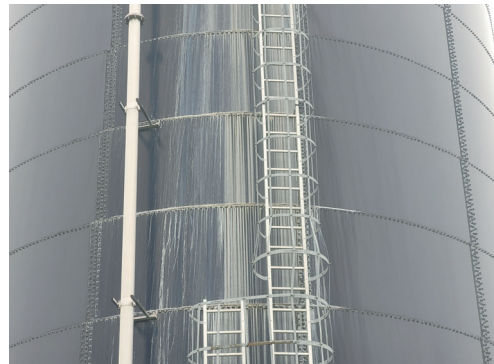
Glass/Sheet Condition: Good

Nut/Washer Condition: Fair

Sealer Condition: Poor

Exterior of tank panels and glass fused to steel coating are in good overall condition however panels are dirty with dirt/moss build up that should be cleaned. Sealer on panel edges is in poor condition with bare steel exposed throughout. Sealer should be replaced in very near future. Threads on exterior of bolts showing surface corrosion and should be sealed and capped.

All sealer on wall and roof sheet edges showing degradation due to age (25 years) and has separated from sheet edges throughout tank exterior leaving bare steel on sheet edges exposed with minor surface corrosion. General life expectancy of sealer is approximately 20-25 years and should be replaced when sheet edges become exposed. Bolt threads and nuts exposed on tank exterior should be sealed and capped when sealer is replaced.

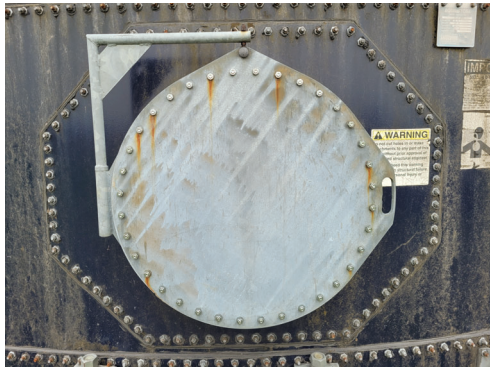
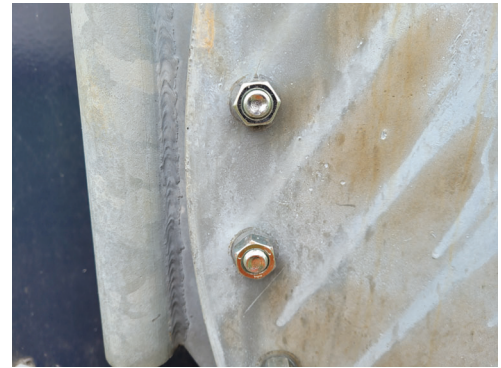
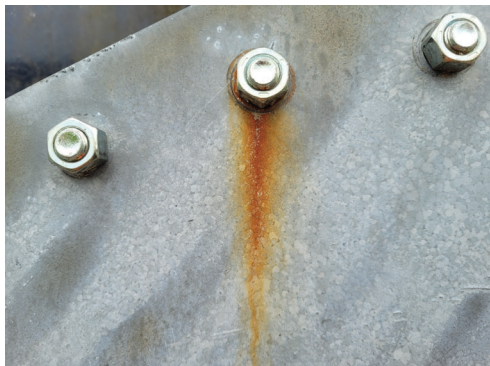
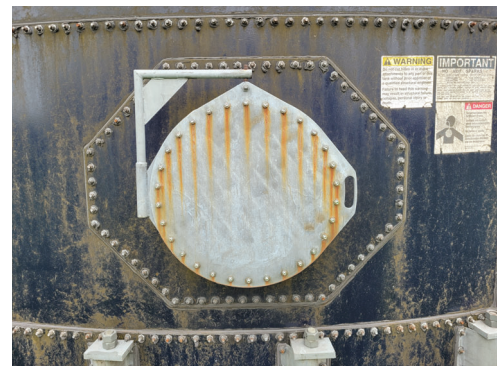
Size:	30"
Quantity:	2
Gasket Condition:	Good
Bolt Condition:	Good
Corrosion Present:	Yes
Overall Condition:	Good

Two 30" sidewall access manways are installed at ground level. Both manways are in good overall condition however staining from previously replaced hardware is present on door plates. Manway door plates should be prepared and re-coated on site.

Both sidewall access manways are in good overall condition however staining on door plates from previously replaced hardware is present. Door plates should be prepared and coated on site.

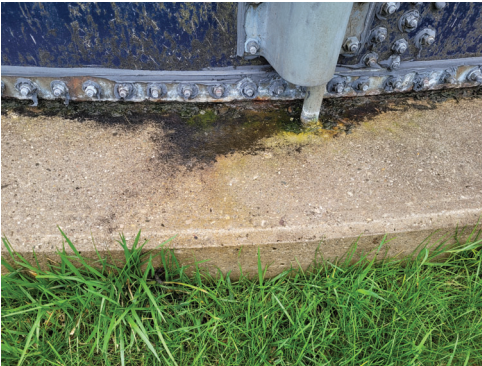
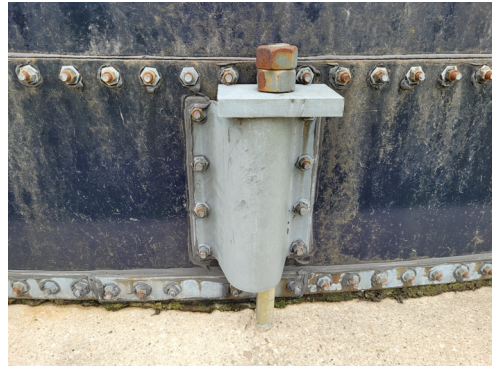
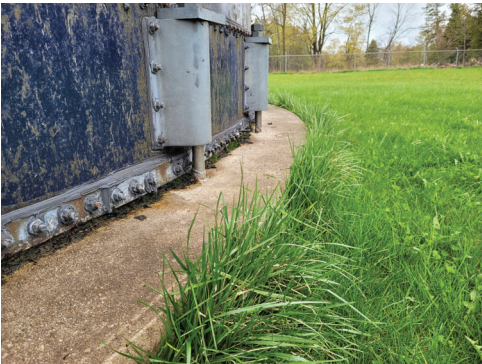
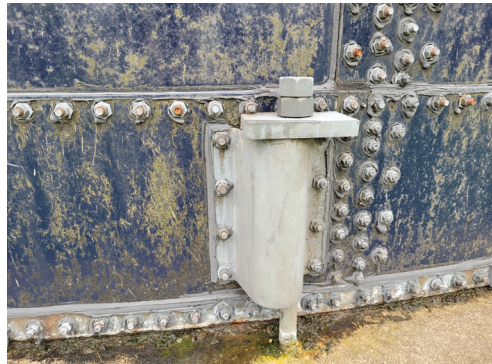
Concrete Curb:	Good
Erosion:	No
Cracking:	No
Settlement:	No
Anchor Bolts:	Yes
Anchor Bolts Condition:	Good

Concrete curb/foundation is in good overall condition. There are no signs of cracking, settlement or erosion present. All anchors are in good overall condition with minor surface corrosion of anchor bolt nuts.

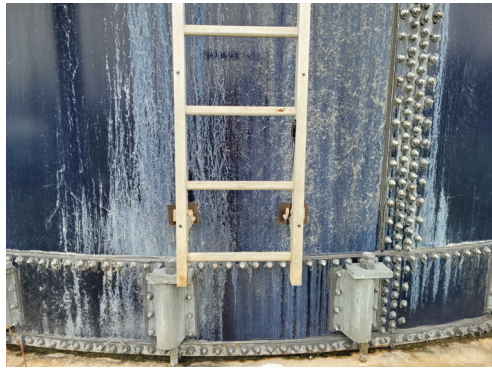
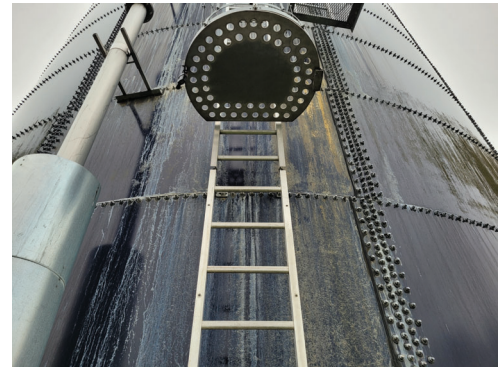
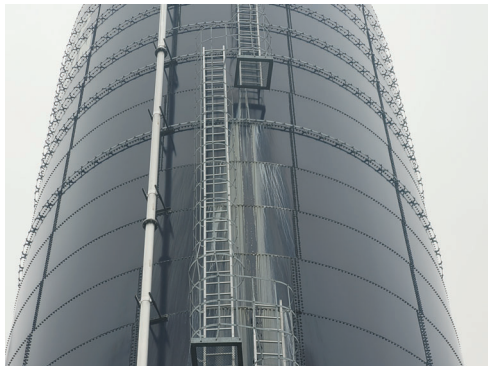
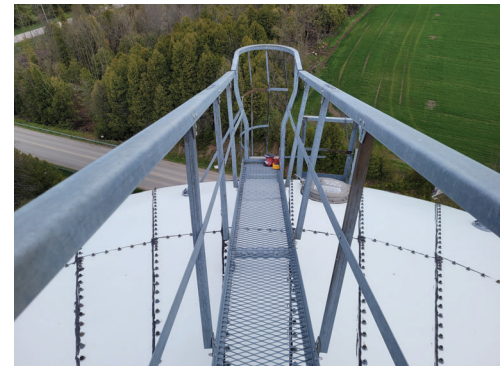
Ladder Type:	Step Offs
Material:	Galvanized Steel
Cage Installed:	Yes
Ladder Gate Installed:	Yes
Fall Arrest System:	No
Corrosion Present:	No
Padlock Installed:	Yes
Overall Condition:	Good

One caged roof access ladder is installed from ground to roof with 3 step off platforms. Ladder and platform assembly including hardware is in good overall condition. Ladder gate is installed and locked at base of ladder.

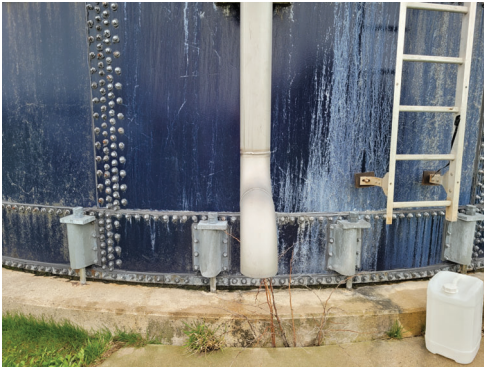
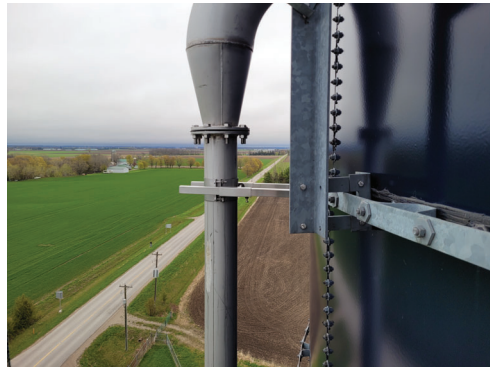
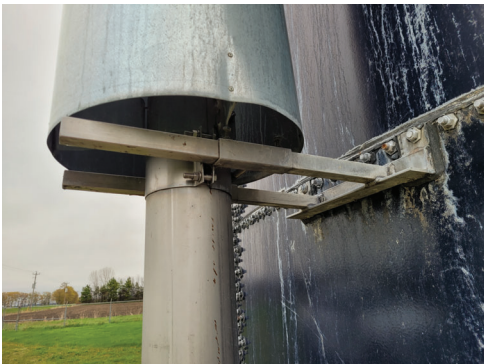
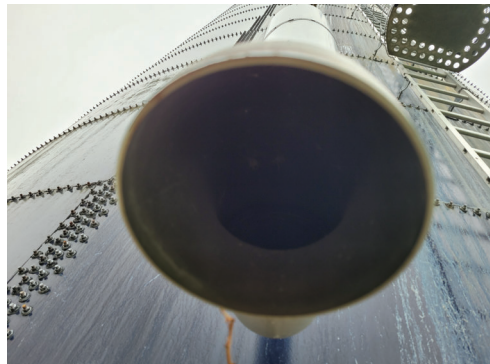
Location:	West
Pipe Size:	6"
Pipe Type:	Stainless Steel
Direct to Ground:	No
Screen Installed:	No
Flapper Installed:	No
Pipe Brackets:	Good
Overall Condition:	Good

One 6" stainless steel overflow pipe is installed on the west side of the tank. Piping, support brackets and hardware are in good overall condition. End of overflow pipe is currently exposed with no screen or flapper valve installed

Overflow piping is in good overall condition. It is recommended that a screen or valve be installed at open end of overflow pipe.

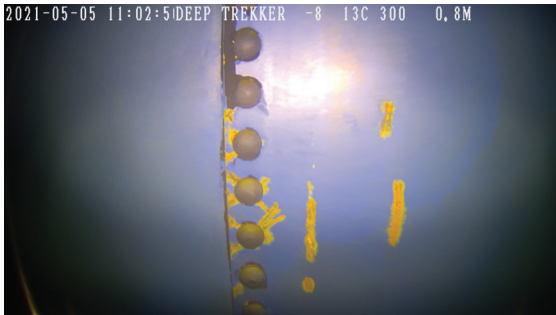
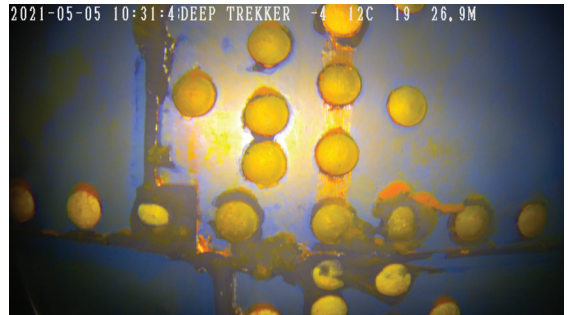
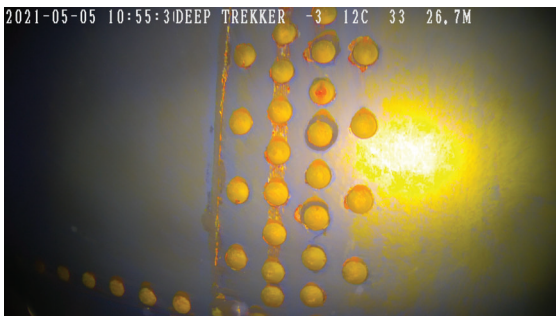
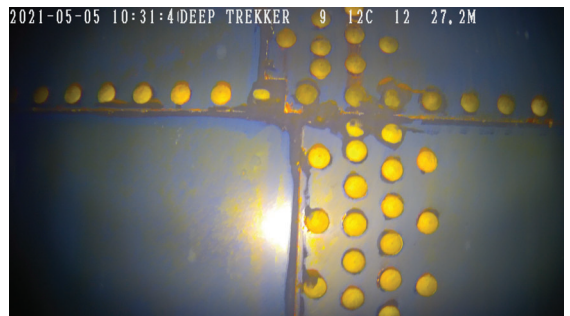
Interior of tank wall panels and glass fused to steel coating is in good overall condition. Sealer showing complete degradation due to age on all sheet edges and bolt heads which should be replaced in near future. Many areas of bare steel exposed with minor corrosion on interior sheet edges

Interior of tank wall panels and glass fused to steel coating is in good overall condition. Sealer on all interior sheet edges and bolts heads is no longer present throughout most of the tank leaving bare steel exposed with minor corrosion present. All interior sheet edges should be prepared and coated with new sealer in the near future. Heavy layer of sediment covers the tank floor which did not allow for visual inspection of floor surface however is expected to be in similar condition to the interior tank walls. Anodes were visible in some areas and appear to be in good overall condition however cathodic protection testing done at time of inspection determined the tank does not currently meet NACE criteria for adequate protection of a water storage tank. More anodes are likely required to protect areas of bare steel inside the tank (this may not be required once new sealer is installed)

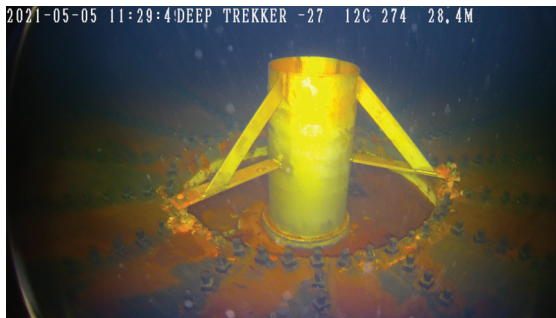
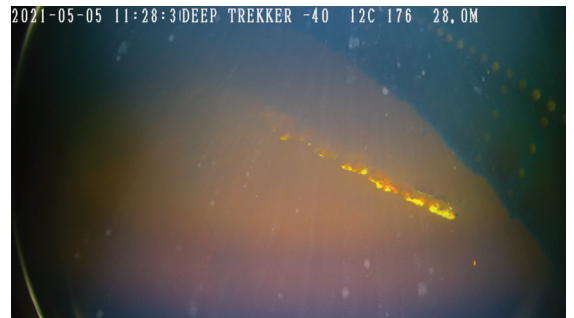
Sediment Thickness:	Heavy
Glass/Sheet Condition:	Unknown
Caps/Encapsulated Nuts:	Unknown
Sump/Link Seals:	Unknown
Anode Assembly:	Fair

A heavy layer of sediment covered the entirety of the tank floor which did not allow for visual inspection of floor surface. Anodes on tank floor were visible in areas and appear to be in good condition.
