TOWNSHIP OF HURON-KINLOSS

**BASELINE SURFACE
WATER QUALITY MONITORING PROGRAM**

2023 ANNUAL REPORT

December 21, 2023

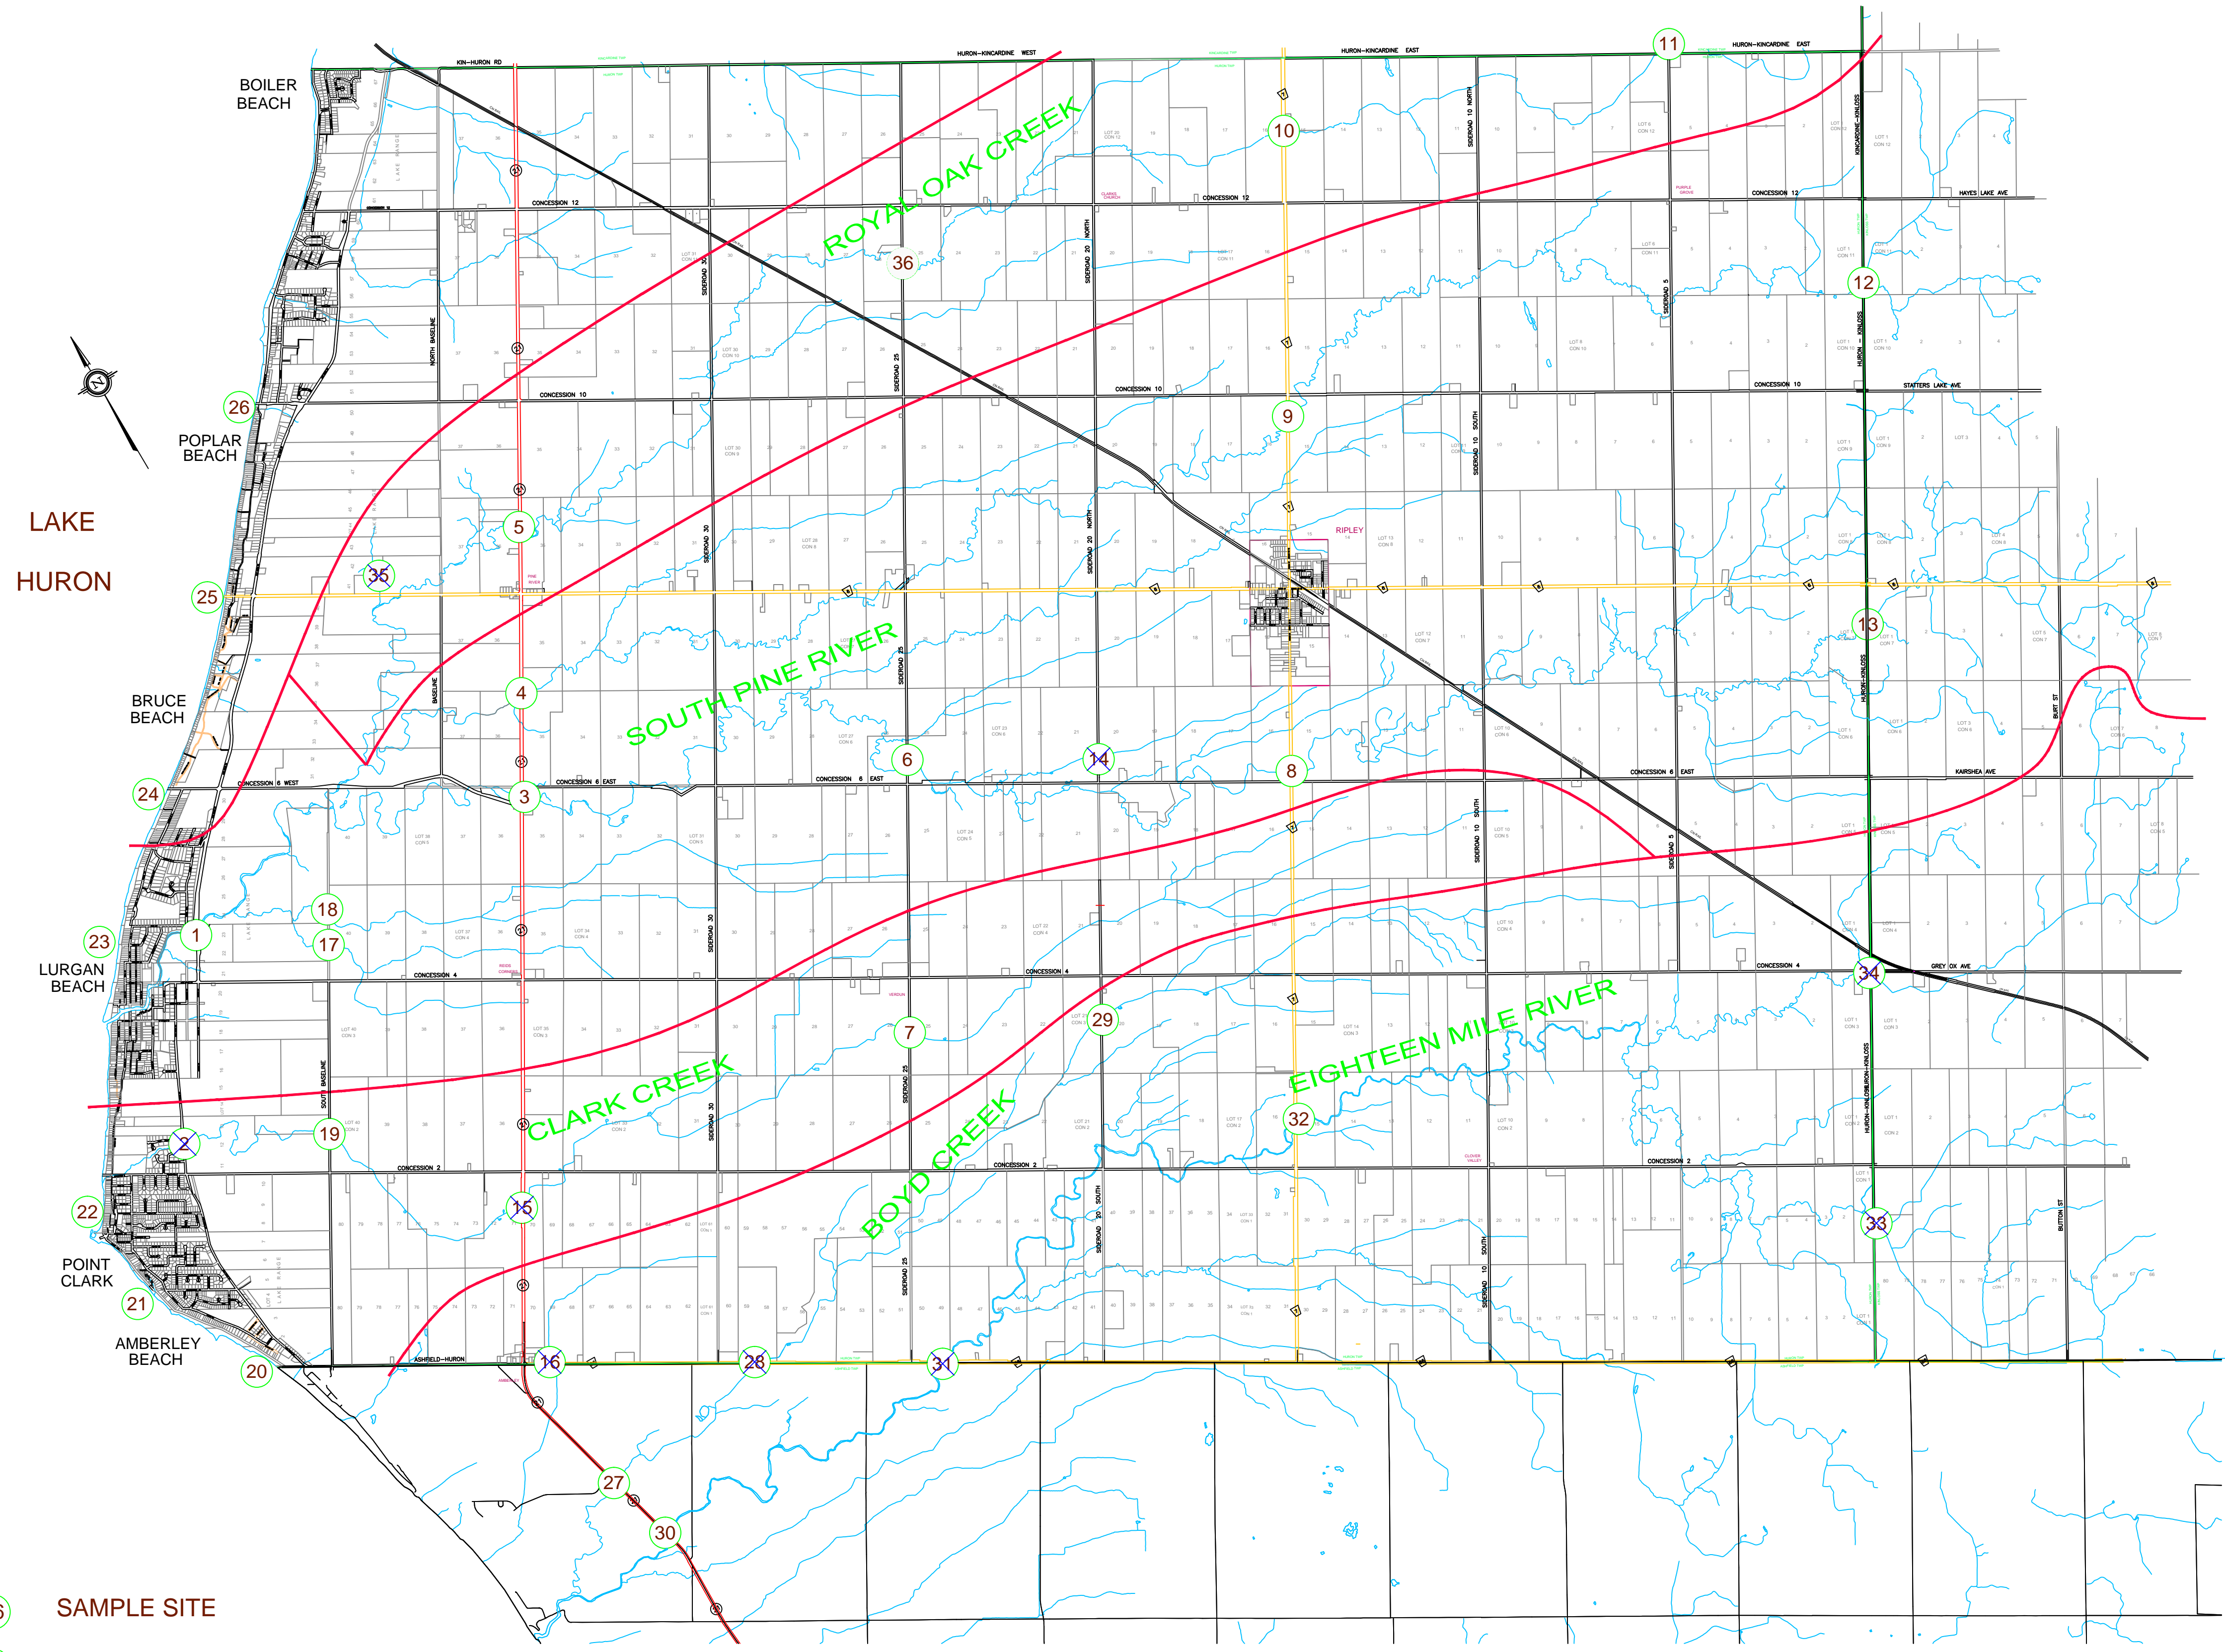
FILE No.
 01124
 FIG. No.
 2.1

- 16 SAMPLE SITE
- X DISCONTINUED SAMPLING
- SUBWATERSHED BOUNDARY

TOWNSHIP OF HURON-KINLOSS
 PINE RIVER WATER QUALITY
 MONITORING PROGRAM (2013)

The Baseline Surface Water Monitoring Program consists of 34 sampling locations; 7 Lake Huron sites, 19 in-stream sites consistent with the Pine River program, and 8 inland sites throughout Point Clark. The sites are presented in Figure 2.1 and 2.2. Water quality results for all monitoring years are included in Appendix A. An inventory of sample locations can be found in Appendix B.

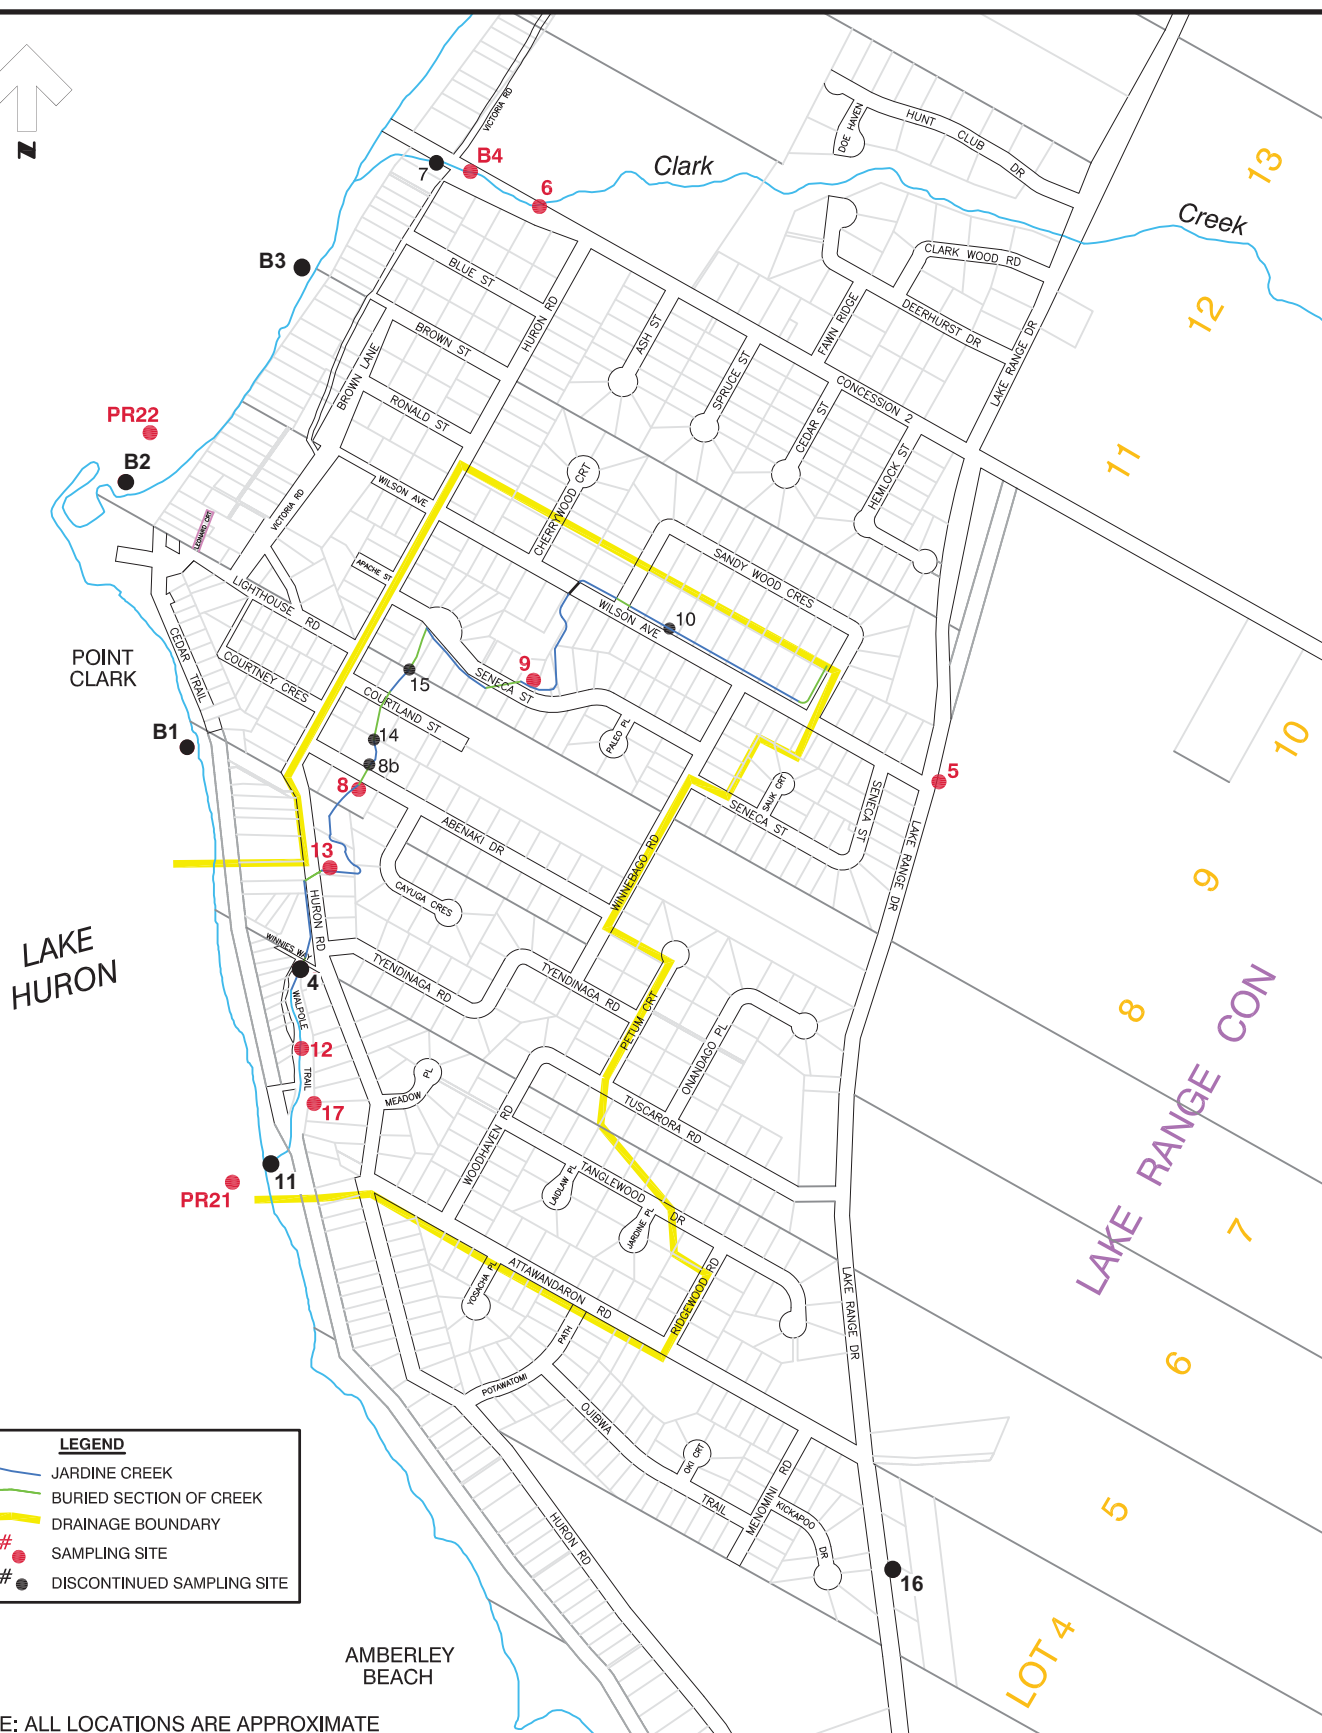
PROJECT No. 93147
FIGURE No. 2.2

Township of Huron-Kinloss
Point Clark Water Quality
Monitoring Program
 Monitoring Location Plan

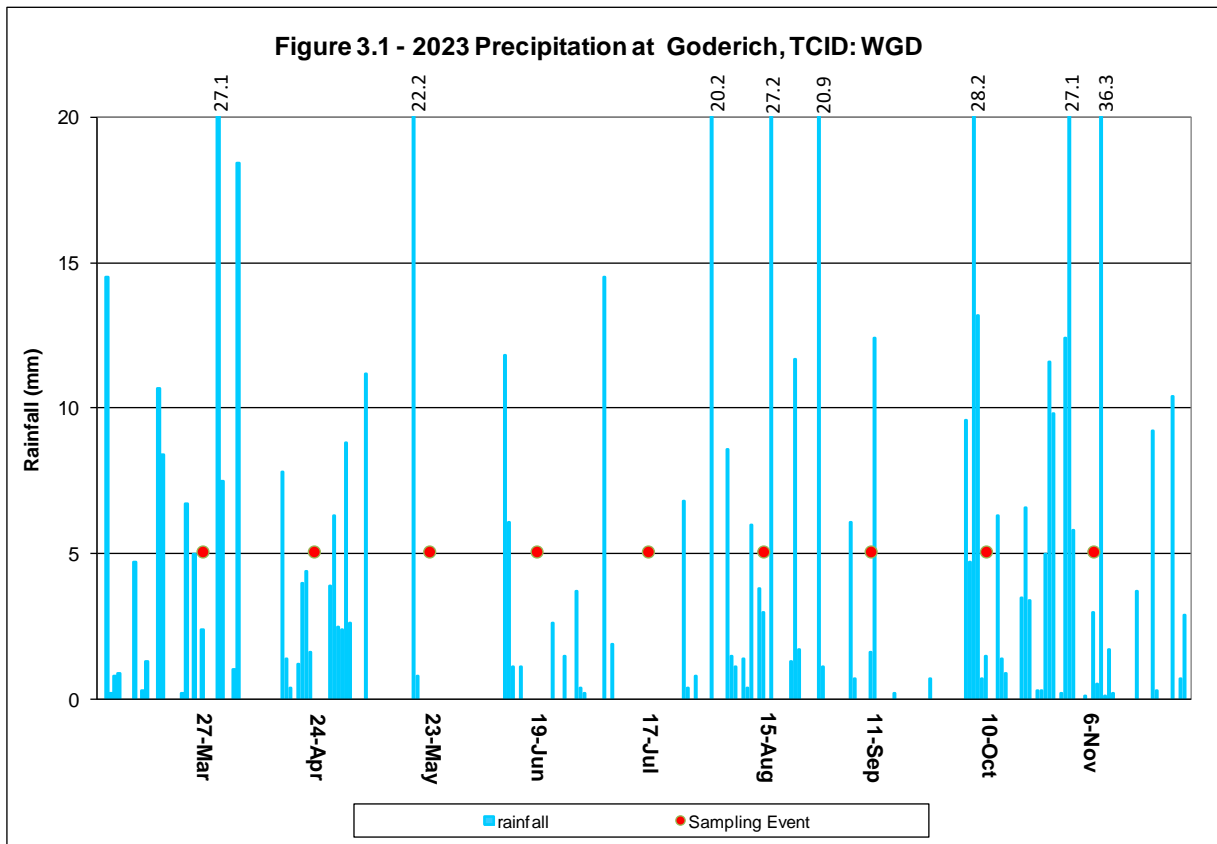
Weather and rainfall through the sampling season varies year to year and is reflected by the number of monitoring sites with insufficient flow at the time of sampling. Table 3.1 summarizes each year's sampling season rainfall from March through November. Peaks in precipitation are often linked to elevated levels of contaminants since various sources are collected through surface runoff and additionally for lakes, from wave and wind action. Specific relationships between increased results and weather conditions are not statistically correlated in this report; however, for illustrative purposes the recorded rainfall for the Pine River area is presented in Figure 3.1. The data is obtained from the Goderich WMO weather station 71261. Water levels were previously obtained from the Environment Canada hydrometric station 02FD001 for Pine River at Lurgan Beach. Station 02FD001 has been decommissioned and data is unavailable after August 2020.

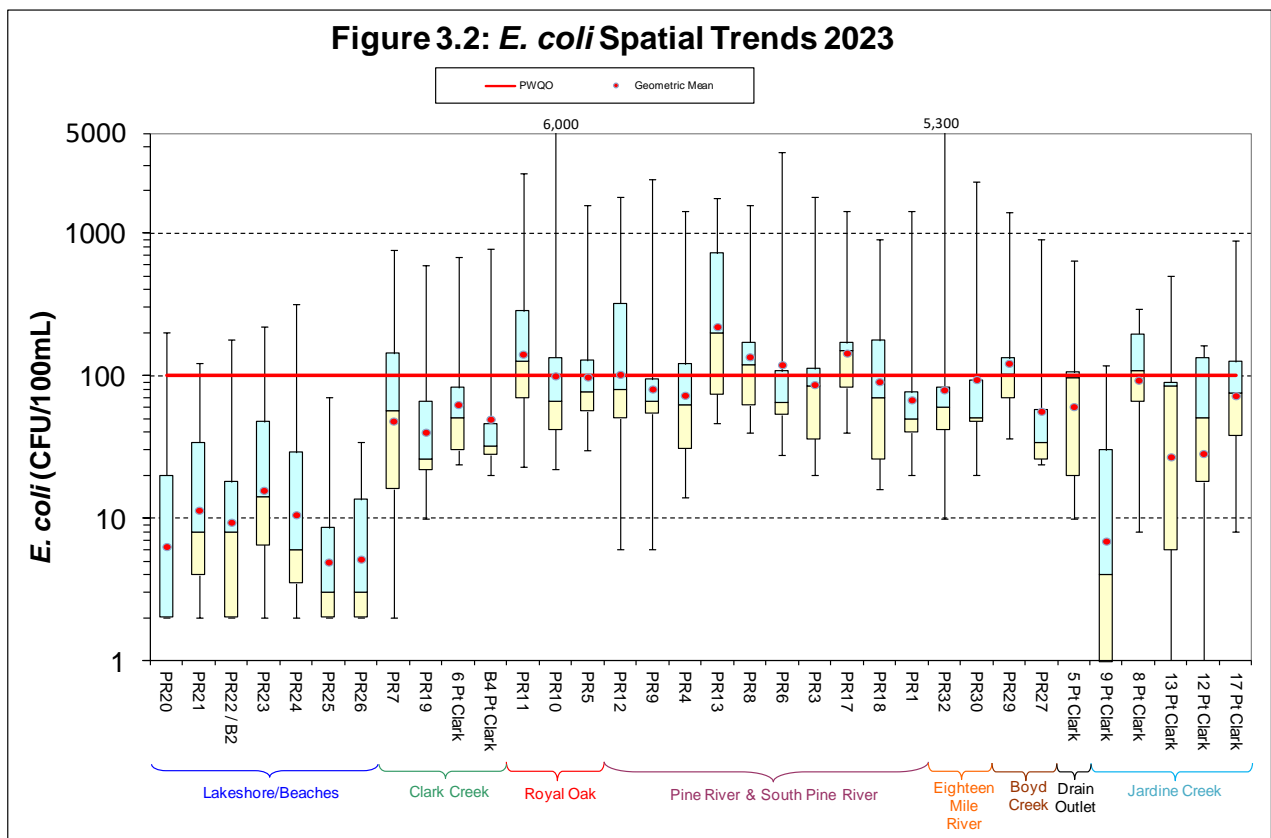
Figure 3.2 shows a typical range for inland site results of about 20-200 CFU, with some larger individual sample exceedances, with most sites showing typically good results in 2023. The highest seasonal geometric means occurred at PR13. The range of geometric means for inland sites was about 20-100 CFU. Eight of the twenty-seven inland sites show geometric means above the PWQO, with these ranging from 100-221 CFU.

Lake sites PR20-PR26 results show geometric means below the PWQO, with the box-plot range showing most individual results in 2023 below the PWQO. Only 10 of the 63 lake samples collected were above the PWQO, ranging from 100-320 CFU. The results include four October samples marked as overgrown and counted as exceedances. Most exceedances occurred in the

Transport distance and survivability of *E. Coli* downstream is not defined and is difficult to determine. Assuming a factor of partial transport and survivability of *E. Coli* downstream, ignoring inputs along the reach we can expect a decrease downstream from an upstream location for sites within each watershed group. Generally elevated watershed groups represent stewardship opportunities through the entire catchment, and elevated results at single sites represent opportunities located within the more local upstream reach.

Clark Creek concentration was consistent through its reach and was typically below the PWQO. Attenuation downstream is not noted, as with such good results and the exponential nature of *E. Coli*, the observed typical variability of 20 to less than 100 CFU is considered nearly consistent. Royal Oak site PR11 is adjacent to agricultural fields and is downstream of livestock activity, where results generally attenuate through downstream sites PR10 and PR5 to typically good results.

The Pine River group consists of multiple reaches. PR12 is the initial upstream site of a Pine River reach and may attenuate through PR9 and PR4, however in 2023 the results are consistent and typically under the PWQO. PR13, PR8, PR6 and PR3 are ordered sites within another reach of Pine River and show attenuation downstream, with sites PR6 and PR3 showing nearly consistently good results. PR17 and PR18 are close proximity upstream sample points along separate small reaches and are in the vicinity of farming and homestead activity. PR1 is located at the confluences of all upstream reaches and represents the attenuated loadings from all upstream catchments and showed nearly consistently excellent results through the 2023 sampling season.

Eighteen Mile River sites have nearly consistently low results through the River’s reach. Boyd Creek Sites PR29 and PR27 show attenuation downstream. Point Clark sites are in close proximity and generally show excellent results through the catchment. Site 5 is located outside of Point Clark in a roadside ditch, at the outlet a large drainage area, where inputs are likely related to farming and wildlife activity within its catchment. Jardine Creek Site 8 was observed to have a white coloured streambed film and sewage like smell throughout much of the sampling season. Jardine Creek’s downstream Sites 12 and 17 generally show good results through the 2023 sampling season.

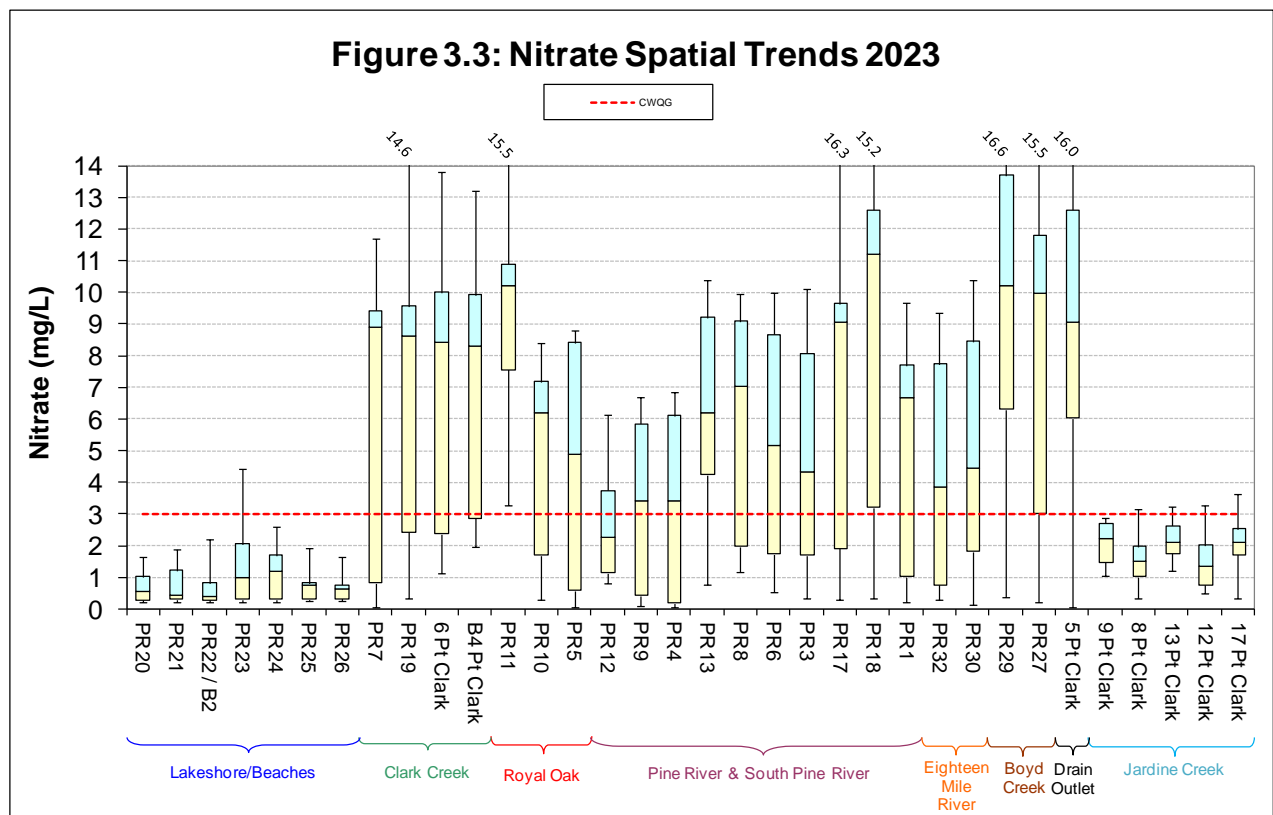
The distribution of nitrate results for 2023 is presented in Figure 3.3. Lake sites show consistently excellent results, with one sample exceeding the CWQG in all of 2023. In contrast, many inland sites were nearly consistently elevated through the 2023 sampling season, highlighting a reduction factor for lake sites. For inland sites, the June, August and September events showed almost no exceedance and may highlight the relationship between loading, transport, and plant productivity changes.

Clark Creek Sites PR7, PR19, 6 and B4 show very similar variability and a median of about 8.5mg/L. Sites 6 and B4 are located at the edge of Point Clark and receive a relatively small proportion of loadings from Point Clark. Site 5 is located at the outlet of a large catchment of typically agricultural land-use within the Clark Creek Catchment and has a high median, indicating consistently elevated nitrate through the Clark Creek catchment. Royal Oak Site PR11 is particularly elevated, with downstream Sites PR10 and PR5 showing attenuation to medians still above the CWQG; indicating a loading factor change upstream of PR11 in the Royal Oak catchment.

Pine River and South Pine River sites are generally elevated, with PR17 and PR18 being particularly high. These two sites have catchments within an agricultural landscape and could represent generally elevated conditions or upstream point-loading. Sites within Point Clark contrasted the generally elevated results of the Pine River watershed, with Jardine Creek results showing low variability, generally below the CWQG. The Eighteen Mile River group shows a median over 4 mg/L and the Boyd Creek results show a median of over 10mg/L.

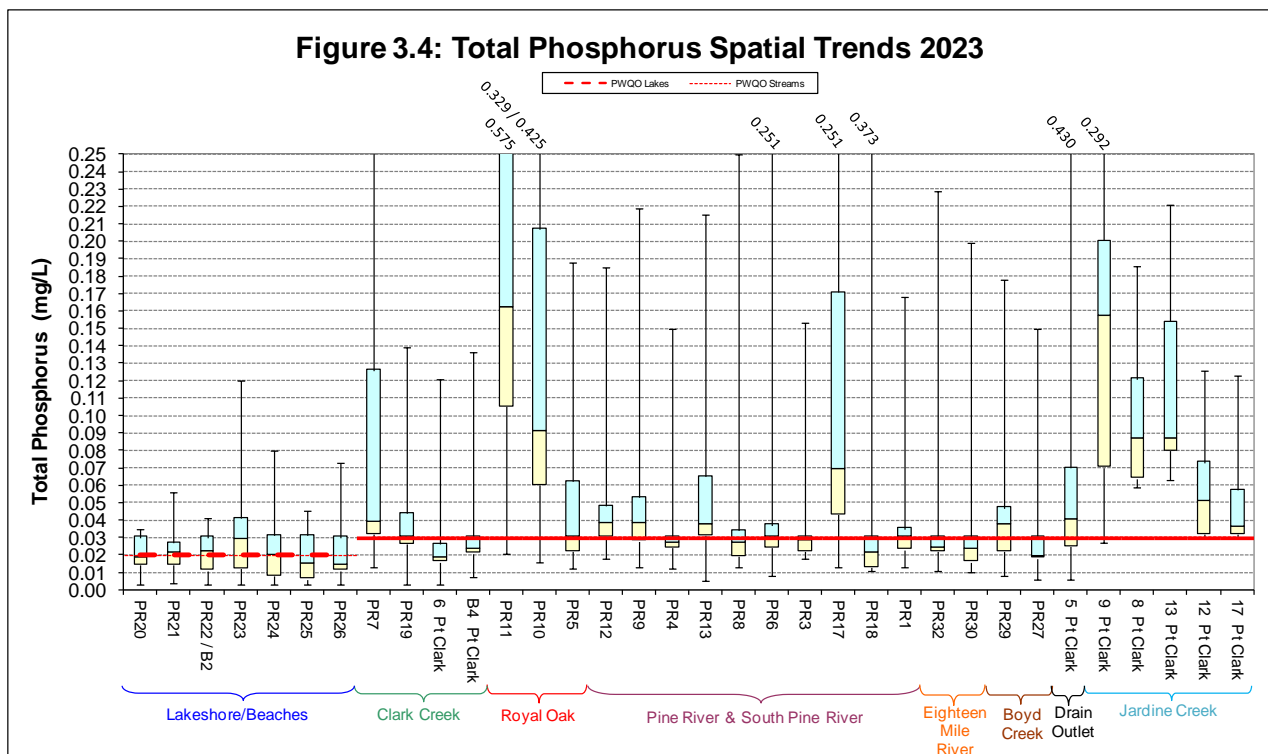
The distribution of phosphorus results for 2023 is presented in Figure 3.4 and the medians and percent of samples in exceedance for each watershed group are presented in Table 3.4.

Lake sites had a combined median of 0.020 mg/L and the interim PWQO was exceeded in 51% of lake samples. All inland sites had good flow conditions in 2023 and results may reflect more consistent nutrient loading and transport through the catchments, and less of a dilution effect at the Lake than typical years. The June 19 event results had a higher detection limit of 0.03mg/L, and are in most sites' cases likely lower than reported. Removing the June results drops the Lake median below the PWQO.

Eighteen of the twenty-seven inland sites, and three group watersheds had elevated seasonal medians with 64% of individual inland samples exceeding the PWQO. Removing the June 19 results only slightly reduces exceedances and medians. Many inland sites displayed lower variability, where typically the sites with higher seasonal medians also had higher variability.

Clark Creek PR7 results were slightly elevated and displayed higher relative variability, where results appear to lower and generally reduce in variability through downstream sites. Point Clark Site 5 is at the outlet of agricultural drainage within the Clark Creek catchment and shows similar results to PR7. Royal Oak upstream Site PR11 was consistently very high, with downstream results at PR10 and PR5 becoming lower and reducing in variability at PR5. Higher upstream results could reflect upstream or site adjacent landscape factors or land use practices, with the downstream attenuation factors including soil uptake and plant productivity, and settling through waterways and the landscape including buffers and tree stands. Pine River and South Pine River results were generally low or not high above the PWQO, with the exception of PR17. The Jardine Creek group results contrast to their particularly low nitrate results. Their results may be mediated by factors different than the predominantly rural sites of the program, such as lawn fertilizer, septic activity, or other organic material. Initiatives to improve results at elevated sites could improve the downstream watershed and decrease group watershed medians toward levels below the CWQG.

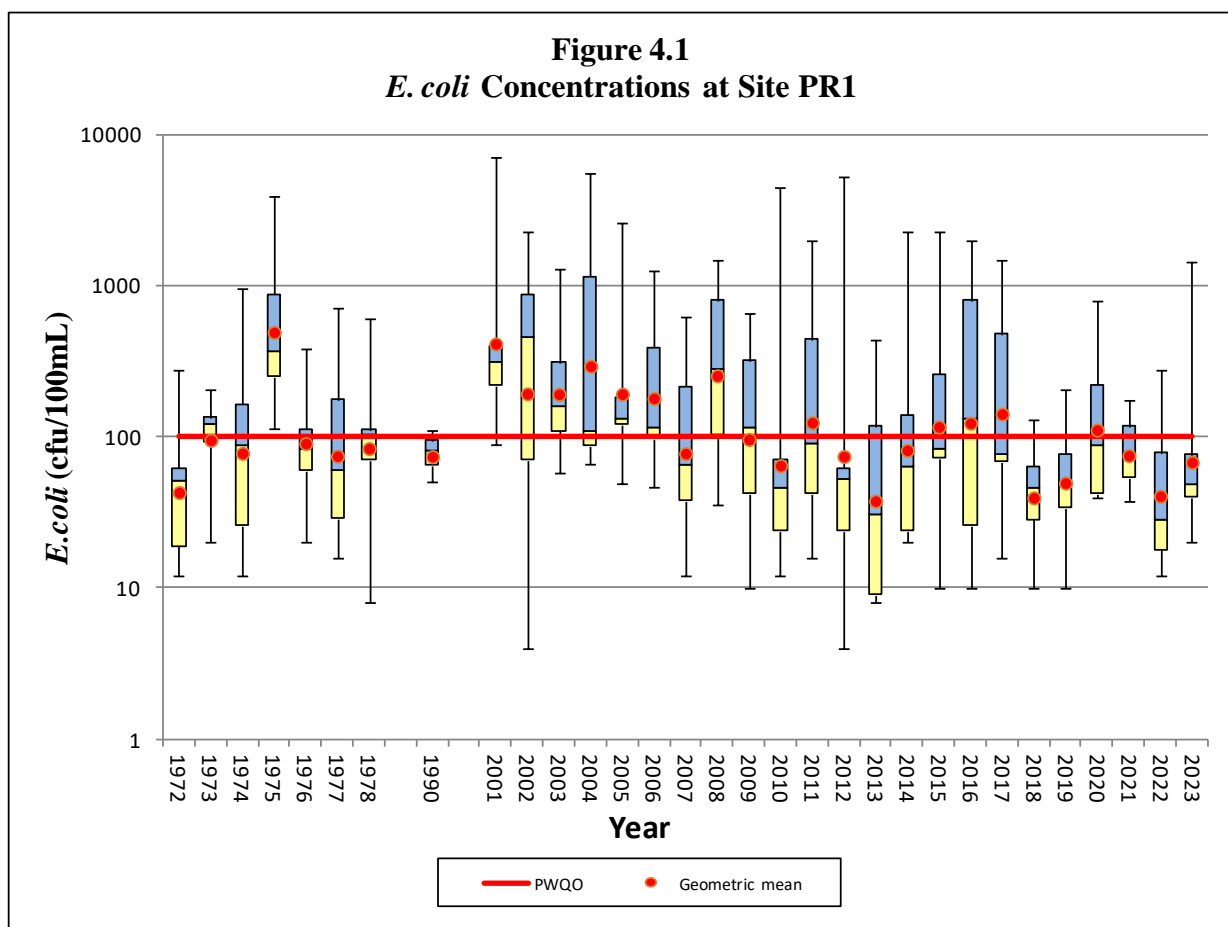
Figure 4.1 presents the 1972 to 1978 historical sample data, the 1990 data, and the data from the current monitoring period Site PR1. The Figure shows that the current and historic group of samples have similar variability, likely due to the influence of the timing of loading factors and weather conditions on measured populations. The variability of geometric means slightly above and below the PWQO throughout the entire monitoring history do not indicate consistent or high concentration loading factors, or a change in inputs between time periods, and may represent a snapshot of the typical natural and agricultural landscape in the monitoring area.

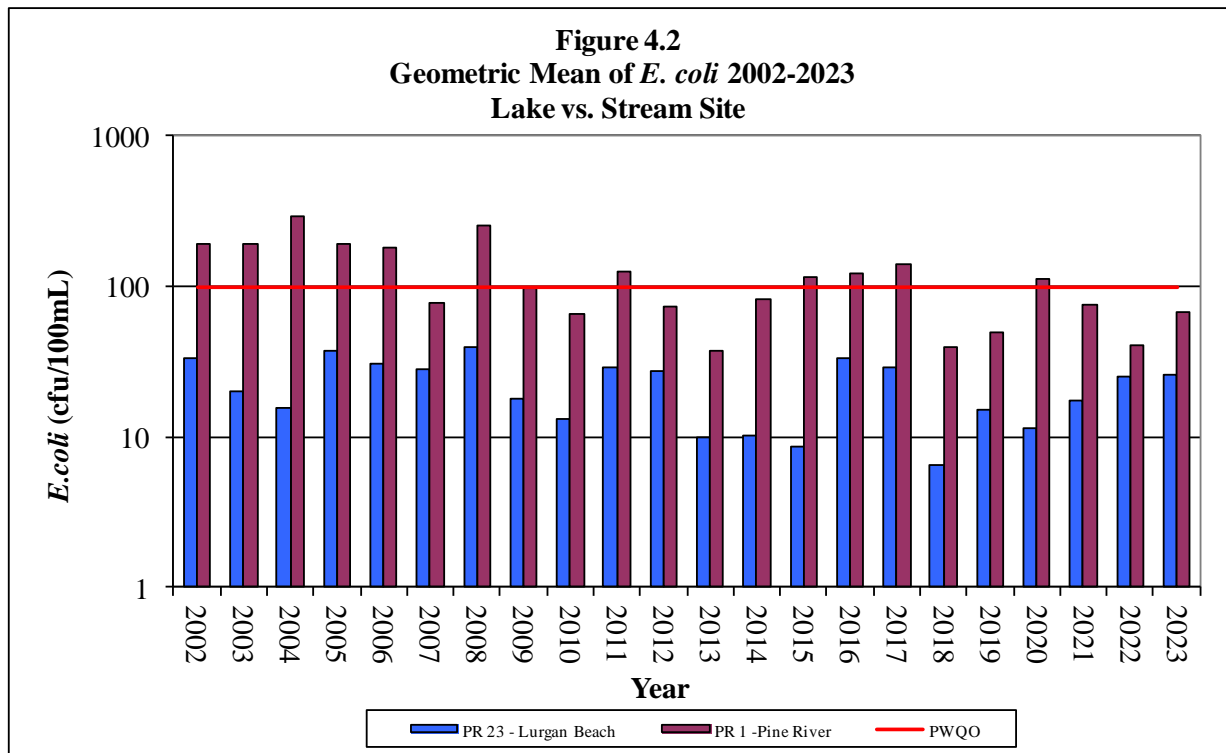
Figure 4.2 shows the results of beach Site PR23 (Lurgan Beach) in comparison to PR1 (Pine River). Lurgan Beach is located near the outflow of the Pine River into Lake Huron. The 2023 sample results are similar to previous years; the stream site continues to have higher bacteria counts than the lake site. Figure 4.22 also shows PR1’s seasonal geometric mean below the PWQO for 5 of the past 6 years. *E. coli* levels are highly variable and have many factors contributing to their origins, transport, survivability, and measured concentrations. The lake dilution factor, the isolation from direct sources of input, as well as site conditions at lake sites that are conducive to bacteria sterilization may partially account for the difference between the in-stream and lake site.

Site conditions and associated sources of bacteria change depending on sampling location, however taking PR1 and PR23 as representatives of in-stream and lake sampling sites, we can assume this relationship generally exists between the Program's in-stream and lake sites.

PR1 results are generally higher than the lake site and have been marginally elevated above the PWQO, with many years, especially recently, showing seasonal medians below the PWQO. PR1 is located at the downstream confluence of the Pine River group of sampling sites and is typically in the low range of group results. Given an expectation of attenuation with no other loading factors, downstream confluence sites may be generalized to represent minimum baseline concentrations for a watershed group.

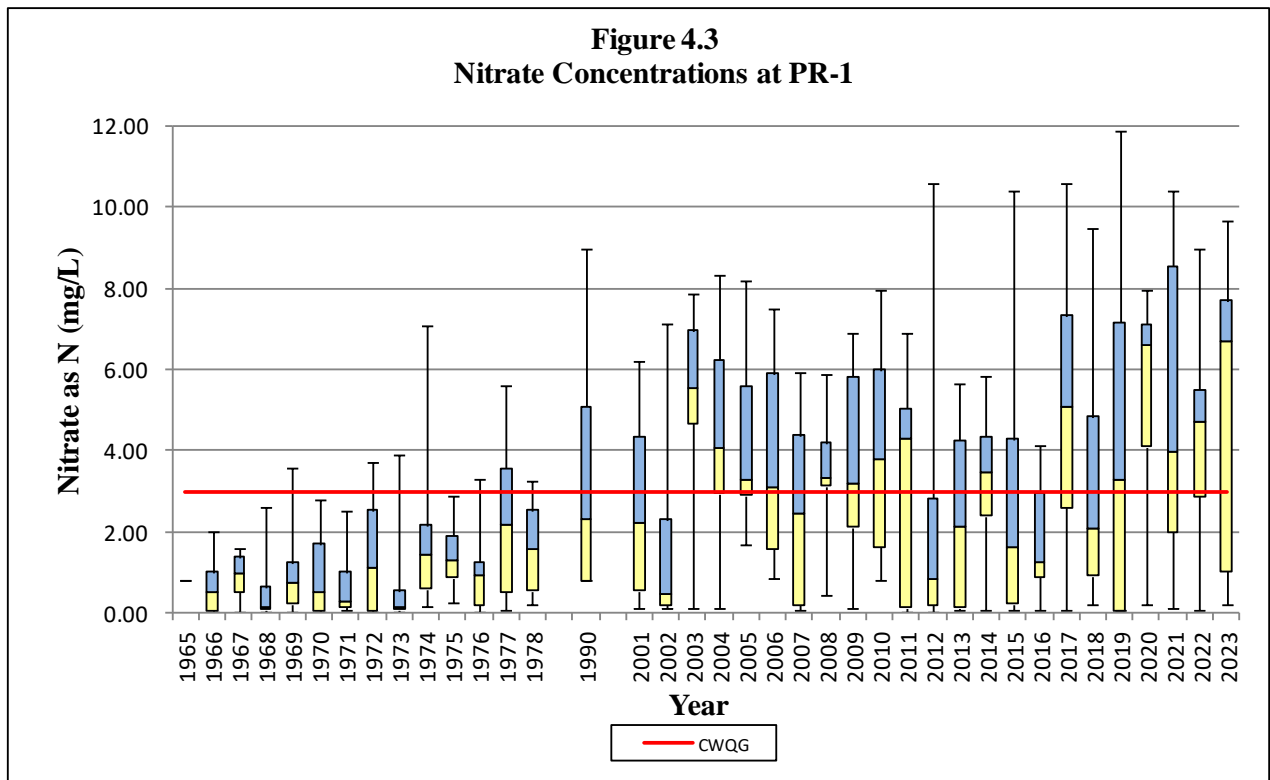
Figure 4.3 presents the historical and current nitrate data for sample Site PR1. Throughout the current sampling program, PR1’s nitrate levels have generally been higher than historical data, with a combined median of over 3 mg/L compared to 0.78 mg/L, and with no historic year median above the CWQG. The median values for the current sampling period have been within the range of those found historically; however, the current period’s large variability towards higher results, as well as with the majority of medians being above the CWQG, indicate the current sampling period results for PR1 are elevated from those found historically at inland sites. Expanding PR1’s current elevated state to all inland sites, there is a wide range of stewardship opportunities to mediate improvements throughout the watershed with respect to nitrate loadings, transport, and availability.

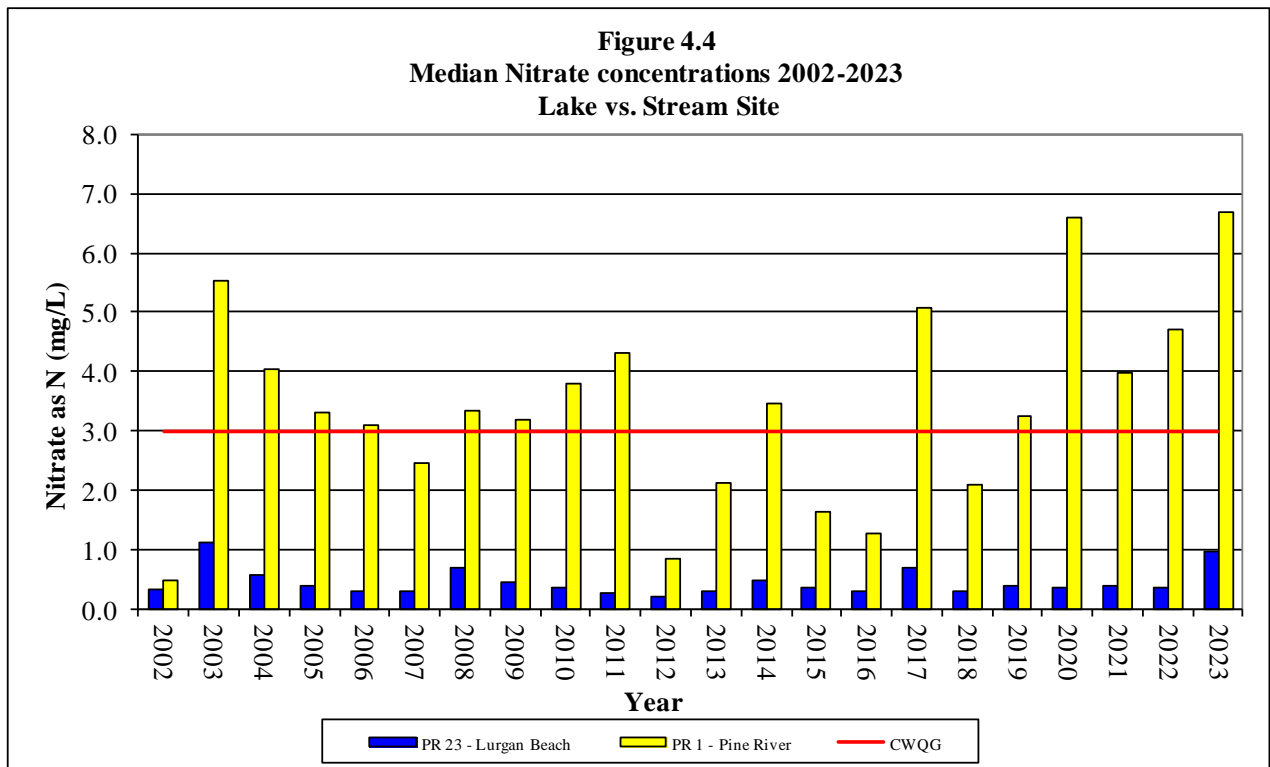
Figure 4.4 compares the nitrate concentrations between a representative stream and lake site. It is apparent that concentrations at the lake site, most likely due to a dilution factor, almost consistently remain below the CWQG, while in-stream the stream site can have concentrations well above the lake site, though not necessarily over the CWQG. Using the two as representative sites, it can be assumed that this relationship exists between in-stream and lake sampling sites.

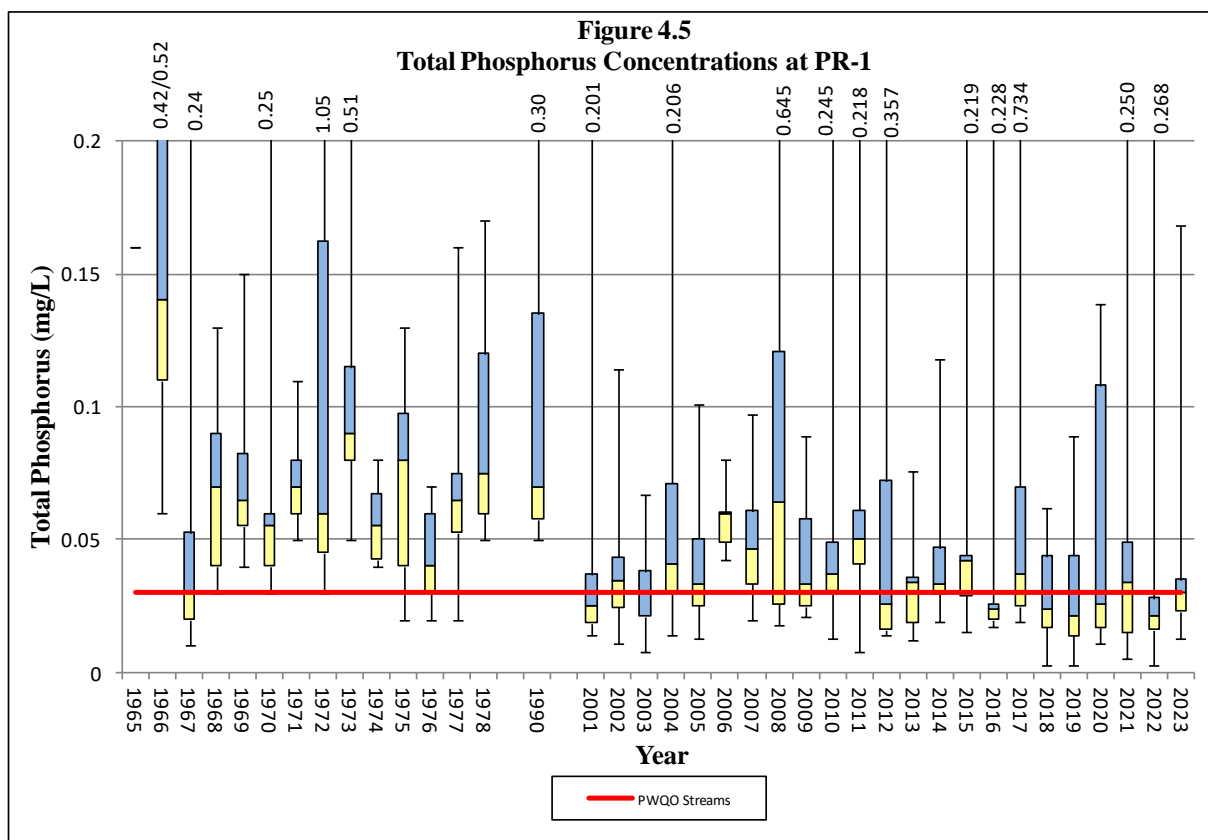
Figure 4.5 presents the accumulated phosphorus data for sample Site PR1. Historically the results have been variable while remaining well above the interim PWQO. Concentrations for the current sampling program group of sites are lower than the historical results; but have generally remained above the interim PWQO with intermittent years displaying seasonal medians below the objective. Possible contributing factors for the lower concentration in the current group may be related to adoption of best management practices, including improvements in soil management to reduce soil erosion, improvements in fertilizer management and application, as well as the updating of septic systems.

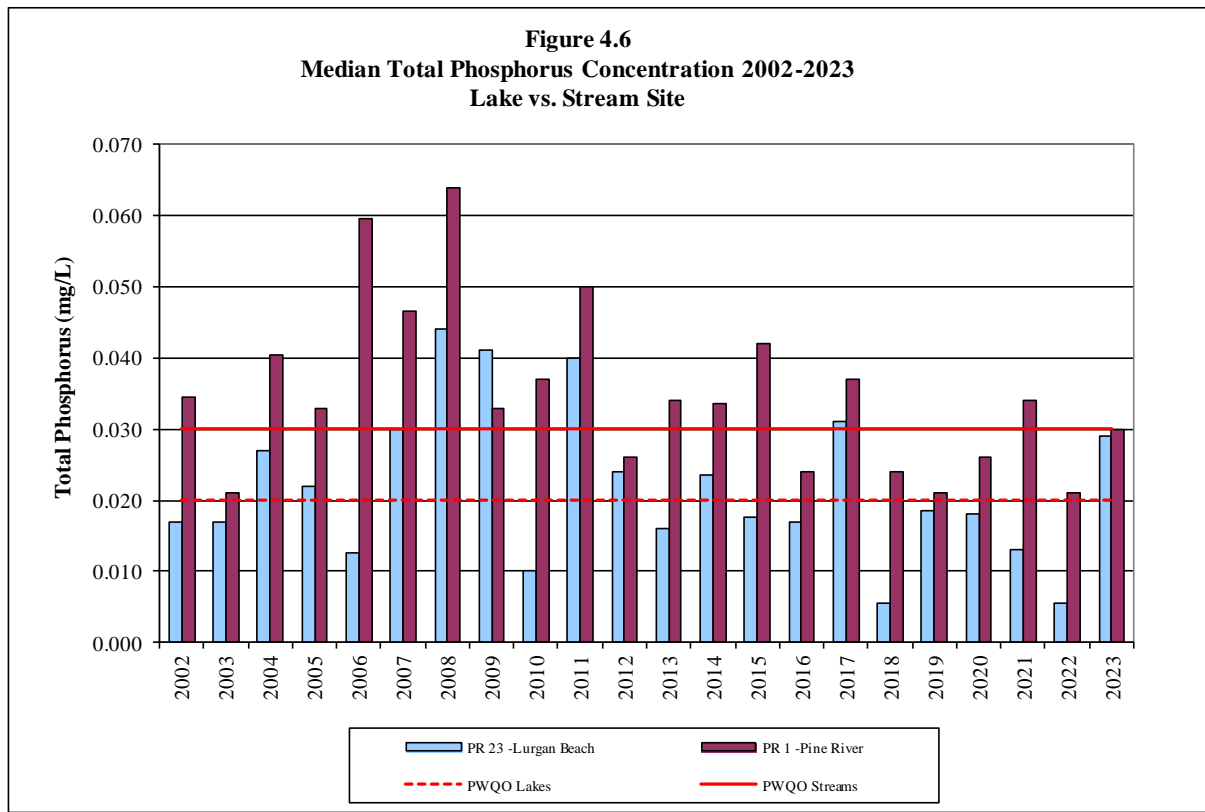
Figure 4.6 compares PR23 and PR1 phosphorus results. Results have been variable from year to year, with the lake site consistently lower than the in-stream site. Lake phosphorus levels reflect landscape level inputs as well as the lakes own storage in the phosphorus cycle, where similar to nitrate, landscape level inputs can be diluted in large waterbodies. Assuming a downstream attenuation factor and PR1 to be representative of minimum baseline concentration, this relationship could be assumed for all downstream confluence sites for the watershed groups.
