TOWNSHIP OF HURON-KINLOSS

BASELINE SURFACE
WATER QUALITY MONITORING PROGRAM

2021 ANNUAL REPORT

February 1, 2022

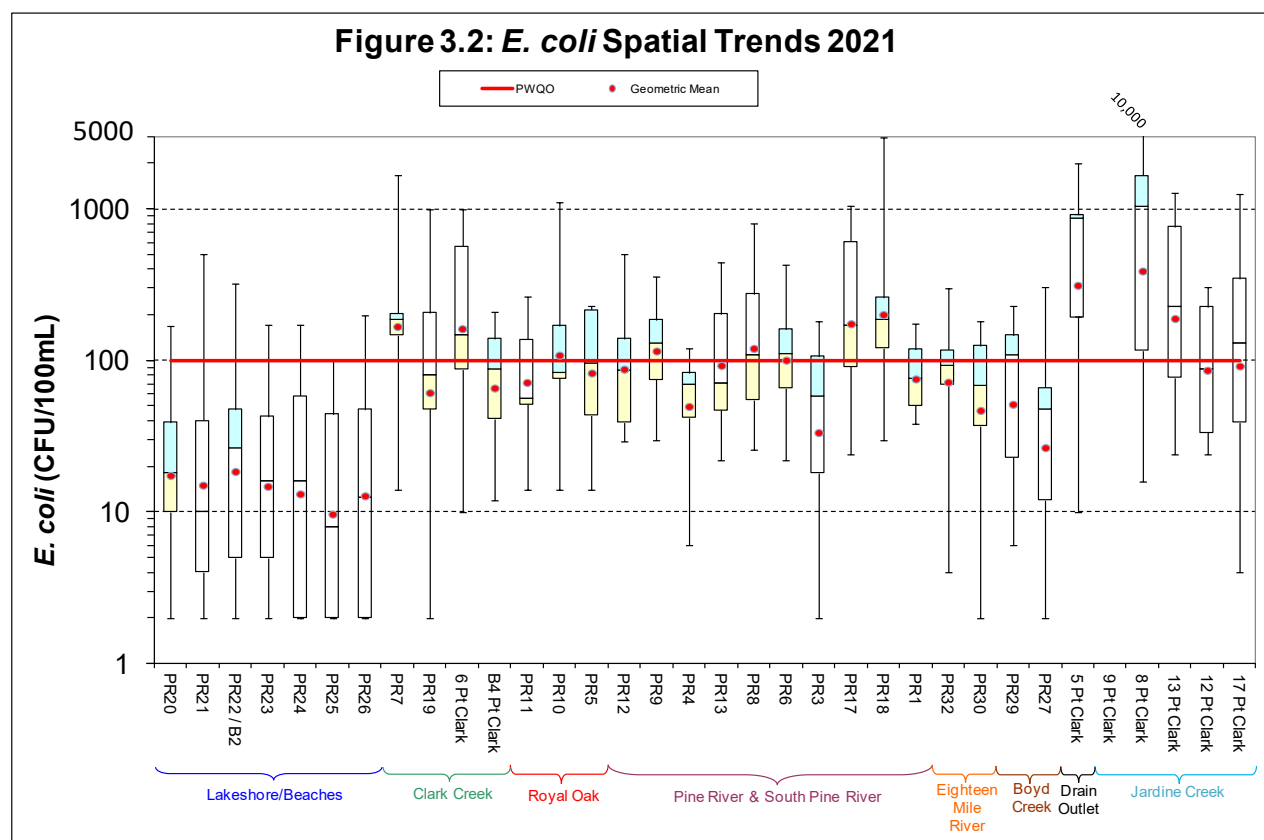
Figure 3.2 shows a typical range for inland site results of about 10-1000 CFU, with the range of geometric means for inland sites of about 30-600 CFU. 10 of the 27 sampled inland sites show geometric means above the PWQO. Of these 10 sites, PR7, PR17, PR18, 5, 8 and 13 show their box-plot ranges almost consistently above the PWQO.

Lake sites PR20-PR26 results show geometric means below the PWQO, with the box-plot range showing nearly all individual results in 2021 below the PWQO. Only 7 of the 61 lake samples collected were at or above the PWQO, ranging from 100-500 CFU, and includes all six lake sites exceeding the PWQO on the October event. The October event was not preceded by significant rainfall and described lake sites as generally very turbid, due to sediment upturn from wave action caused by strong winds. The events which were preceded by significant rainfall did not show elevated results, highlighting the compounding nature of loading factors; Lake mixing and sediment upturn from wind works to distribute overland loading from rainfall events, as well is a separate loading factor which works to distribute the lake's own *E. coli*.

PR7 is surrounded by agricultural fields, PR17 and PR18 are surrounded by agricultural fields and are in the vicinity of farming and homestead activity, with inputs likely related to those activities. Site 5 is located outside of Point Clark in a roadside ditch at the outlet a large drainage area, where inputs are likely related to farming and wildlife activity. Site 8 is located in Point Clark, where inputs are likely related to animal and possibly septic activity. Site 8 was observed to have a white coloured streambed film and sewage like smell through much of the sampling season. Site 13 is located immediately downstream of Site 8 and may reflect attenuation from the upstream site or similar inputs.

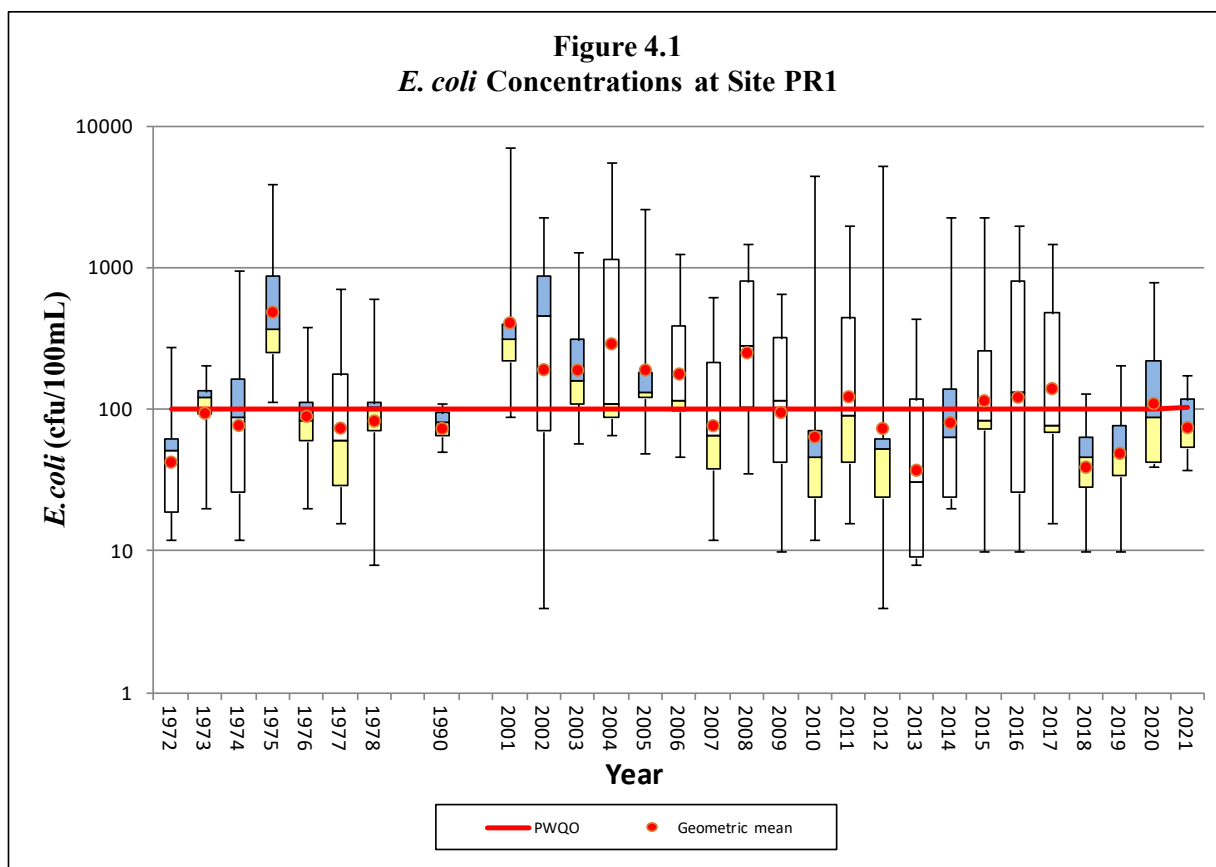
Figure 4.1 presents the 1972 to 1978 historical sample data, the 1990 data, and the data from the current monitoring period Site PR1. The Figure shows that the current and historic group of samples have similar variability, likely due to the influence of the timing of loading factors and weather conditions on measured populations. The variability of geometric means slightly above and below the PWQO throughout the entire monitoring history do not indicate consistent or high concentration loading factors, or a change in inputs between time periods, and may represent a snapshot of the typical natural and agricultural landscape in the monitoring area.

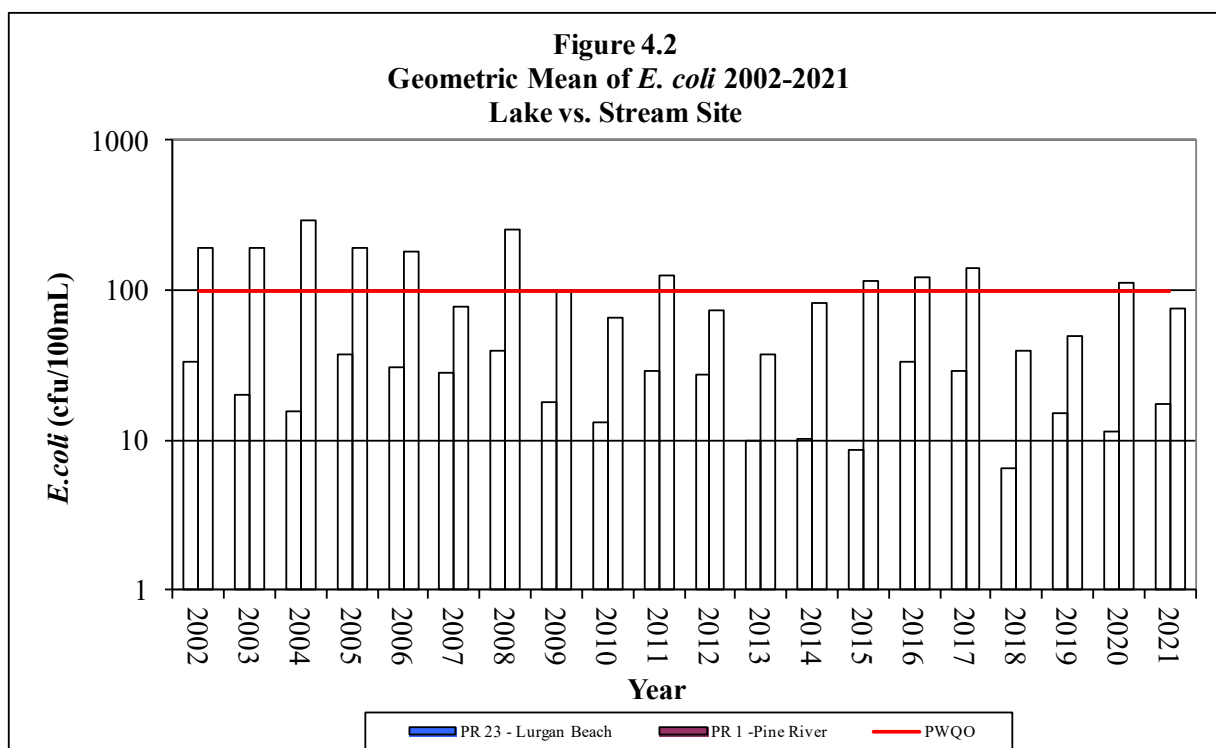
Figure 4.2 shows the results of beach site PR23 (Lurgan Beach) in comparison to PR1 (Pine River). Lurgan Beach is located near the outflow of the Pine River into Lake Huron. The 2021 sample results are similar to previous years; the stream site continues to have higher bacteria counts than the lake site. *E. coli* levels are highly variable and have many factors contributing to their origins, transport, survivability, and measured concentrations. The lake dilution factor, the isolation from direct sources of input, as well as site conditions at lake sites that are conducive to bacteria sterilization may partially account for the difference between the in-stream and lake site. Site conditions and associated sources of bacteria change depending on sampling location, however taking PR1 and PR23 as representatives of in-stream and lake sampling sites, we can assume this relationship generally exists between the program's in-stream and lake sites.

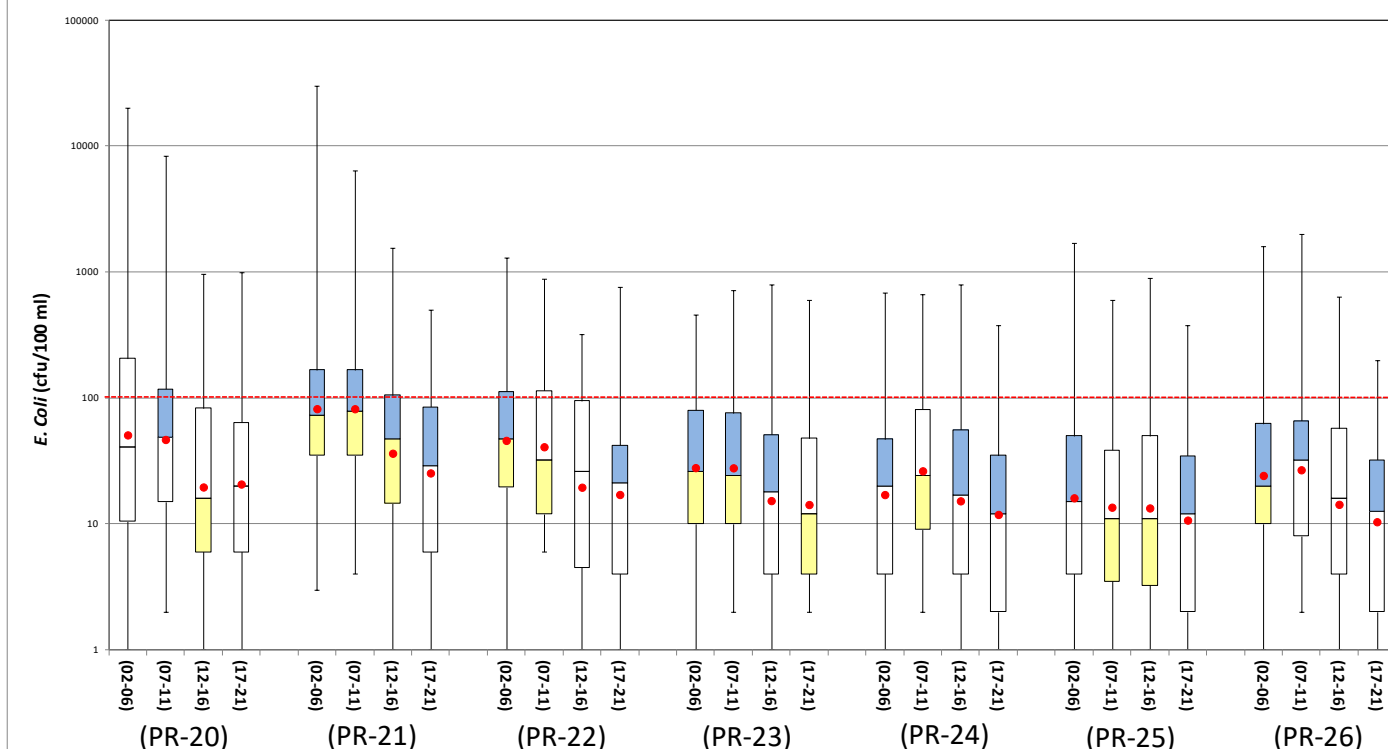
Figure 4.3: 5 Year Comparison of *E. coli* at Lake Sites

In the lake site group, as shown in Figure 4.3, given that the geometric means for all 5-year periods are below the PWQO and given that their upper ranges rarely exceed the PWQO, the 0-100 CFU variability observed in the box-plots should be considered against the exponential growth potential of *E. Coli*; single digit downward trends may be present in some lake sites but are unattributable due to the small magnitude. Throughout the sampling history almost any elevated result has had an acute factor observed, such as preceding weather, high winds, turbidity observations or the presence of waterfowl. Lake results have been almost consistently excellent through the history of the sampling program. The former Point Clark sampling program's lake site *E. Coli* results overlap with one Pine River lake site; PR22/B2 were sampled at the same location but with increased frequency for the Point Clark program. The sample data from Point Clark was not incorporated into the Pine River dataset in order to maintain an even basis of comparison. Using the full dataset in Figure 4.4, the ranges through most 5-year periods are slightly more variable than the respective Figure 4.3 site, and there is no significant difference between respective geometric means.

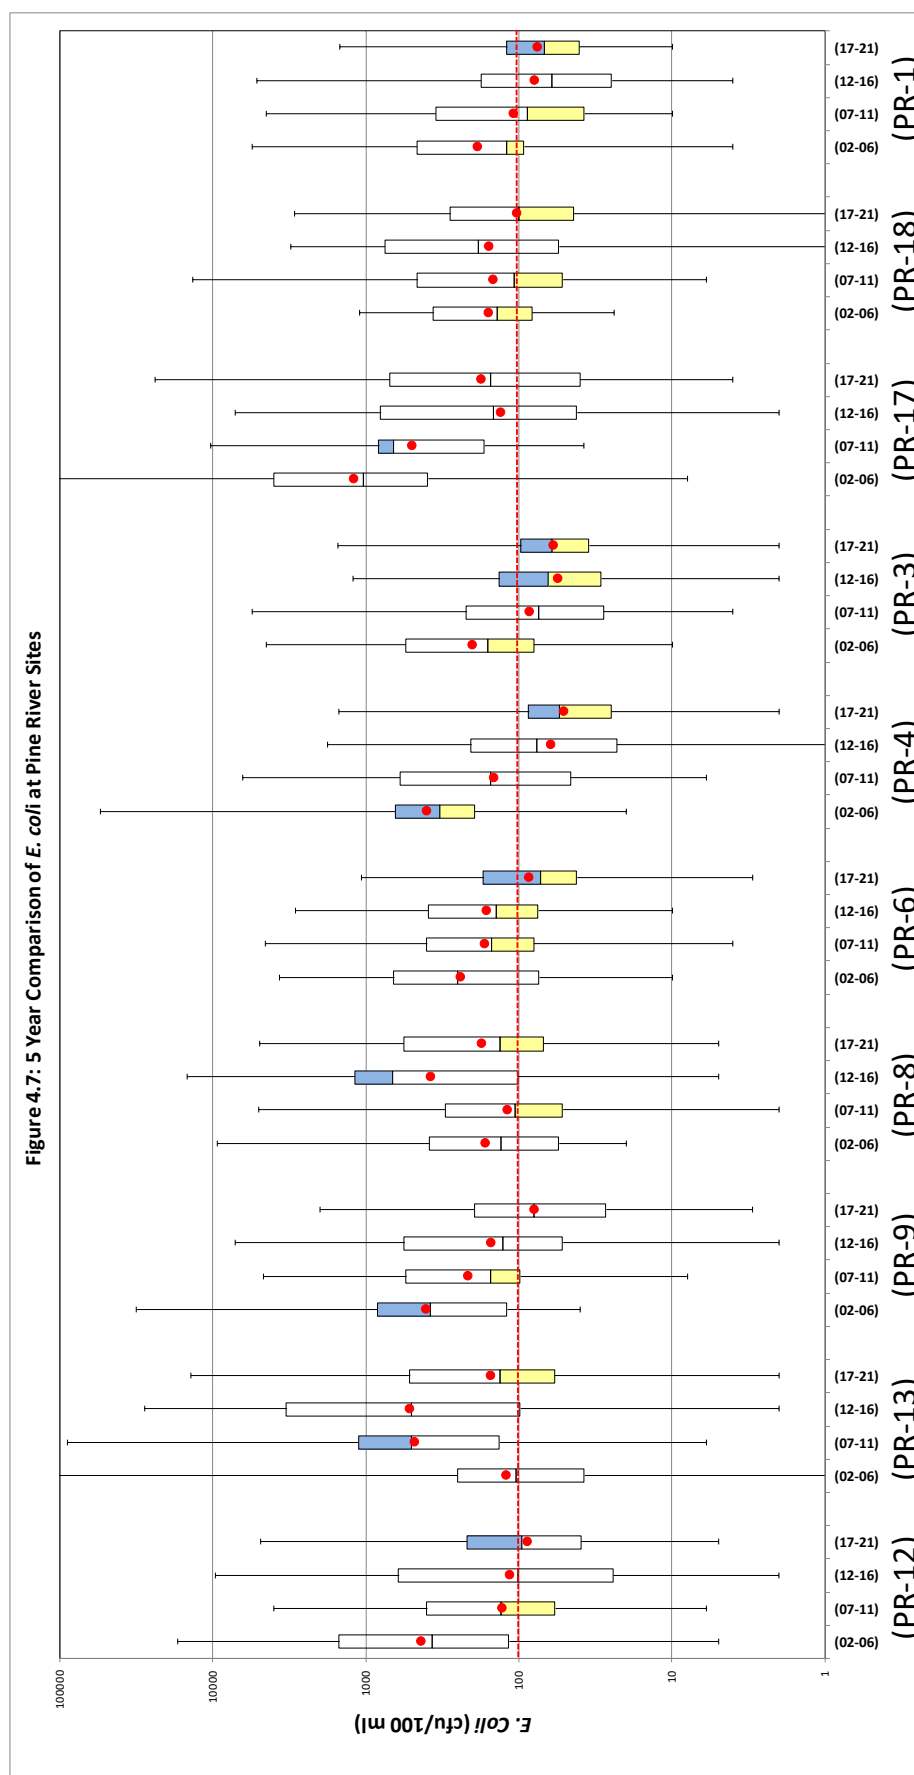
Almost every site in Pine River group, as shown in Figure 4.7, shows a decreasing trend through time, with the latest 5-year period showing geometric means below or similar to the lowest levels observed. From well below to slightly above the PWQO, the majority of sites show improvement through time.

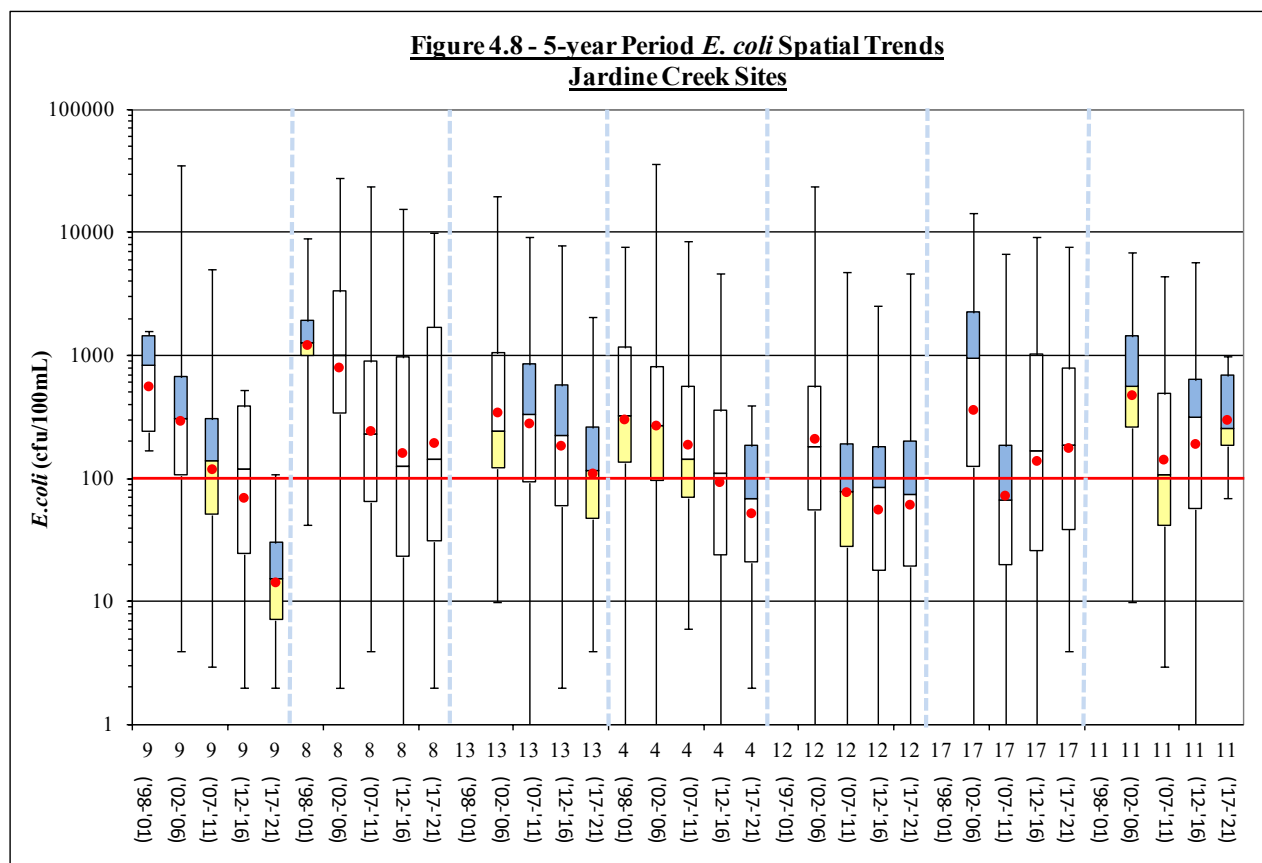
Point Clark's Jardine Creek sites, as shown in Figure 4.8, show an almost consistent decrease through time periods, with the latest time period significantly lower than many previous periods. Site 17 and site 11 show an increasing trend after an initial decrease in the second period. A large storm outlet is located between site 12 and downstream sites 17 and 11, and may be contributing to the increasing trend observed downstream of site 12.

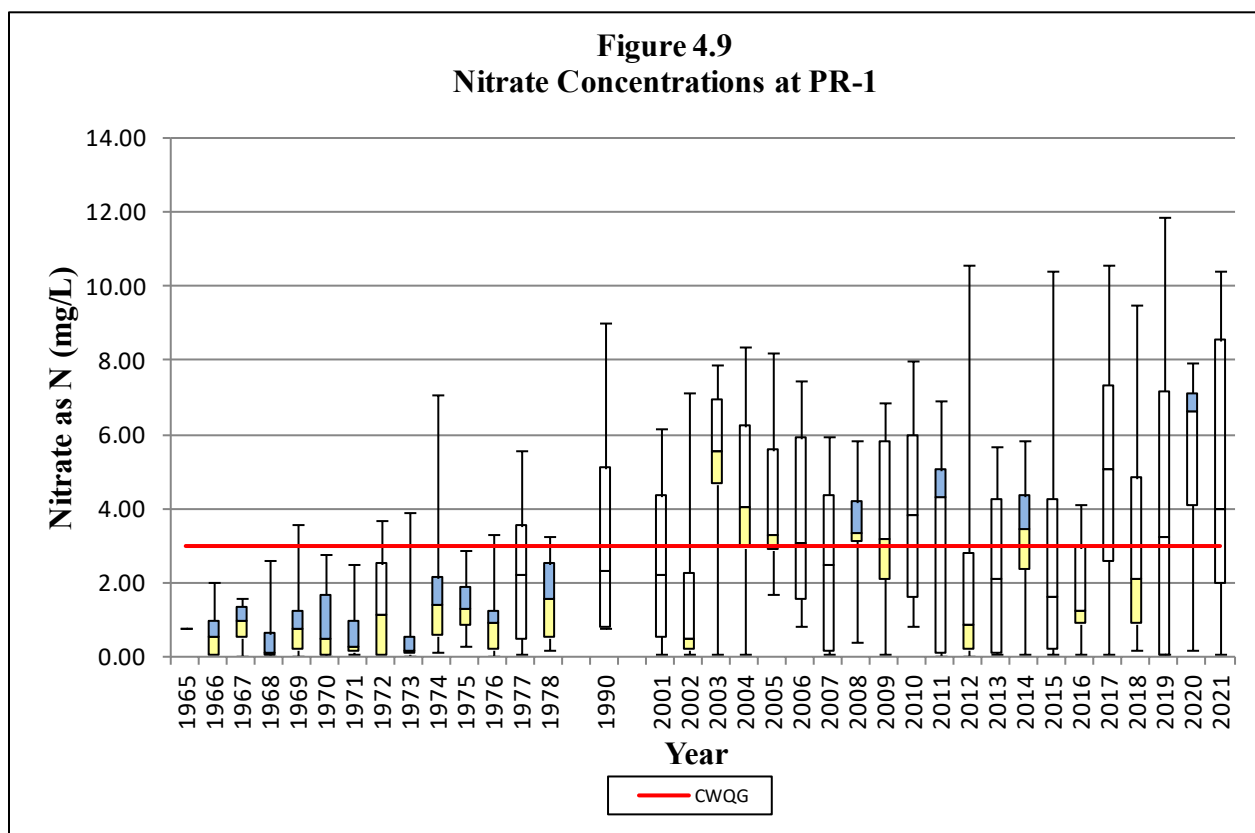
Figure 4.9 presents the historical and current nitrate data for sample Site PR1. Throughout the current sampling program, PR1's nitrate levels have generally been higher than historical data, with a combined median of over 3 mg/L compared to 0.78 mg/L, and with no historic year median above the CWQG. The median values for the current sampling period have been within the range of those found historically, however the current period's large variability towards higher results, as well as with the majority of medians being above the CWQG, indicate the current sampling period results for PR1 are elevated from those found historically at inland sites. Expanding PR1's current state to all inland sites, there is a wide range of stewardship opportunities to mediate improvements throughout the watershed with respect to nitrate loadings and transport.

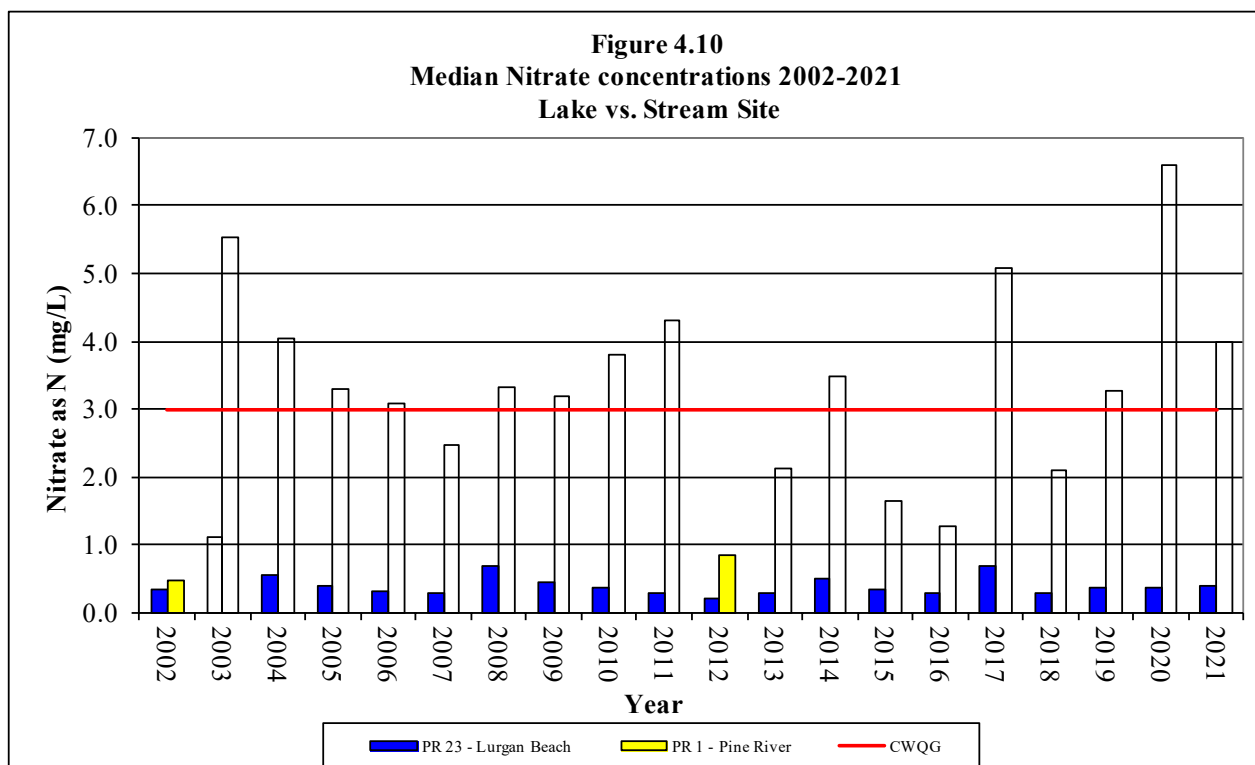
Figure 4.10 compares the nitrate concentrations between a representative stream and lake site. It is apparent that concentrations at the lake site, most likely due to a dilution factor, almost consistently remain below the Canadian Water Quality Guideline while in-stream the stream site can have concentrations well above the lake site, though not necessarily over the CWQG. Using the two as representative sites, it can be assumed that this relationship exists between all in-stream and lake sampling sites.

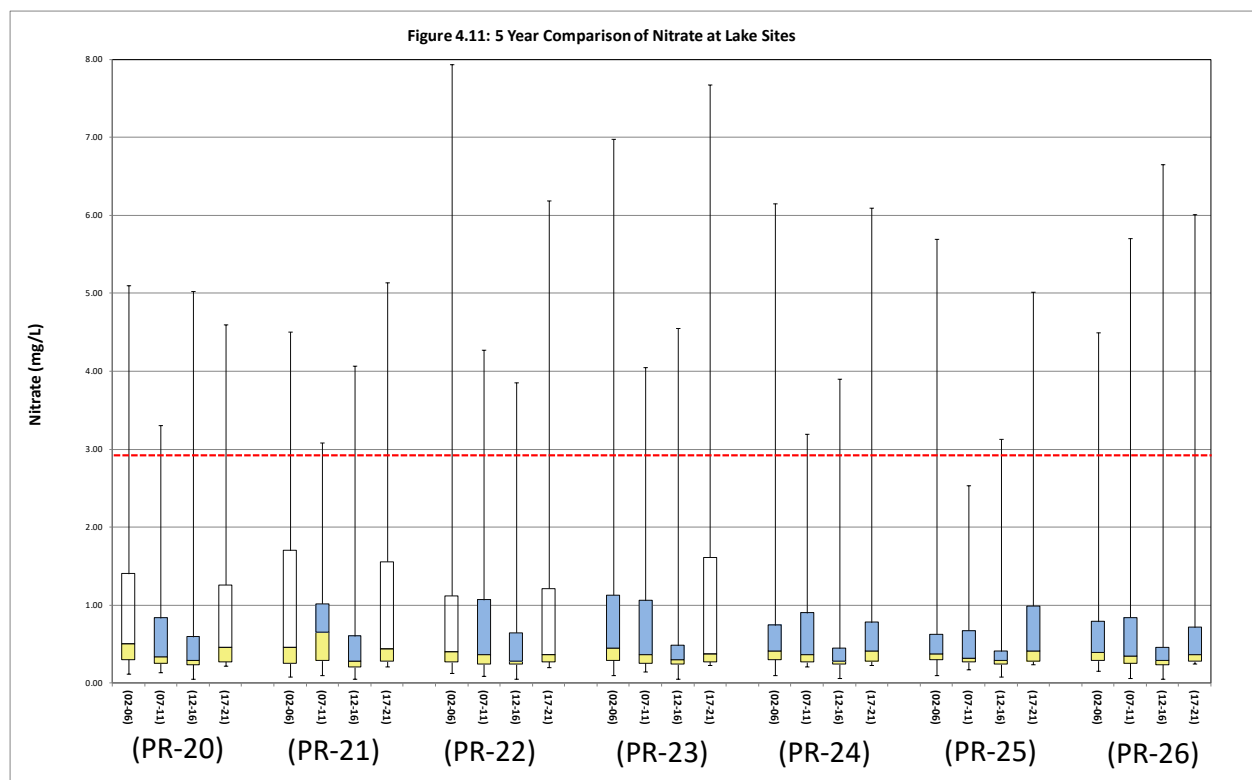
As shown in Figure 4.11, the lakeshore/beach site group displays medians well below the CWQG at typically under 0.4 mg/L, for all sites and through all 5-year periods. Figure 4.11 shows no notable change in medians through time and that except for very rare occurrences, individual results have been consistently below the CWQG which shows the Lake dilution effect has been consistent through the sampling history. The rare exceedances could contribute to over-productivity and nuisance algal growth, where nitrate is a limiting nutrient. Stewardship initiatives focused on mediating downstream nitrate loading impacts would ultimately affect Lake nitrate levels.

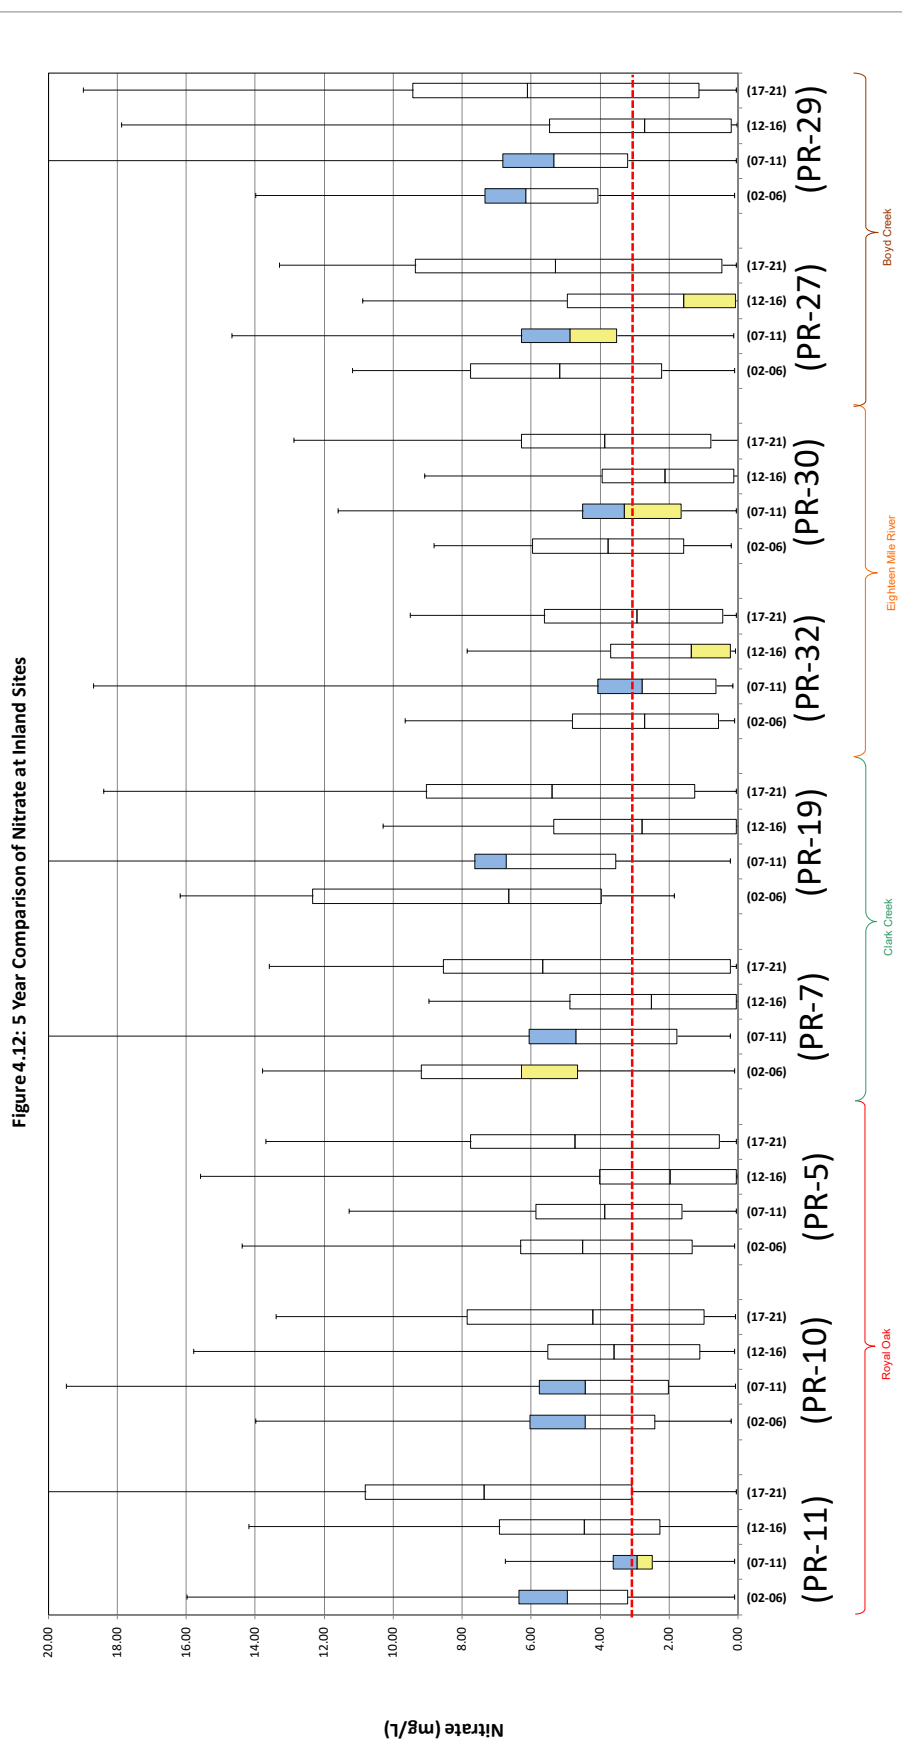
The inland subwatersheds are grouped and displayed in Figure 4.12. The Royal Oak group's medians are nearly consistently above the 3 mg/L CWQG and usually over 4 mg/L. PR-11 shows a significant increase in the latest time period, with a large range in results and a median of over 7 mg/L. Clark Creek sites show a decreasing trend through the first three 5-year periods, with the latest 5-year period showing a possible significant increase at both sites, to levels found before the downward trend began. Eighteen Mile River sites show results fairly split above and below the CWQG, with the latest 5-year period showing the highest median for both sites. Boyd Creek sites show trends similar to Clark Creek sites; a decreasing trend through time until the latest period, showing results similar to the historically highest levels.

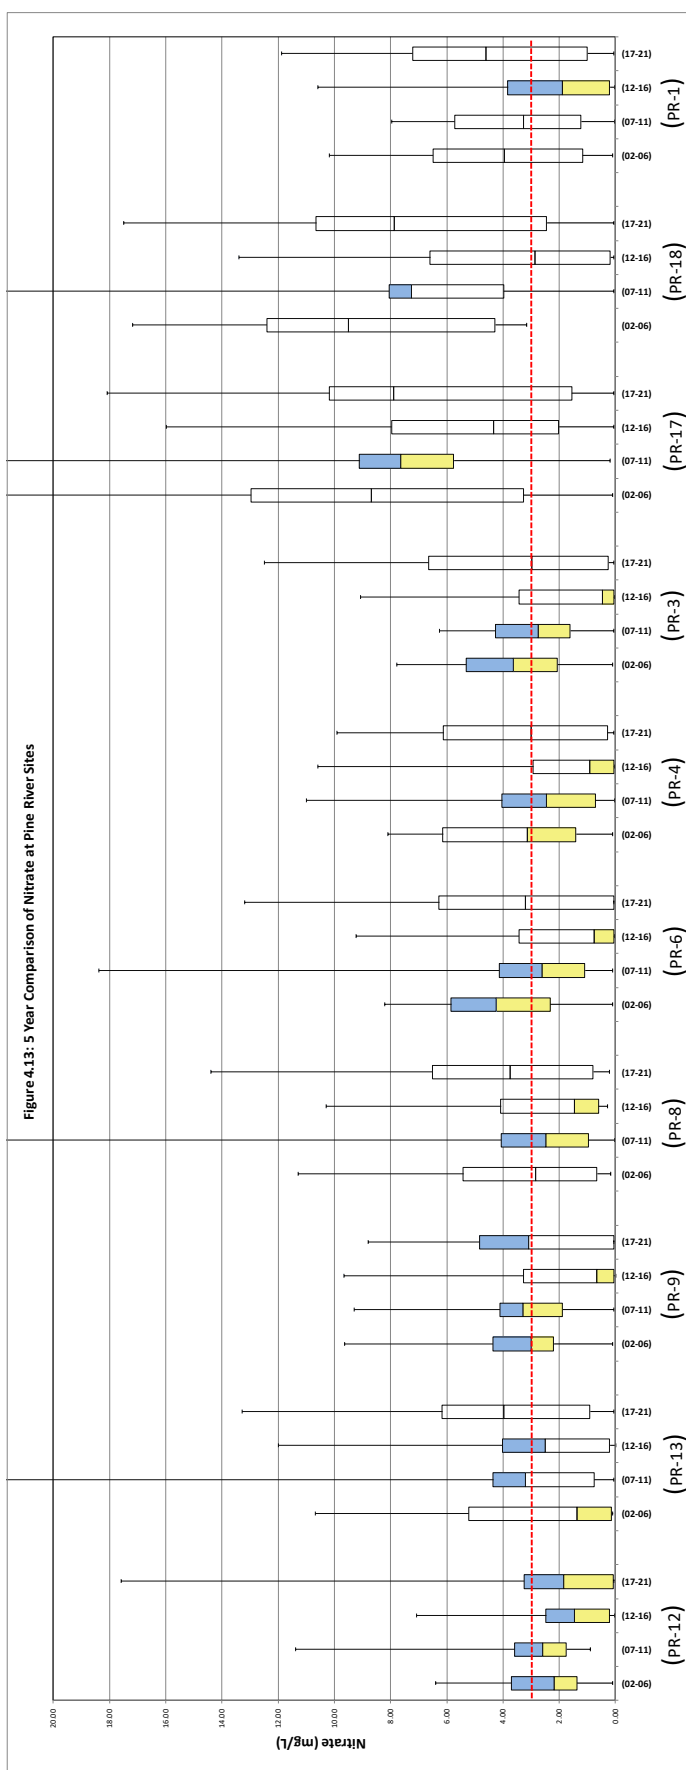
The Pine River group is displayed in Figure 4.13 and shows many sites with similar downward trends followed with increased results through the latest 5-year period, where many of the medians are above the CWQG. PR-17 and PR-18 are once again particularly elevated.

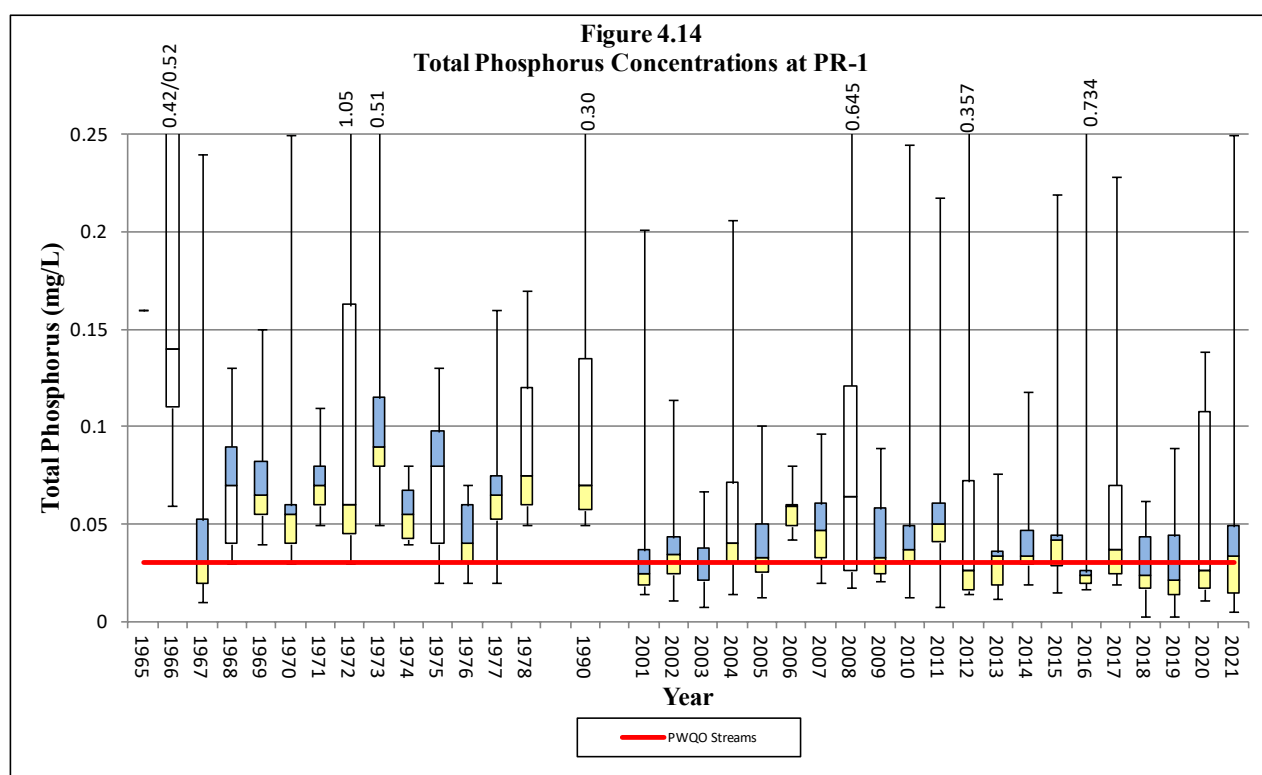
Figure 4.14 presents the accumulated phosphorus data for sample Site PR1. Historically the results have been variable while remaining well above the interim PWQO. Concentrations for the current sampling program group of sites are lower than the historical results but have generally remained above the interim PWQO, with intermittent years displaying seasonal medians below the objective. Possible contributing factors for the lower concentration in the current group may be related to adoption of best management practices including improvements in soil management to reduce soil erosion, improvements in fertilizer management and application, as well as the updating of septic systems.

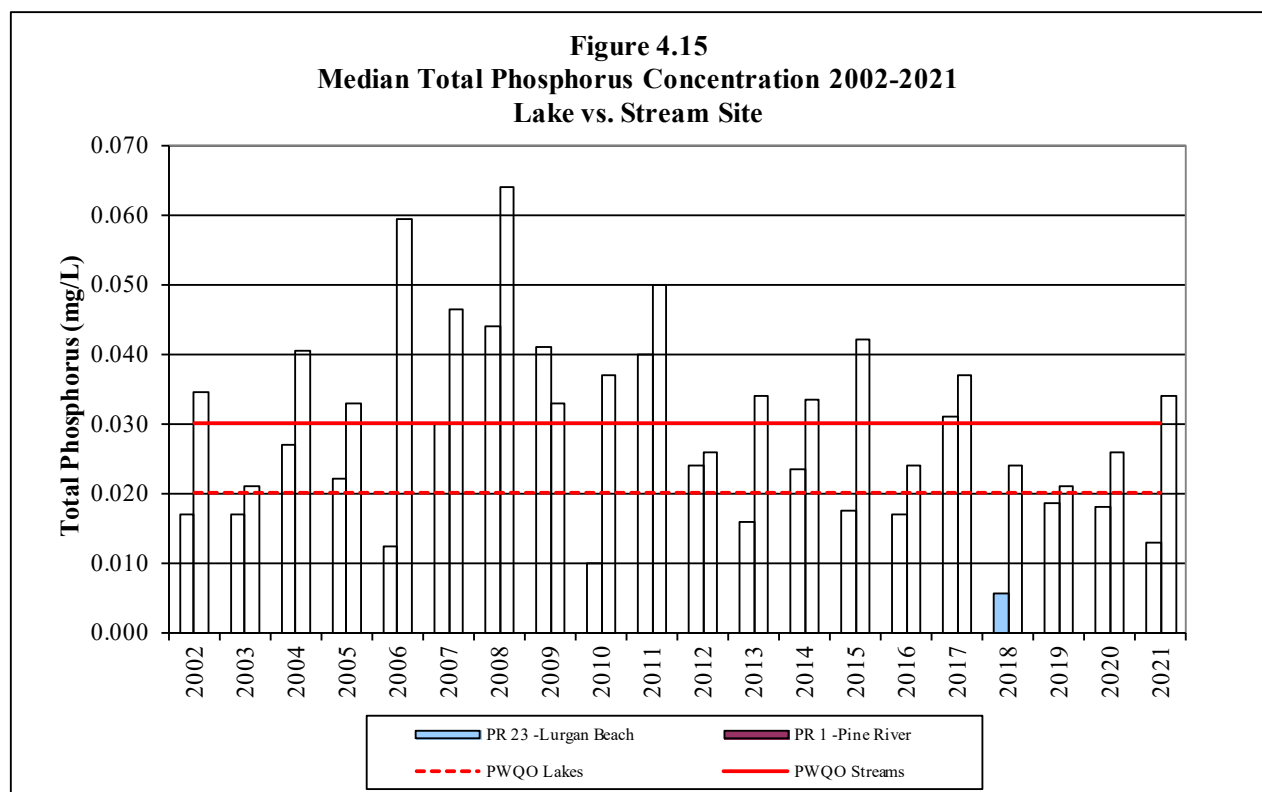
Figure 4.15 compares PR23 and PR1 phosphorus results. Results have been variable from year to year, with the lake site consistently lower than the in-stream site. Lake phosphorus levels reflect landscape level inputs as well as the lakes own storage in the phosphorus cycle, where similar to nitrate, landscape level inputs can be diluted in large waterbodies.

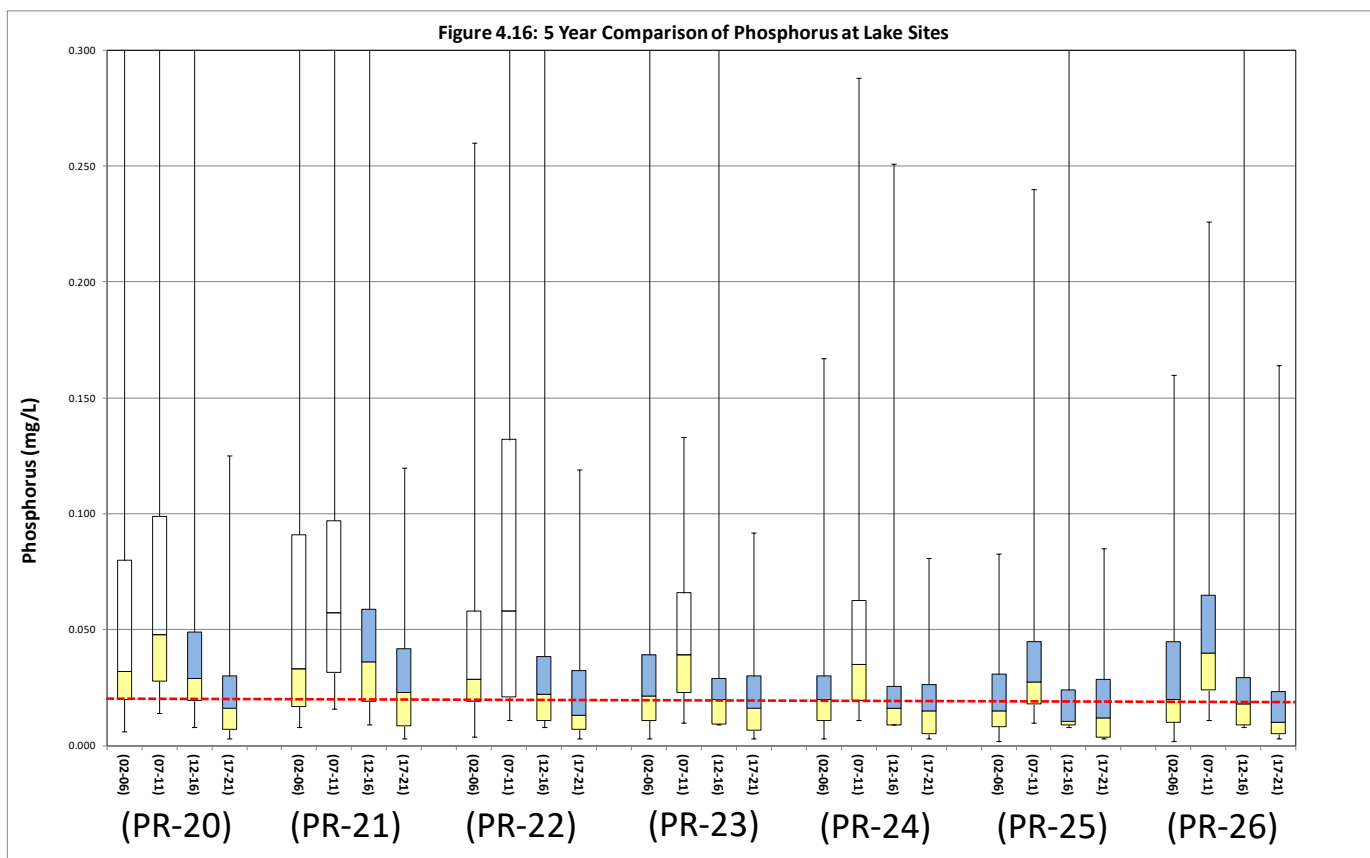
The lakeshore/beach site group results are displayed in Figure 4.16 which shows a proportional pattern for all sites through the 5-year periods. The second period shows a marked increase in variability and median, followed by the third and latest period's showing a decrease in variability and median to levels similar to or below the first 5-year period, as well as a notable reduction in extreme results marked by the standard error bars. All medians for all sites in the lake group in the latest period are either the lowest of all 5-year periods or well below the interim PWQO. Despite some historical variability, the lake site phosphorus levels have decreased almost consistently, to levels below the interim PWQO for lakes.

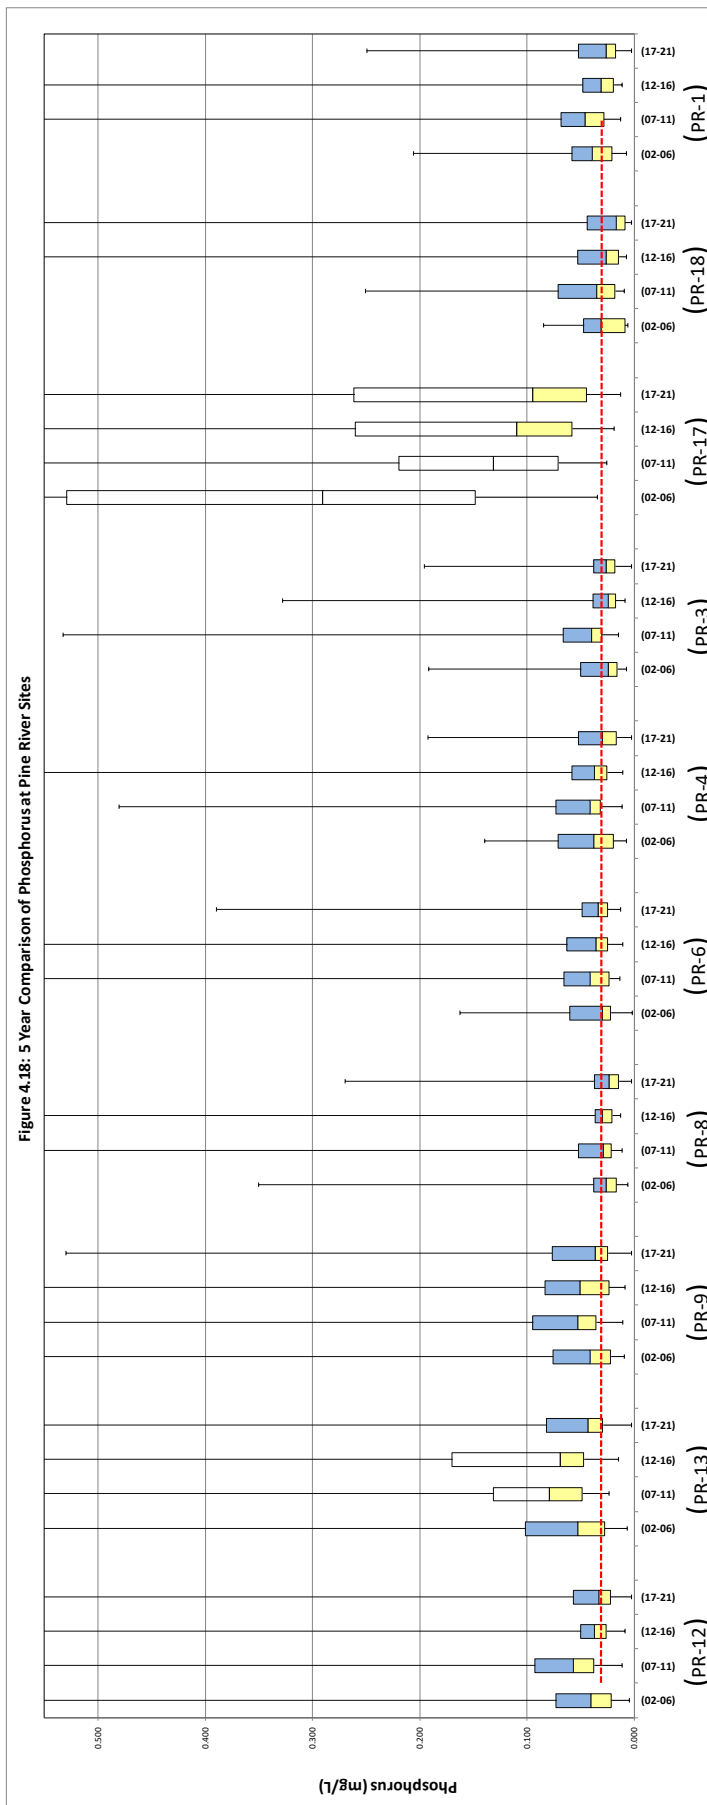
The Pine River group is displayed in Figure 4.18 and shows relatively low variability between sites as well as between 5-year periods, mostly split relatively evenly above and below the PWQO. While there are no apparent trends the latest 5-year period almost consistently shows a decrease through the watershed, with the lowest median of all periods. PR-17 shows decreased levels since the first 5-year period however it has remained particularly elevated, with a median in the current period of almost 0.100 mg/L and very high variability.

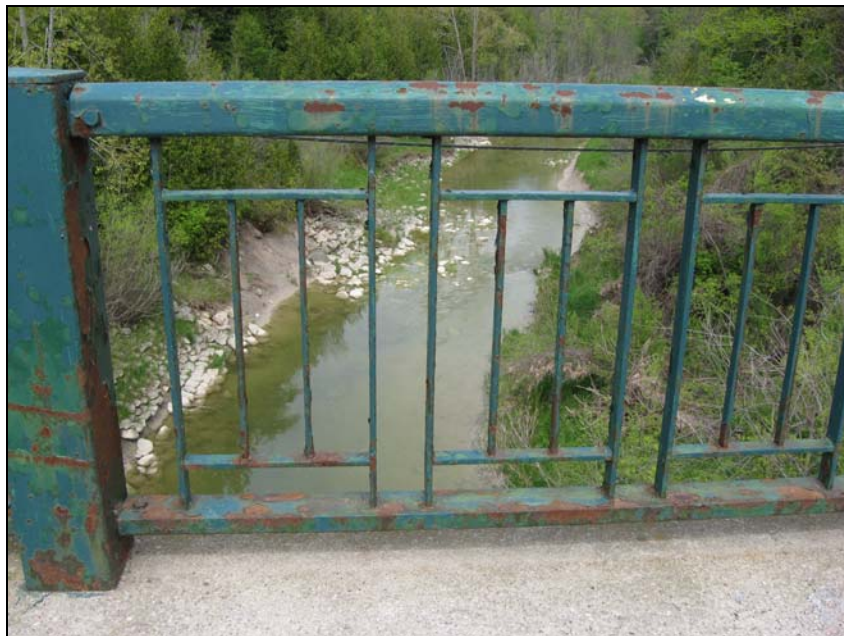
PR 1

PR 1-Facing WEST

Bridge over Pine River on Lake Range Road, South of Lurgan Beach Road.

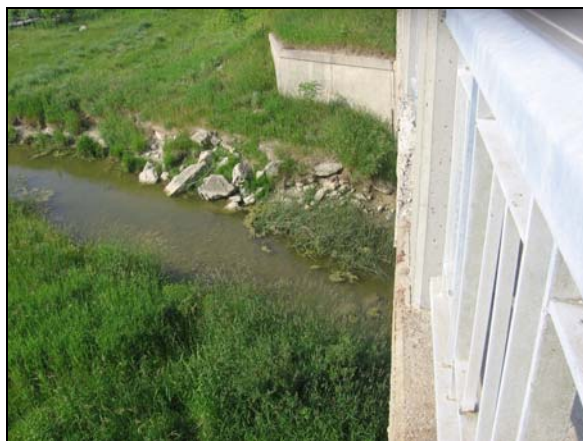
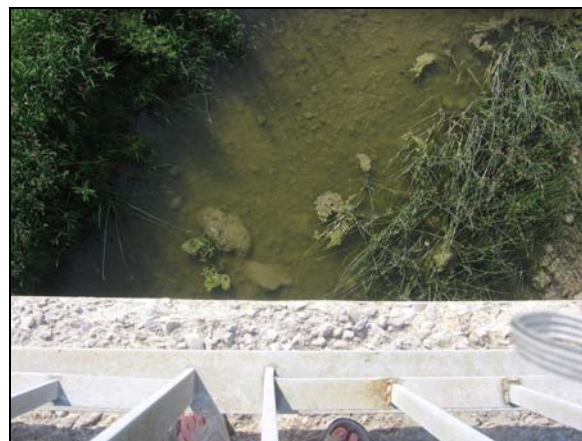
PR 3

PR 3-Looking across EAST side of bridge

PR 3-Looking down over bridge on EAST side

South Pine River Bridge on Highway 21, North of Concession 6

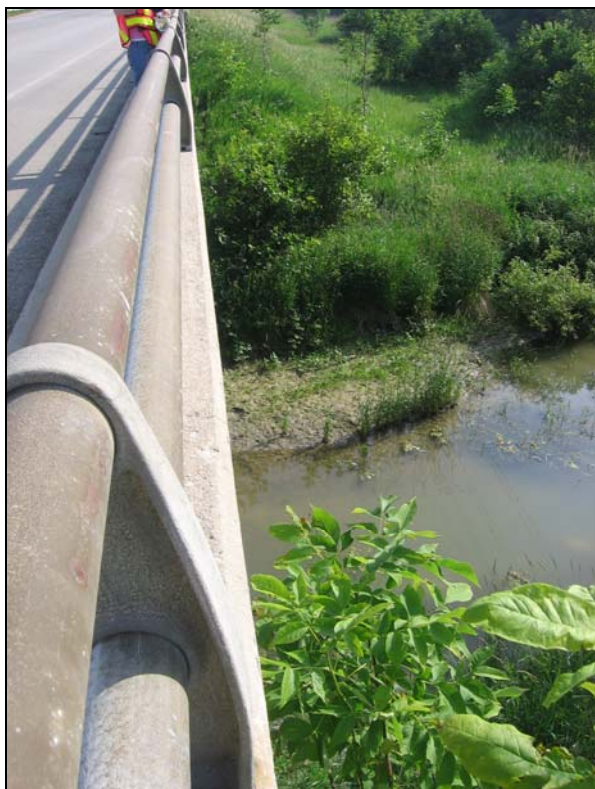
PR 4

PR 4-Looking across EAST side of bridge

Pine River tributary Bridge on Hwy
21 North of Concession 6

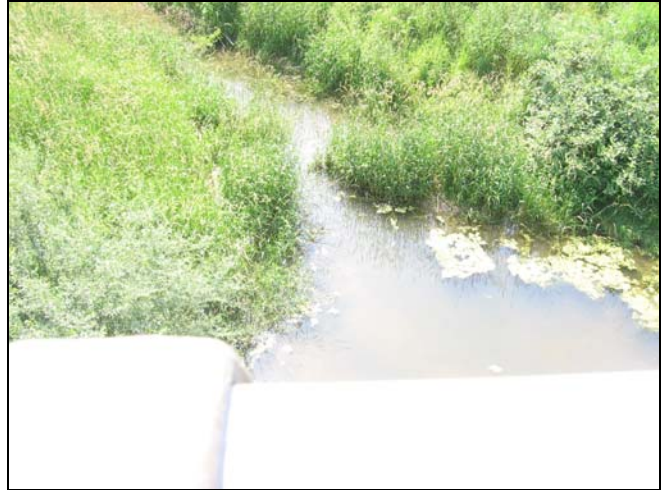
PR 6

Concrete Bridge over South Pine River
on Sideroad 25 North of Concession 6
east.

PR 6-Looking over Bridge on EAST side

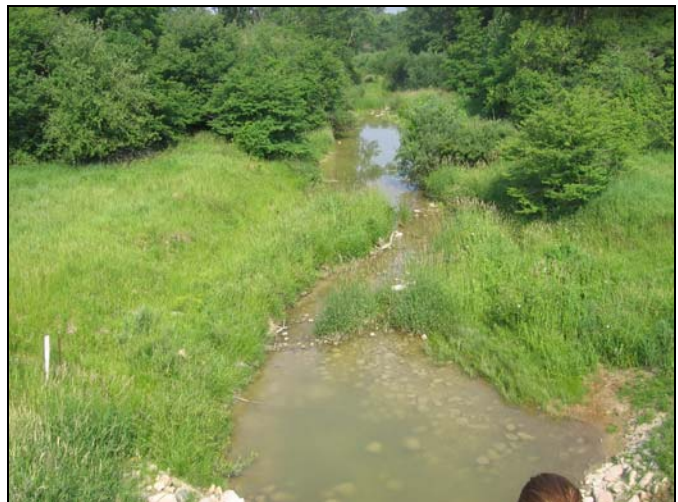
Rounded top concrete culvert over the
South Pine River, on Bruce County Road 7,
North of 6th Concession.

PR 8 –Facing WEST over Pine River tributary
