TOWNSHIP OF HURON-KINLOSS

BASELINE SURFACE
WATER QUALITY MONITORING PROGRAM

2021 ANNUAL REPORT

February 1, 2022

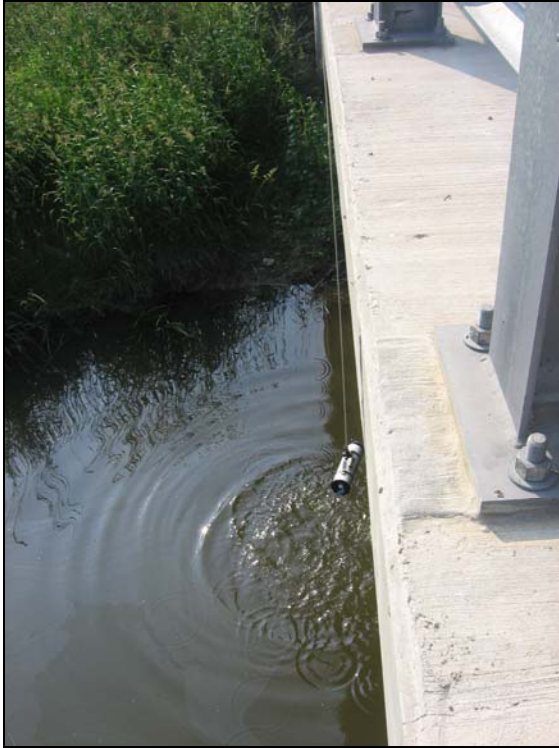
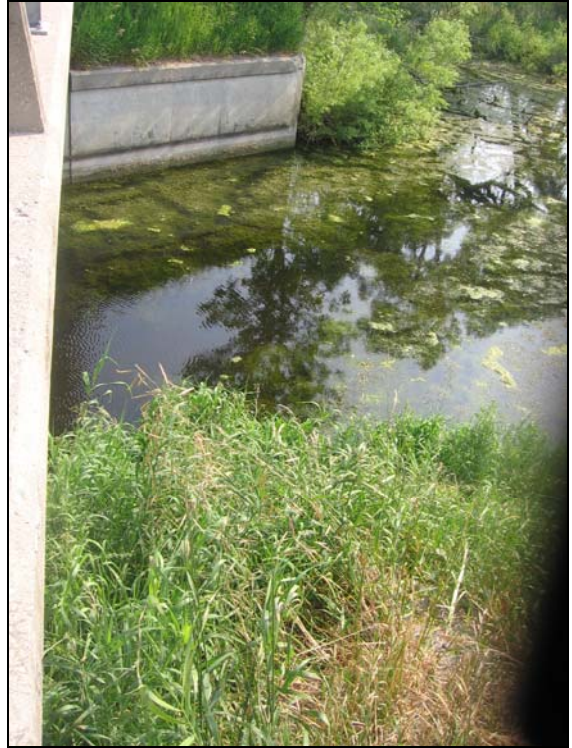
PR 9

PR 9-Looking across bridge on EAST side

PR 9-Looking at River on EAST side

Pine River concrete bridge on County Road 7, south of 10th Concession

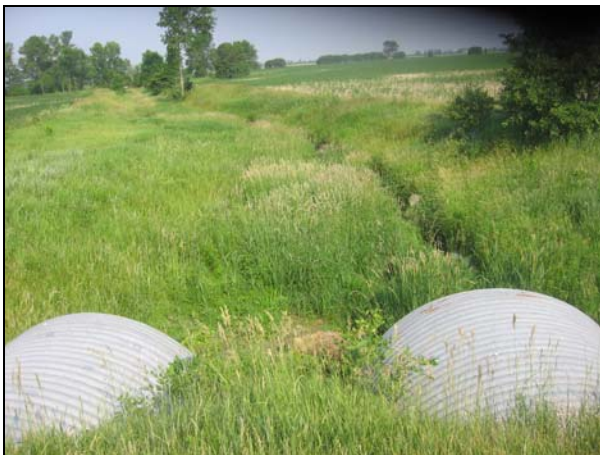
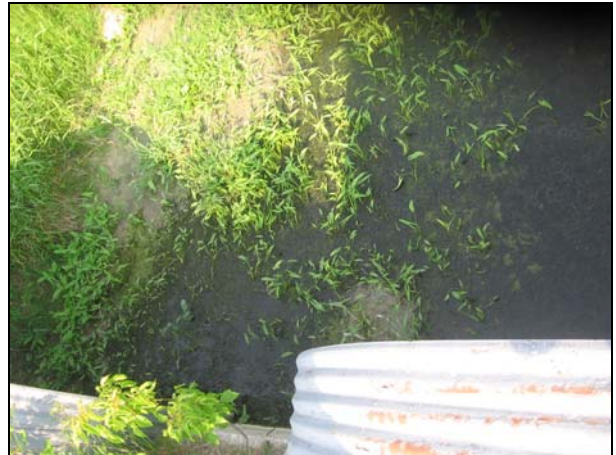
PR 10

PR 10-Looking WEST over dual CSPs

PR 10- WEST side of creek

Royal Oak Creek; dual CSPs on County Road 7, north of concession 12

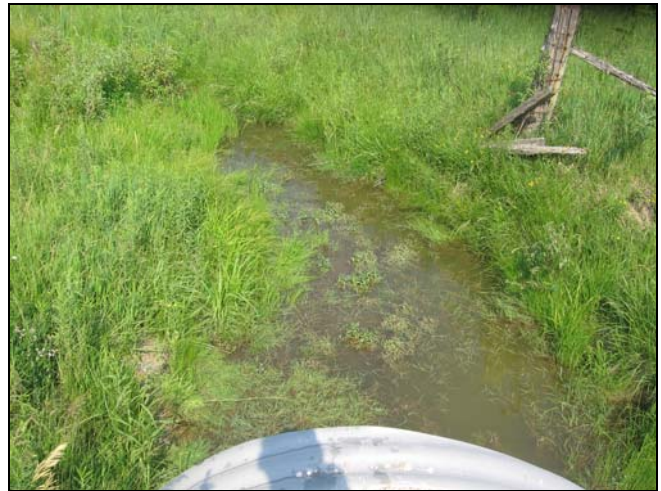
South Pine River bridge at Huron Twp./Kinloss Twp. Boundary south of 8th Concession.

PR 13 –Facing EAST

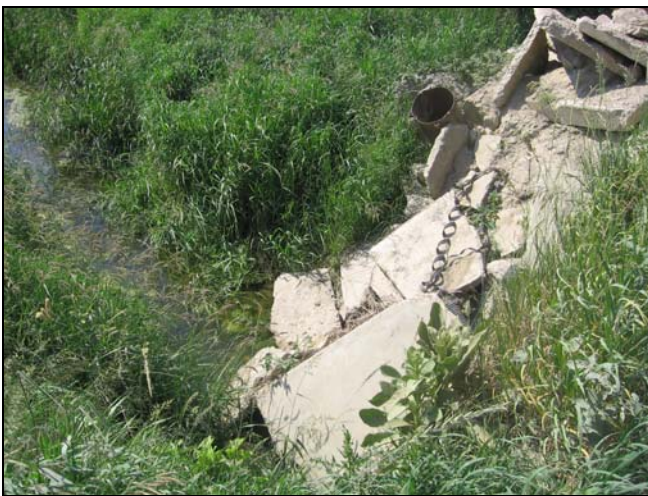
PR 17 – Facing EAST over Concrete Culvert

Pine River Tributary, Southern Culvert at South Baseline Road North of 4th Concession

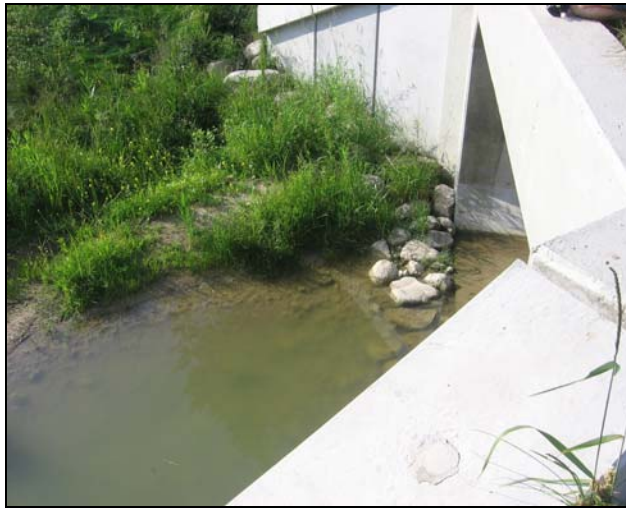
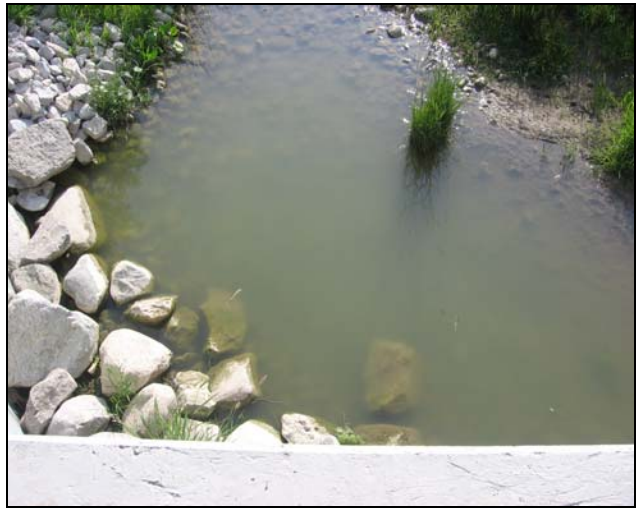
PR 27

PR 27-Looking across EAST side of culvert

PR 27-Facing EAST

Boyd Creek concrete bridge/culvert on Highway 21(Ashfield)

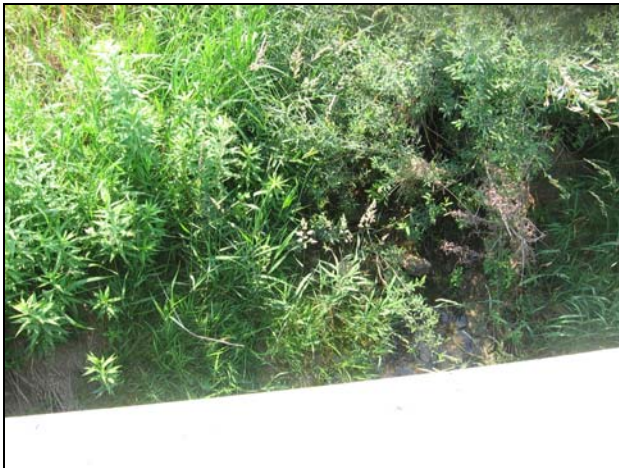
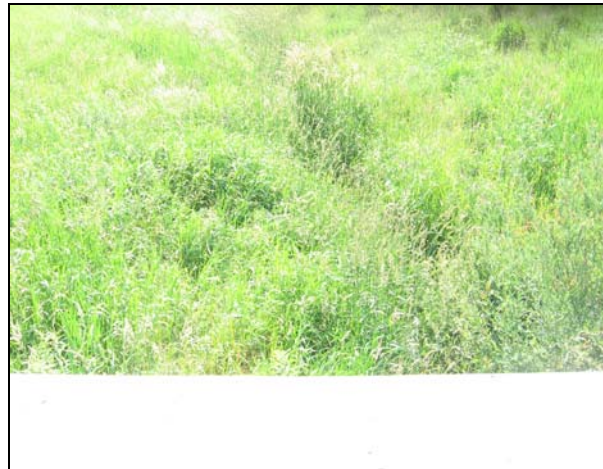
PR 29

PR29-Looking down on WEST side of creek

PR 29-Looking WEST over culvert

Boyd Creek on Sideroad 20, just south of Concession 4

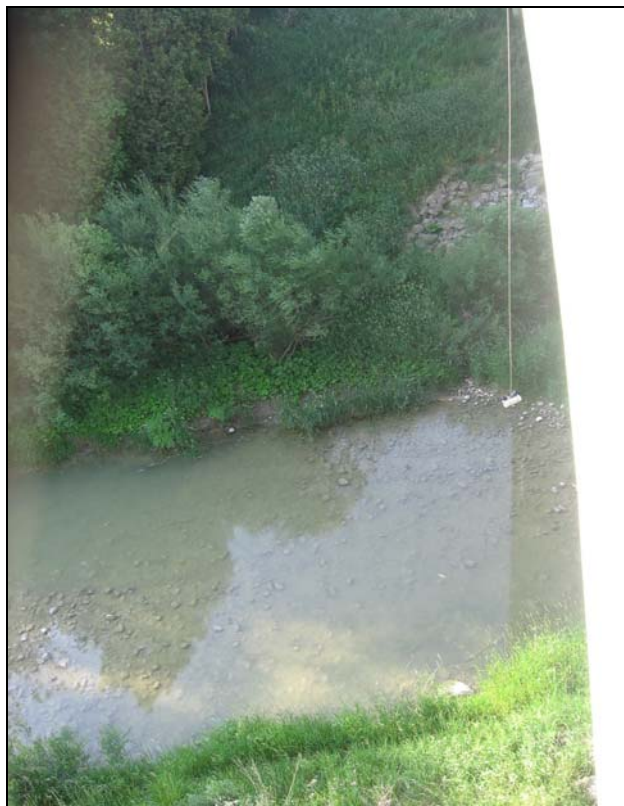
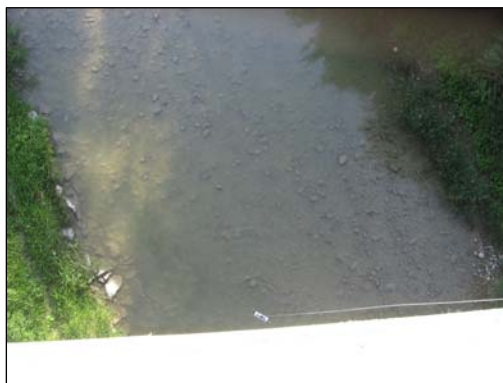
PR 30

PR 30-Facing EAST across bridge

PR 30-Facing East over bridge

Bridge over Eighteen Mile River on Highway 21
