**MARINE ARCHAEOLOGICAL ASSESSMENT  
OF WRECKAGE FOUND ALONG  
POINT CLARK BEACH  
LAKE HURON**

**Licence No. 2021-08**

**Licence Holder: Scarlett Janusas**

**May 8, 2024**

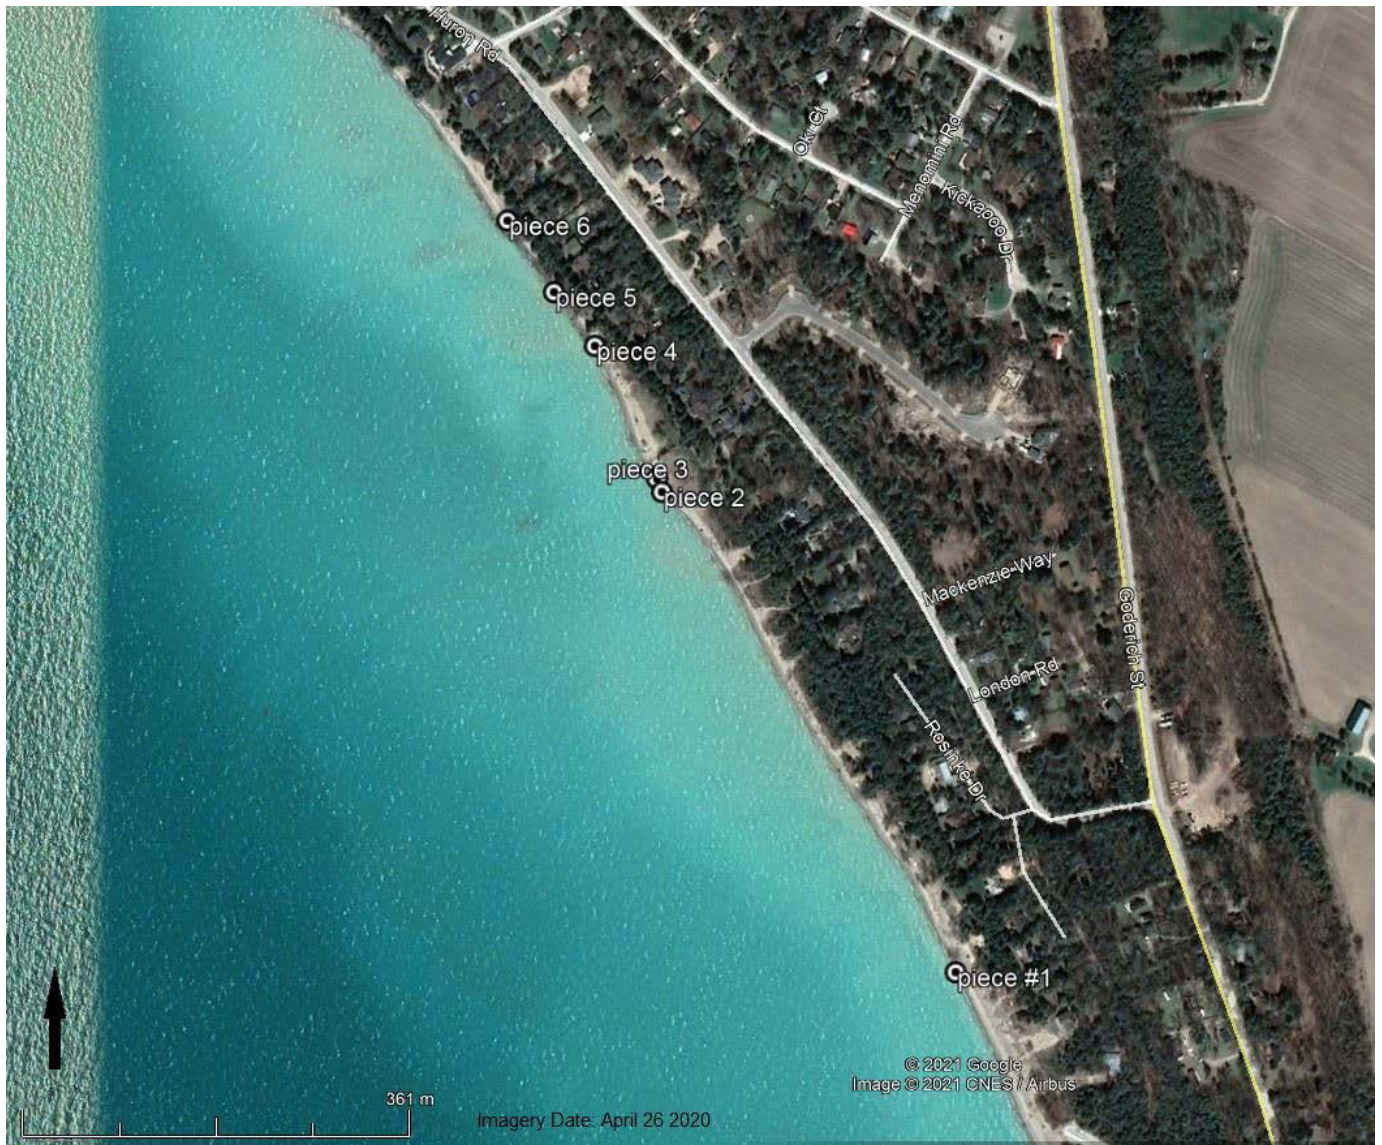
Figure 2: Location of Six Pieces of Wreckage

The following is a brief description of the six pieces found along the shoreline and of those recovered pieces (Figure 2). All pieces were documented using an iPhone camera and GPS (the recovered pieces were not recorded at the stored location). GPS georeferencing was conducted in decimal minutes.

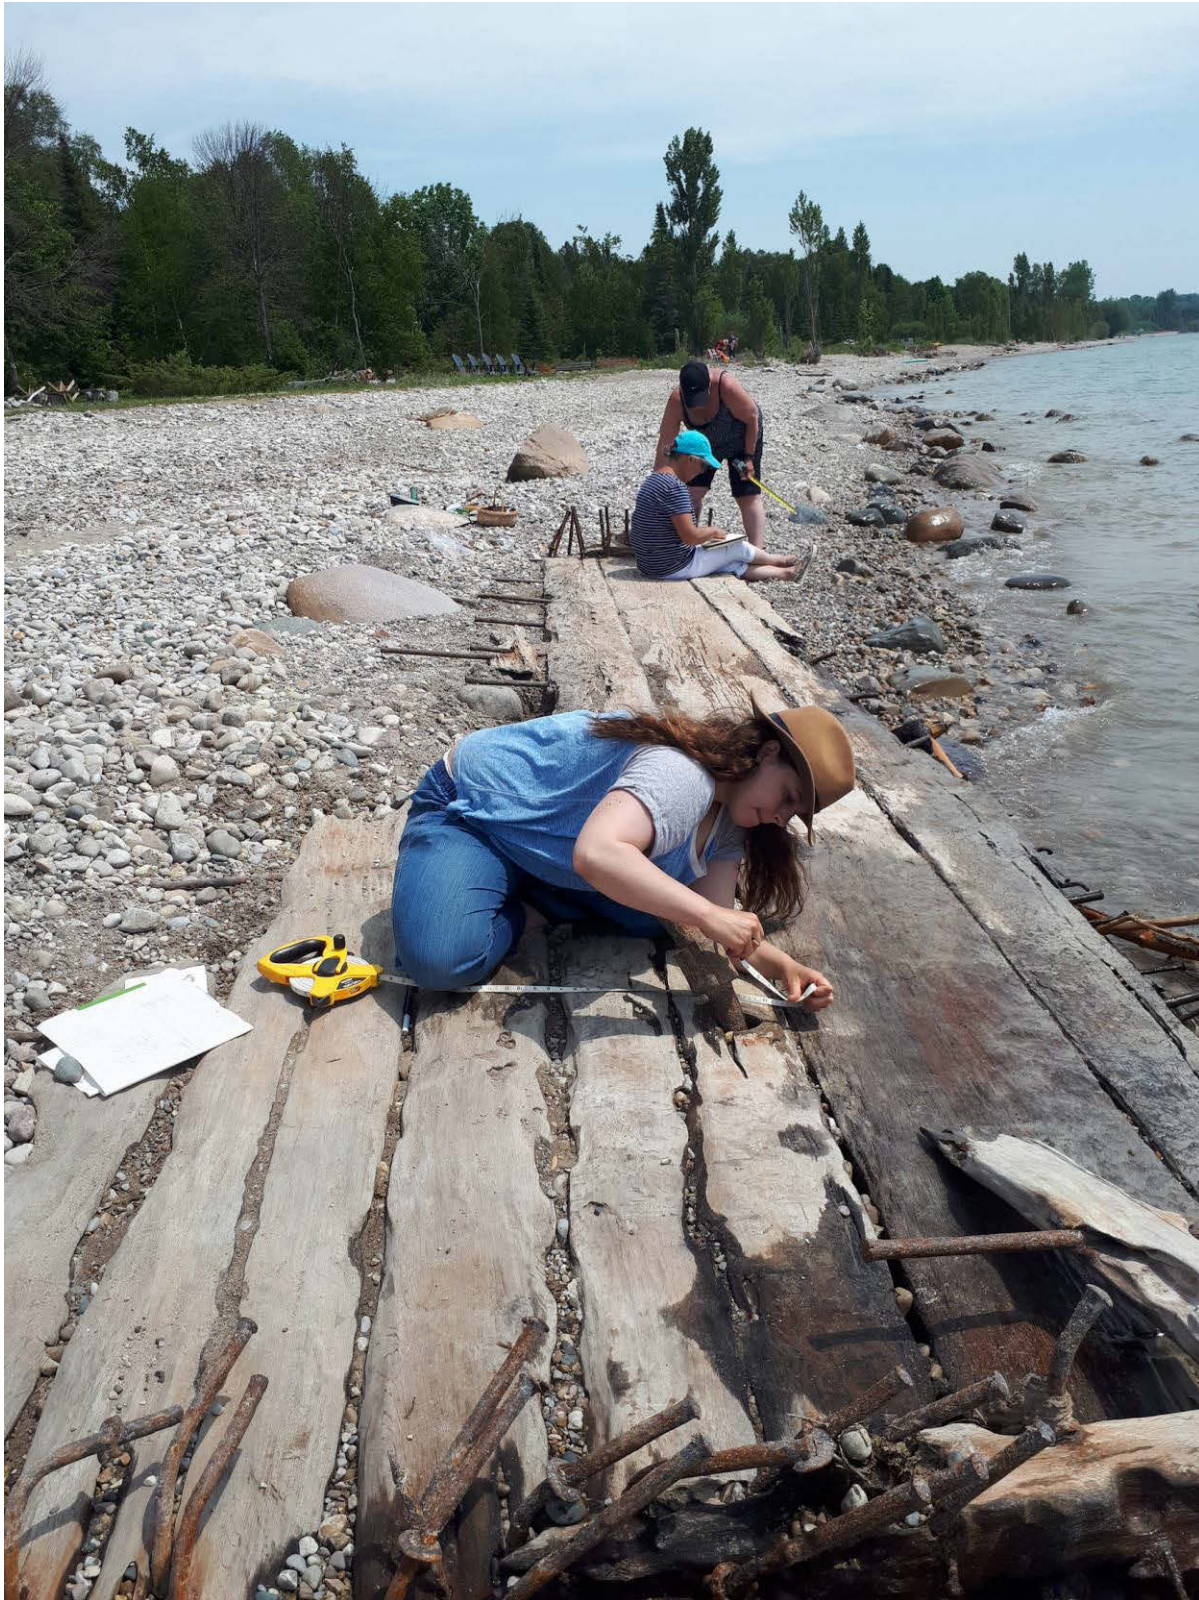
Image 12: Piece 2 (June 2021)

Images 12 – 16 illustrate **Piece 2** during the second field visit in June, where the piece was cleaned for recording purposes. Although the piece was supposedly recorded by volunteers, the drawing was never submitted. Subsequent attempts were made to revisit the site, but the piece had been reclaimed by Lake Huron and is now submerged. Nonetheless, the basic measurements and some more specific ones were obtained at the site during the May visit and from photographs.

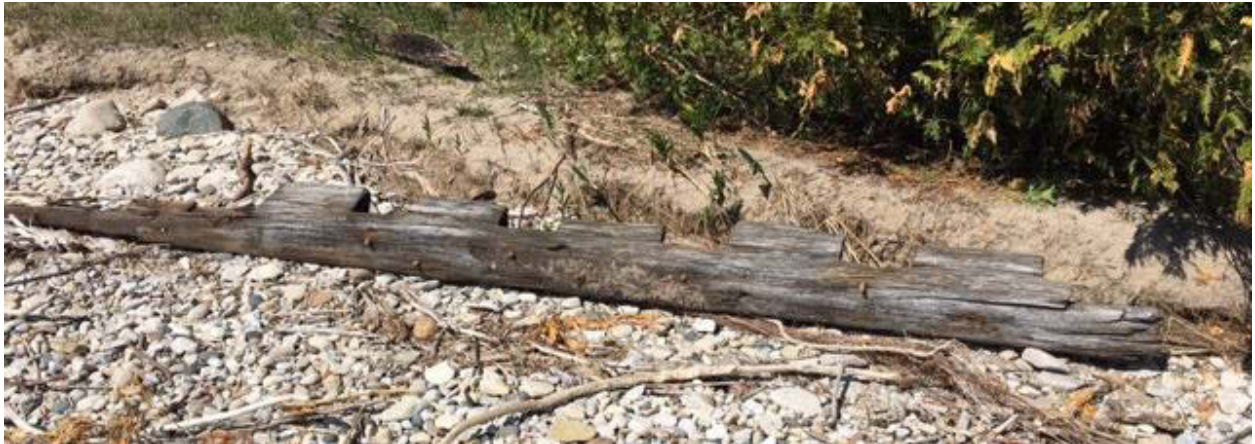
**Image 25: Possible Pocket Piece 6**

**Piece 6** is a pocket piece, and the configuration of the pocket pieces is shown in Figure 25 and 29.

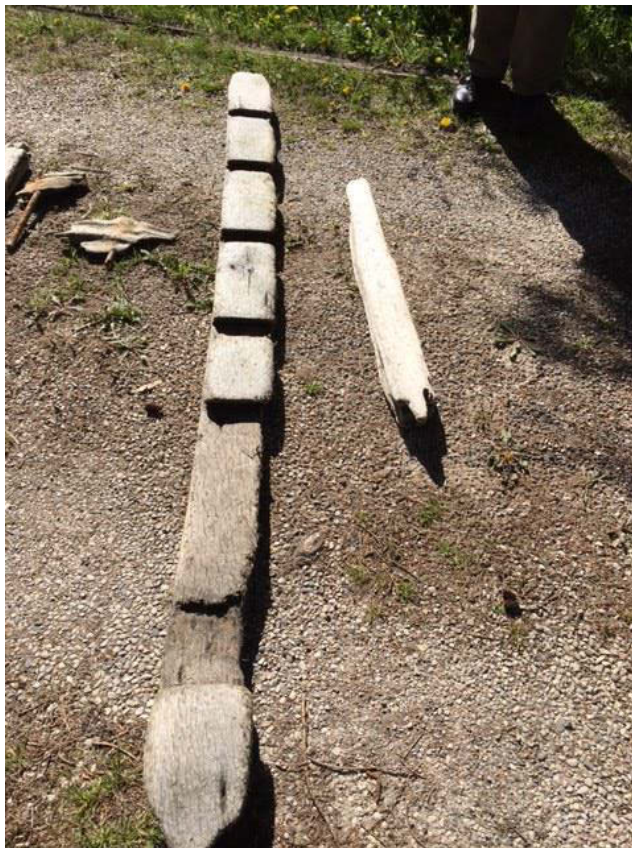
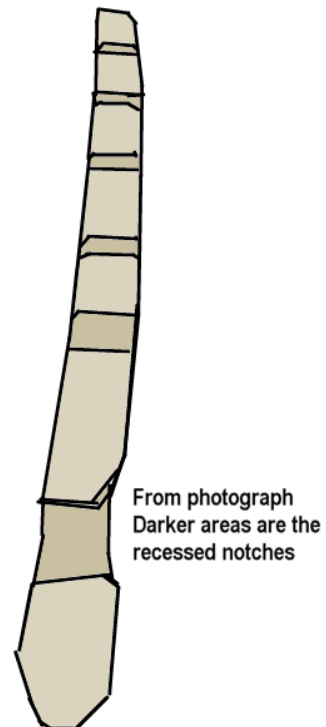
**Image 29: Salvaged Pocket Piece**

As indicated earlier in the report, several pieces were rescued by the informants and stored in their garage. These were also investigated and rough measurements taken and the pieces photographed. Of note is one large piece with a length of 8.6' (2.6 m) with an inside height of 8' and an outside height of 6". The piece was notched and made of one single piece of wood, likely white oak. This may be a "pocket piece" and the relationship to **Piece 2** is obvious. The notches are beveled. While there are no fasteners present, there is evidence that fasteners were once there from the holes located on the underside of the piece. The salvaged pieces are shown in Image 29 – 34.

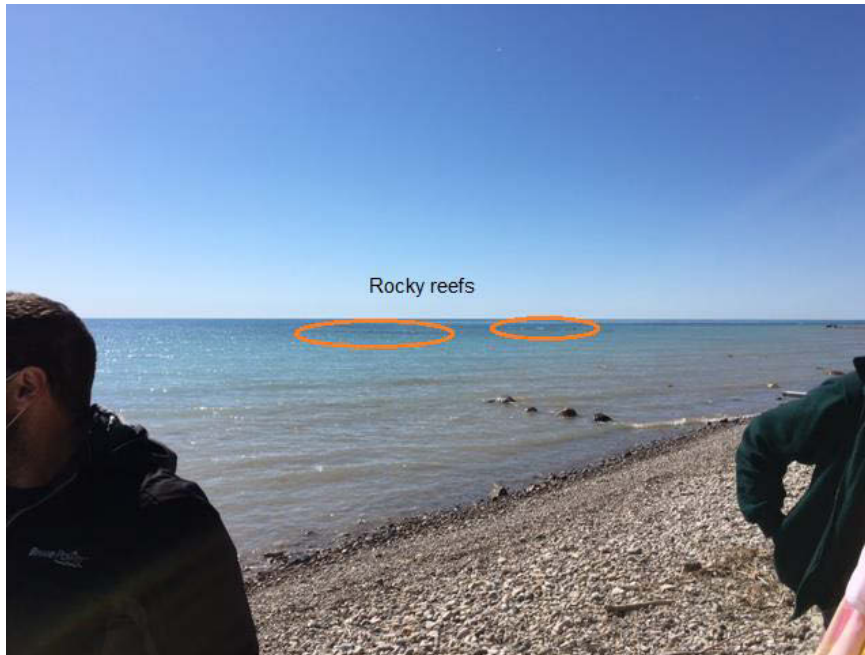
**Image 47: Reef facing NW from Piece 6**

Noteworthy is that if the winds are blowing northeast, this results in little wave action. Waves from previous days of the first field visit in May had stirred up the bottom making visibility in the water nil. The June visit met with ideal conditions and the water clarity was pristine allowing for visual assessment approximately three to five metres offshore and for volunteers searching the area with paddeboards, visibility to the bottom reached well over a metre. Also offshore, located more at the northern end of the survey area are a series of rocky reefs which no doubt played a part in breaking up the wreckage. These rocky reefs were not visible at the southern end. Images 47 - 49 illustrate the reefs offshore. These rocky reefs, as will be further discussed in the historic background

section of the report, are the result of human made groynes. So, while they may have factored into the continued wrecking of the ship, they were not there in the mid-19<sup>th</sup> century to contribute to her wrecking.

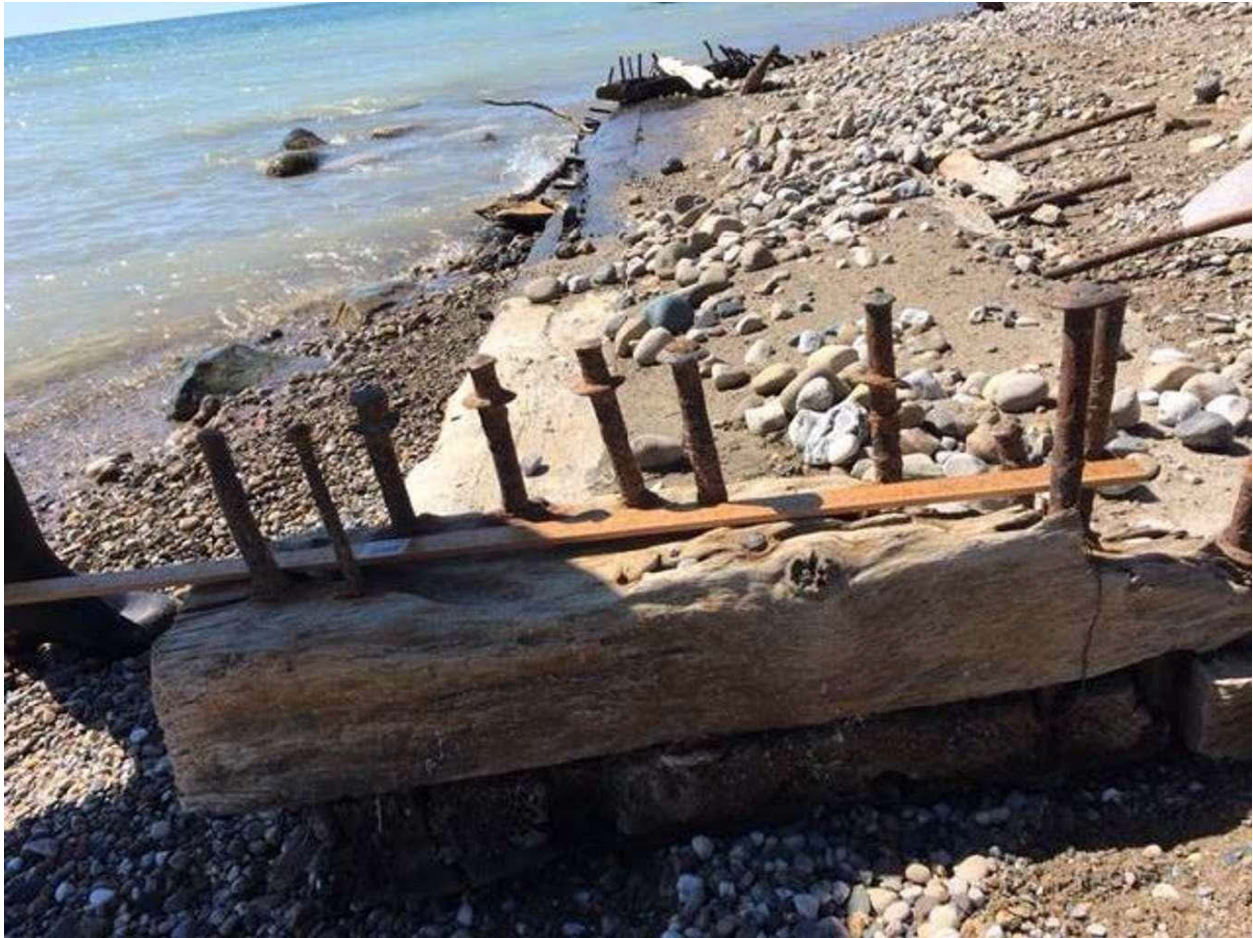
Please do not move, remove, or damage any of the shipwreck pieces while the investigation is underway.

There are concerns with safety at this area, as there are metal pieces protruding from the shipwreck, please do not touch or climb on them.
