Glass Fused to Steel

Complete Inspection Report

PROJECT NAME Township of Huron
LOCATION 3405 Concession Rd 2, Ripley ON
INSPECTION DATE May 5, 2021
INSPECTOR Josh Rodrigues

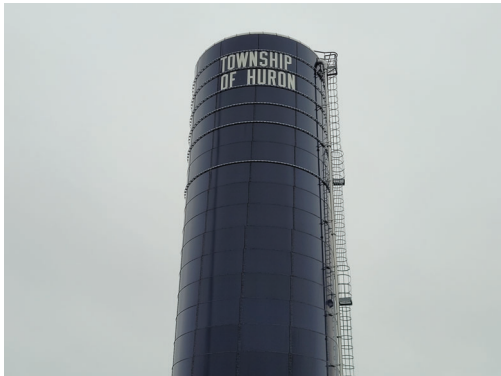
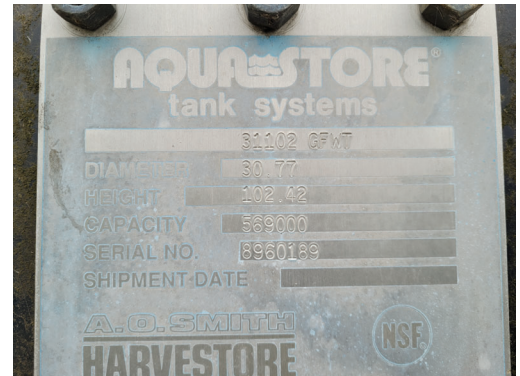
Constructor:	Greatario	Tank Capacity:	2154m3
Dwg's Available:	Yes	Year Built:	1996
Dwg's Reviewed:	Yes	Diameter:	9.38m
Coating System:	Glass Fused to Steel	Height:	31.22m
Lining System:	Glass Fused to Steel	Tank S/N:	8960189

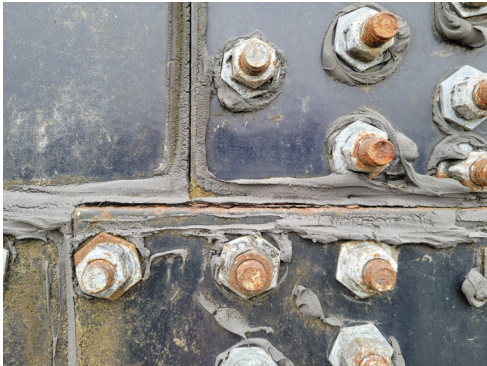
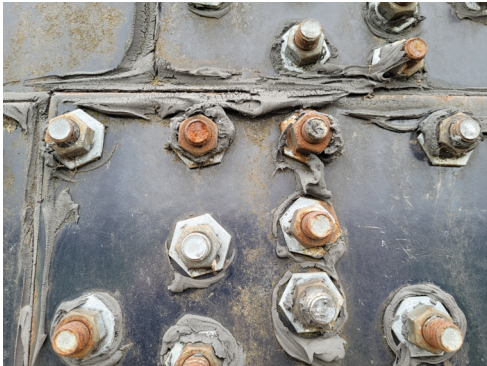
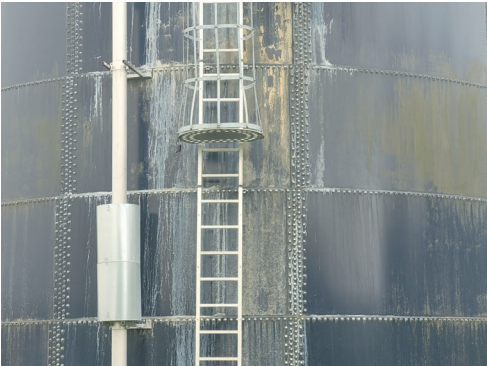
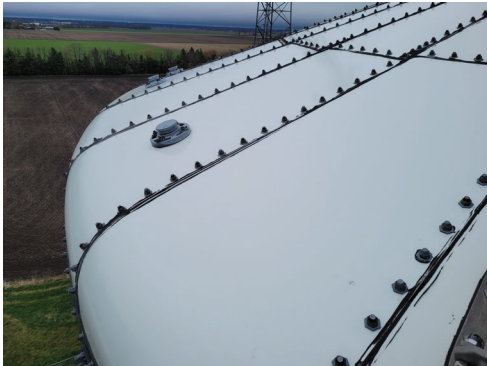
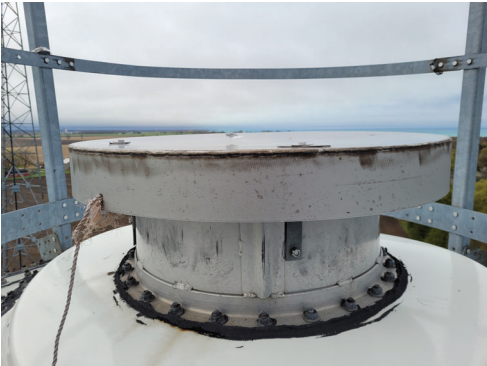
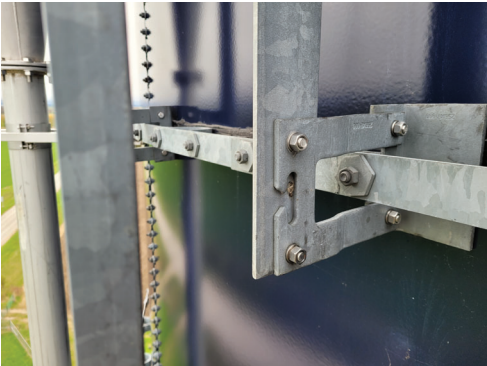
ADDITIONAL EXTERIOR PHOTOS

Exterior of tank wall and roof panels and glass fused to steel coating are in good overall condition. Exterior of tank surface is very dirty with heavy moss buildup on sidewalls that should be cleaned when possible.

All sealer on wall and roof sheet edges showing degradation due to age (25 years) and has separated from sheet edges throughout tank exterior leaving bare steel on sheet edges exposed with minor surface corrosion. General life expectancy of sealer is approximately 20-25 years and should be replaced when sheet edges become exposed. Bolt threads and nuts exposed on tank exterior should be sealed and capped when sealer is replaced.

Both sidewall access manways are in good overall condition however staining on door plates from previously replaced hardware is present. Door plates should be prepared and coated on site.

Overflow piping is in good overall condition. It is recommended that a screen or valve be installed at open end of overflow pipe.

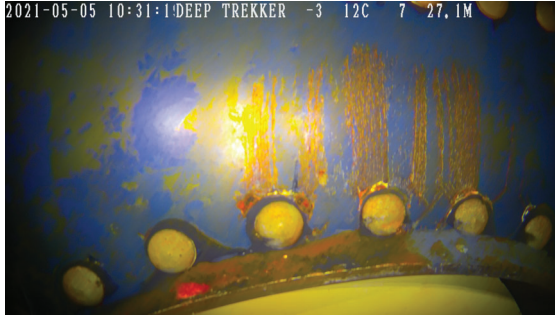
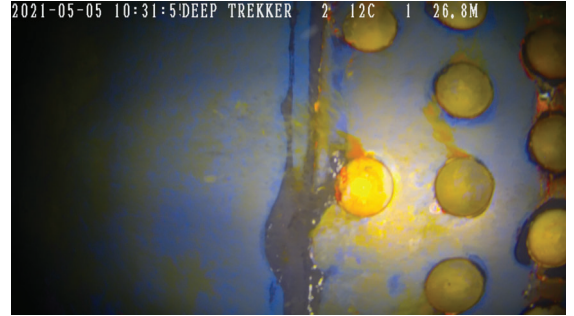
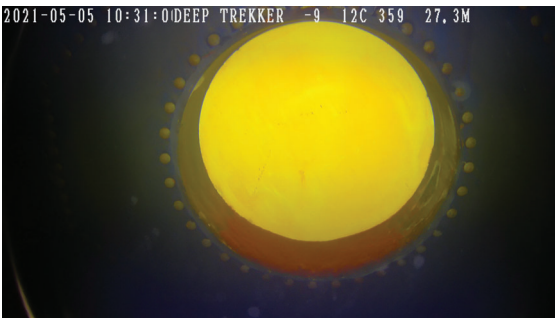
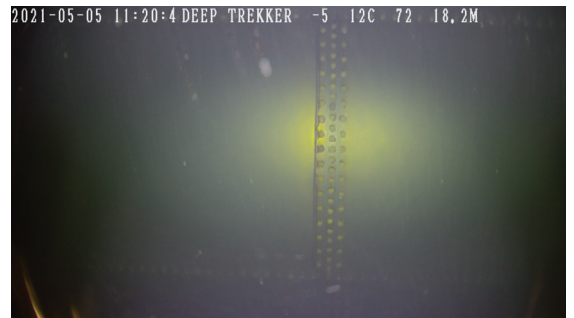
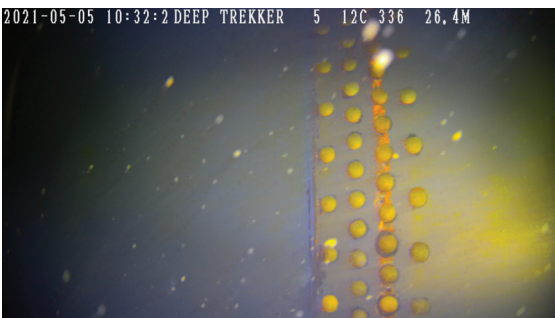
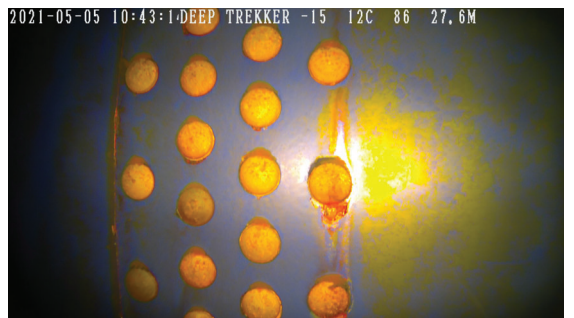
ADDITIONAL INTERIOR PHOTOS

Interior of tank wall panels and glass fused to steel coating is in good overall condition. Sealer showing complete degradation due to age on all sheet edges and bolt heads which should be replaced in near future. Many areas of bare steel exposed with minor corrosion on interior sheet edges

A heavy layer of sediment covered the entirety of the tank floor which did not allow for visual inspection of floor surface. Anodes on tank floor were visible in areas and appear to be in good condition.

Interior of tank wall panels and glass fused to steel coating is in good overall condition. Sealer on all interior sheet edges and bolts heads is no longer present throughout most of the tank leaving bare steel exposed with minor corrosion present. All interior sheet edges should be prepared and coated with new sealer in the near future. Heavy layer of sediment covers the tank floor which did not allow for visual inspection of floor surface however is expected to be in similar condition to the interior tank walls. Anodes were visible in some areas and appear to be in good overall condition however cathodic protection testing done at time of inspection determined the tank does not currently meet NACE criteria for adequate protection of a water storage tank. More anodes are likely required to protect areas of bare steel inside the tank (this may not be required once new sealer is installed)

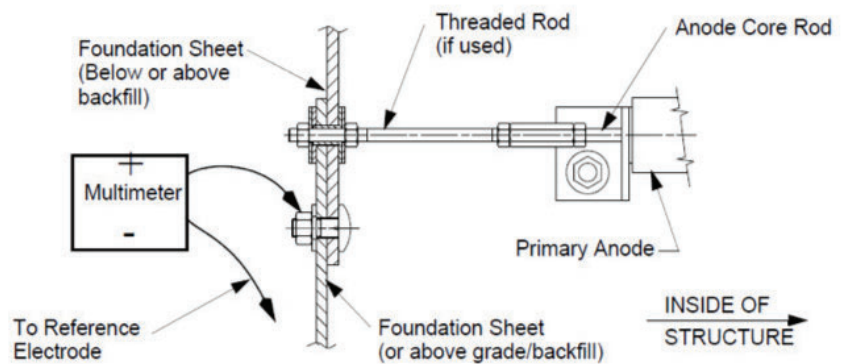
Tank to Liquid "Native" Potential Measurements (VS Cu/CuSO4)

Top	-0.715 V CSE
25%	-0.721 V CSE
50%	-0.722 V CSE
75%	-0.724 V CSE
Bottom	-0.724 V CSE

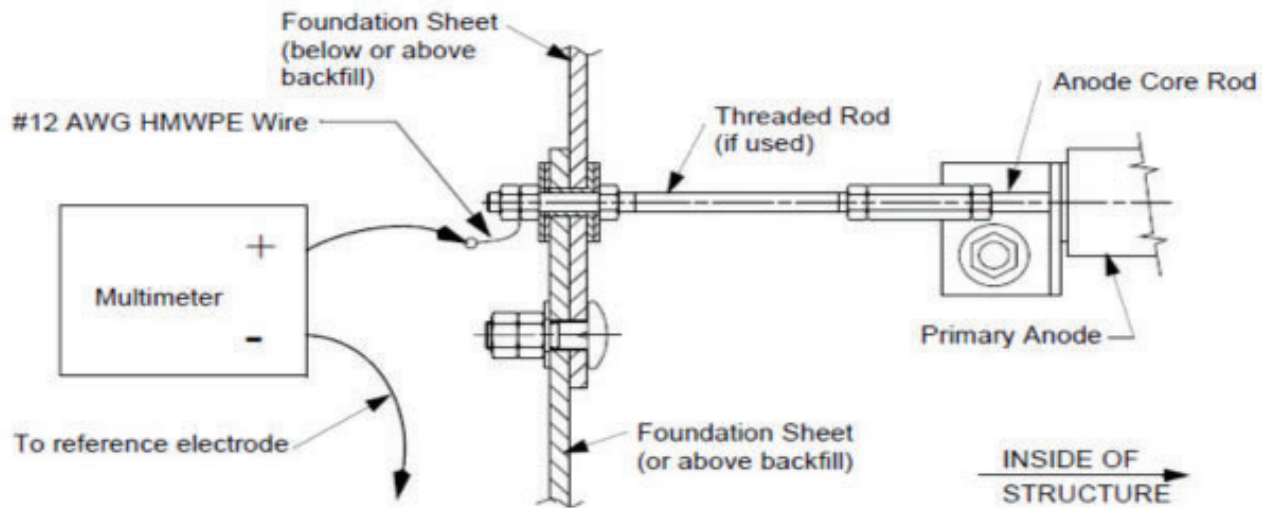
Anode Open Circuit Potential Measurements (VS Cu/CuSO4)

1	-1.619 V CSE	11	V CSE	21	V CSE
2	-1.535 V CSE	12	V CSE	22	V CSE
3	-1.550 V CSE	13	V CSE	23	V CSE
4	-1.547 V CSE	14	V CSE	24	V CSE
5	-1.526 V CSE	15	V CSE	25	V CSE
6	-1.448 V CSE	16	V CSE	26	V CSE
7	V CSE	17	V CSE	27	V CSE
8	V CSE	18	V CSE	28	V CSE
9	V CSE	19	V CSE	29	V CSE
10	V CSE	20	V CSE	30	V CSE

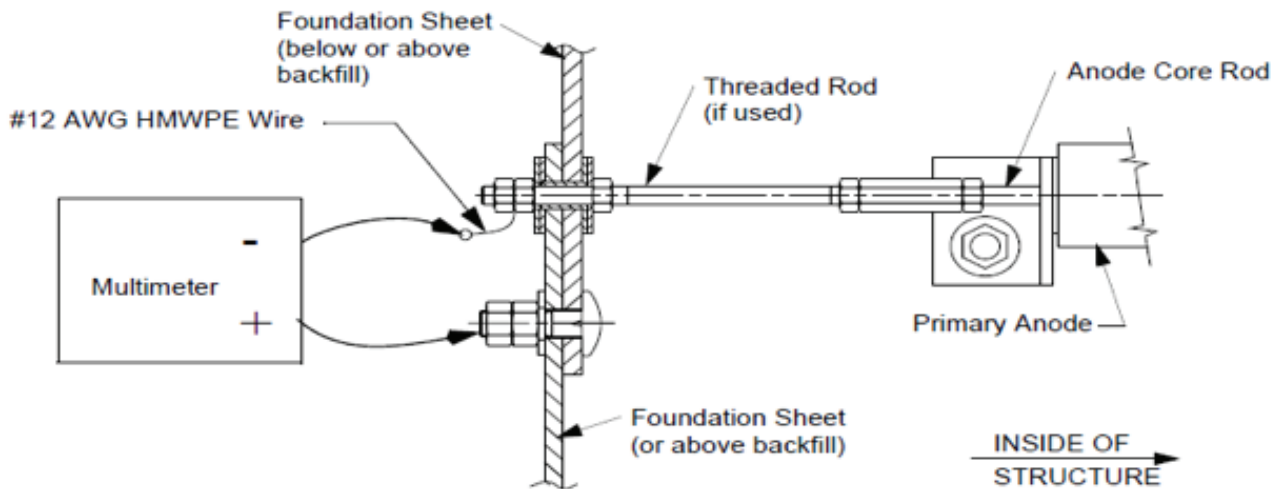
Anode Current Output Measurements with Multimeter Direct Connection

1	0.042 A	11	A	21	A
2	0.027 A	12	A	22	A
3	0.031 A	13	A	23	A
4	0.021 A	14	A	24	A
5	0.034 A	15	A	25	A
6	0.034 A	16	A	26	A
7	A	17	A	27	A
8	A	18	A	28	A
9	A	19	A	29	A
10	A	20	A	30	A

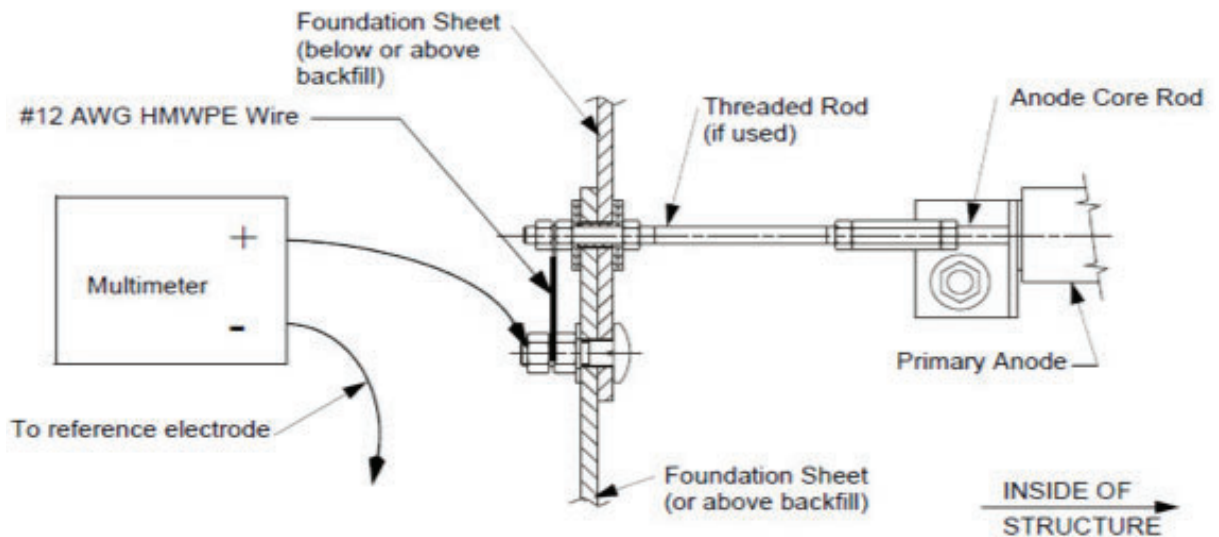
Tank to Liquid "ON" Potential Measurements (VS Cu/CuSO4)

1	-0.732 V CSE	11	V CSE	21	V CSE
2	-0.738 V CSE	12	V CSE	22	V CSE
3	-0.747 V CSE	13	V CSE	23	V CSE
4	-0.757 V CSE	14	V CSE	24	V CSE
5	-0.764 V CSE	15	V CSE	25	V CSE
6	-0.777 V CSE	16	V CSE	26	V CSE
7	V CSE	17	V CSE	27	V CSE
8	V CSE	18	V CSE	28	V CSE
9	V CSE	19	V CSE	29	V CSE
10	V CSE	20	V CSE	30	V CSE
