TOWNSHIP OF HURON-KINLOSS

BRIDGE INSPECTION REPORT

2021

B. M. ROSS AND ASSOCIATES LIMITED
Engineers and Planners
62 North Street
Goderich, ON N7A 2T4
Phone: 519-524-2641
www.bmross.net

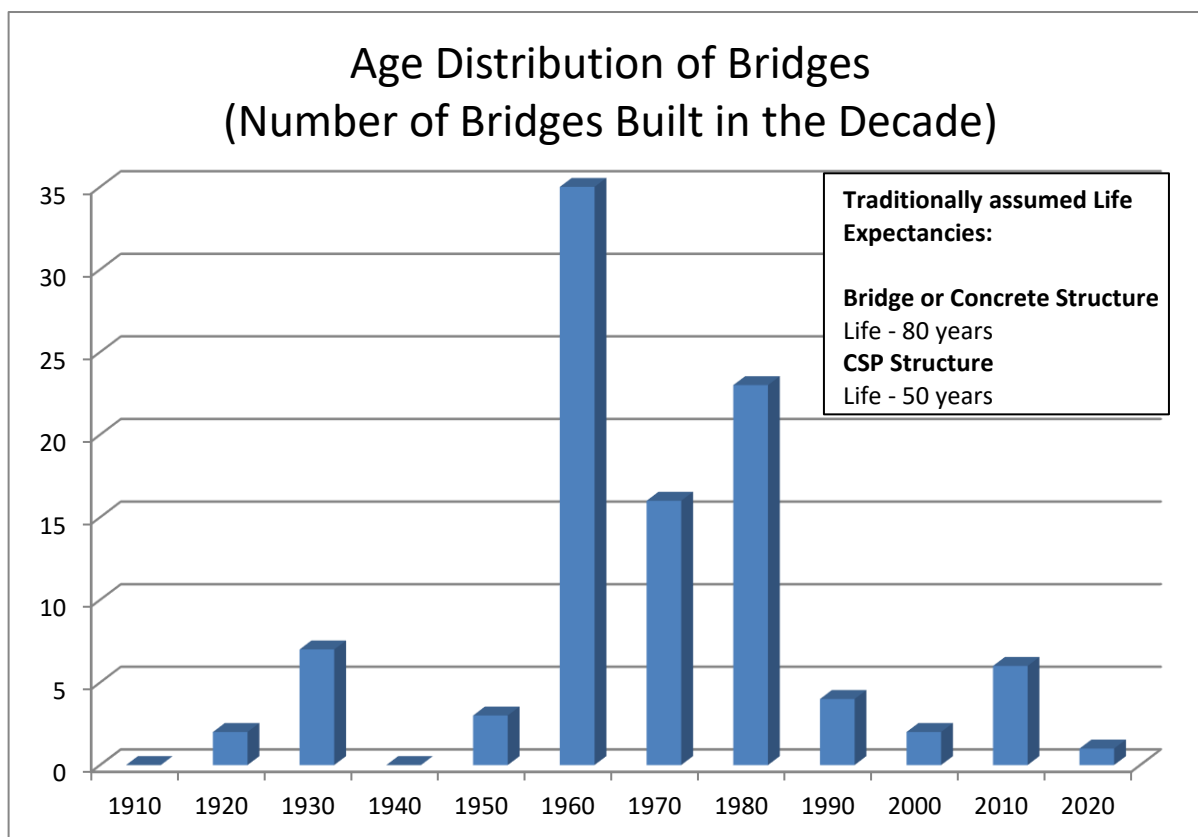
Figure 2
Age Distribution of Bridges

Figure No. 2 shows an age distribution of the bridges in the Township using the assumed year-built information provided, or when it was not provided, the year built estimated by BMROSS was used. The average assumed age of the structures within the Township is 49 years.

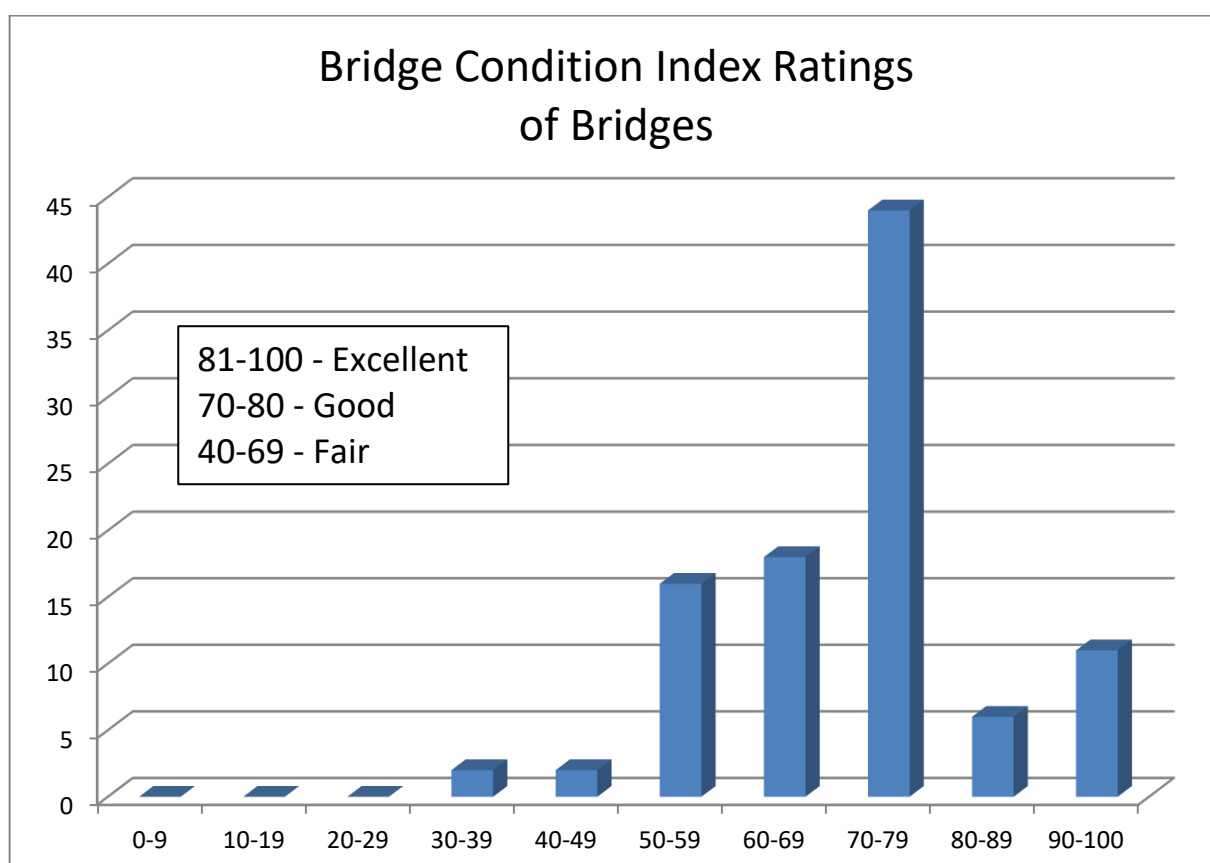
Figure 3
BCI Distribution of Bridges

Figure 3 provides a breakdown of the Bridge Condition Index (BCI) range for the Township's bridges. The Ontario Ministry of Transportation's Bridge Condition Index information from 2009 indicates that the BCI is a measure of the overall structural condition of the bridge. The score is developed with a weighted average of the condition ratings for the individual components assessed. Generally, a structure with a BCI greater than 90 is in excellent condition, 75 to 89 good condition, 40 to 74 is in fair condition and below 40 the structure is in poor condition. The average BCI score for the structures in the Township is 71.

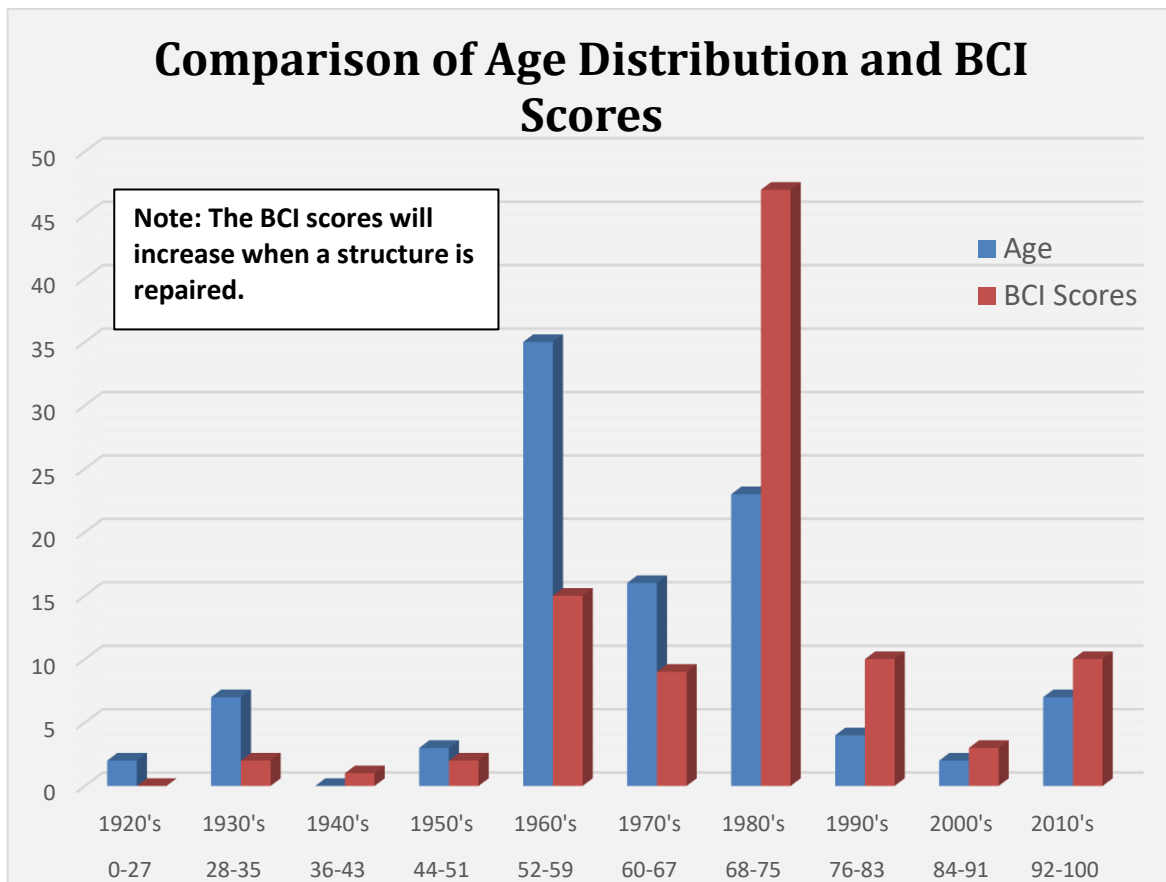
Figure 4
Comparison of Age Distribution and BCI Scores

Figure 4 provides a comparison of the bridge ages with the bridge condition ratings within the Township. The MTO has suggested that a bridge with a condition rating below 40, as calculated using the OSIM scoring method, should be considered for replacement. As noted earlier, we have suggested that the average service life of bridges in a lower tiered municipality should be higher suggested by the MTO. We had suggested an average service life for bridges to be 80 years and uncoated CSPs to be 50 years. When comparing the condition rating with the expected service life of the bridges, we have assumed the over-all average service life for all the structure will be 80

years. If our service life and condition score assumptions are correct, after 80 years a structure should have a condition rating of about 40. Figure 4 was prepared to match up the assumed timelines of these two parameters. When reviewing the figure, it appears that the condition scores are not deteriorating at the same pace as expect for the age of the structure.

The average age of the bridges within the Township is 50 years old. If the average life expectancy is 80 years, that suggests that they are on average 61% of their way through their service life. Meanwhile, the average BCI rating is 71 which suggests that the structures, on average, are only 48% of their way through their life expectancy. Based on this statistic and a review of Figure 4; which suggests the BCI scores are on average higher than they should be for the average ages of the structures, we are of the opinion that the average life expectancy of your structures will be greater than 80 years. We performed a more detailed review of each structure and using engineering judgement we tried to predict when further rehabilitation and replacements will be required. Based on this review, we suspect that the average life expectancy of the bridge structures within your Township could be greater than 100 years, concrete culverts greater than 100 years and CSP will be about 60 years, if proper maintenance and rehabilitation work completed at the appropriate time. To help ensure the life expectancy of the bridges is greater than 100 years, we
