# Ripley Annual and Summary Report

*For the 2020 Operating Year*

Veolia Water Canada  
100 Cove Road, Box 185  
Goderich, ON  
N7A 3Z2  
Author: Nancy Mayhew

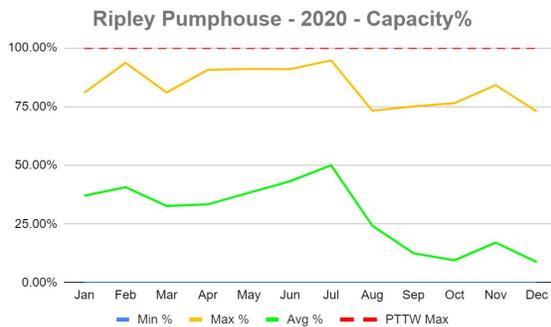
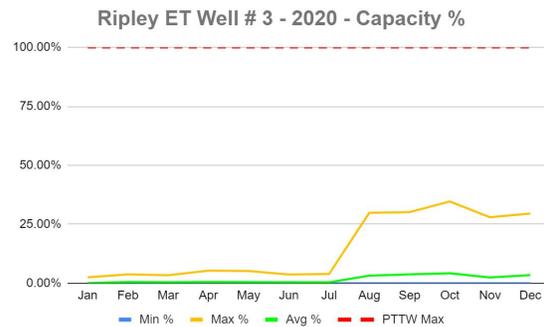
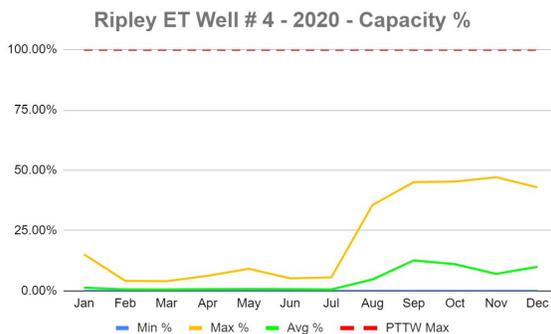
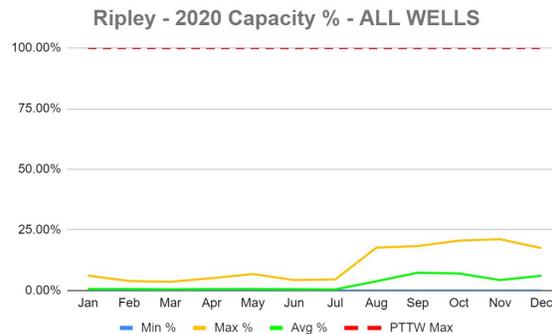
Location (Well Supply)	Total Volume for 2020 (m³)
Ripley Pumphouse (Well #1 and #2)	91,486.47
Ripley Elevated Tank (Well #3)	12,447.36
Ripley Elevated Tank (Well # 4)	21,491.99
<b>Total Annual Rated Capacity, PTTW (m³)</b>	<b>1,561,356.00*</b>
Grand Total Water Taking (m³)	125,182.71
Overall Operating Capacity, Actual %	8.02%

<b>6.3</b>	<b>System Capacity (O. Reg. 170/03, Schedule 22-2(3) Continued)</b> ..... • Table 24 - Total Volumes of All Well Supplies • Figures 2, 3, 4, and 5	<b>27</b>
<b>7.0</b>	<b>IMPROVEMENTS TO SYSTEM AND ROUTINE AND PREVENTATIVE MAINTENANCE (s. 11 (6) (e))</b> .....	<b>28</b>
<b>8.0</b>	<b>MINISTRY OF THE ENVIRONMENT , CONSERVATIONS AND PARKS INSPECTIONS AND REGULATORY ISSUES (Schedule 22-2 (2))</b> .....	<b>28</b>
<b>9.0</b>	<b>REGULATORY CHANGES</b> .....	<b>29</b>
<b>9.1</b>	<b>Arsenic Sampling (O. Reg. 170/03, Schedule 13-5 (1), ss. 13-2 and ss. 13-4)</b> ..... • Table 25 - Arsenic Results	<b>29</b>
<b>10.0</b>	<b>WELL LEVELS (PTTW)</b>	<b>29</b>

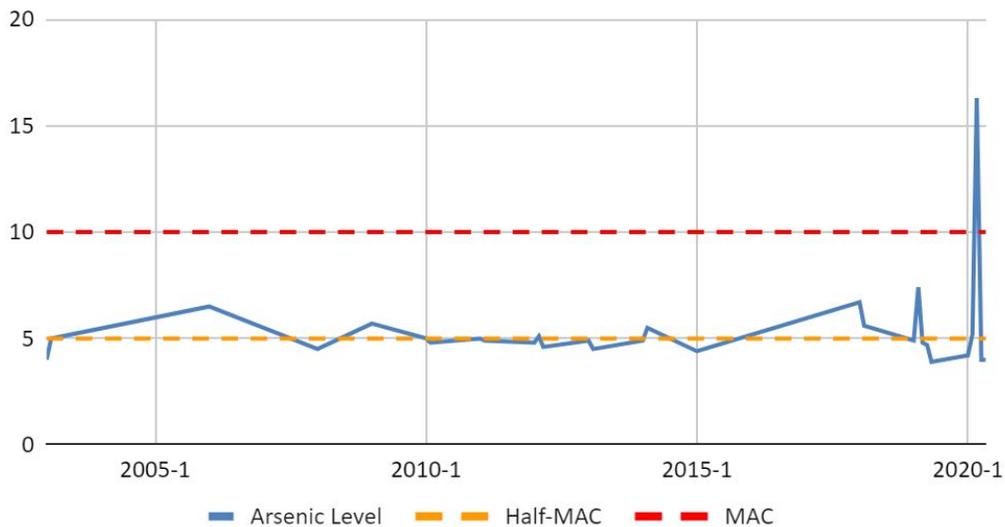
**Figure 6**

**Ripley Pumphouse - Historical Arsenic (ug/L)**

- Chemical Parameters:
  - Ripley Pumphouse: There was one exceedance for Arsenic in 2020, and historically, Sodium and Fluoride are always in exceedance. Sodium and Fluoride are tested every 60 months and were not required in 2020. These parameters will be sampled again in 2021.
  - Ripley Elevated Tank: It should be noted that Sodium and Fluoride samples were not collected from the Ripley Elevated Tank site in 2020. They will be sampled in 2021.

Year	Ripley Pumphouse		
	Sodium	Fluoride	Arsenic
2009	--	1.92	5.7
2010	--	2.13, 2.24	5.0, 4.8, 5.0
2011	23.9	2.07, 2.23	5.0, 4.9
2012	--	2.02, 2.11	4.8, 5.1, 4.6
2013	--	2.14, 2.22	4.9, 4.5
2014	--	2.02, 2.07	4.9, 5.5
2015	--	2.03	4.4
2016	30.8	--	---
2017	--	2.10	---
2018	---	---	6.7, 5.6
2019	---	---	4.9, 7.4, 4.8, 4.7, 3.9

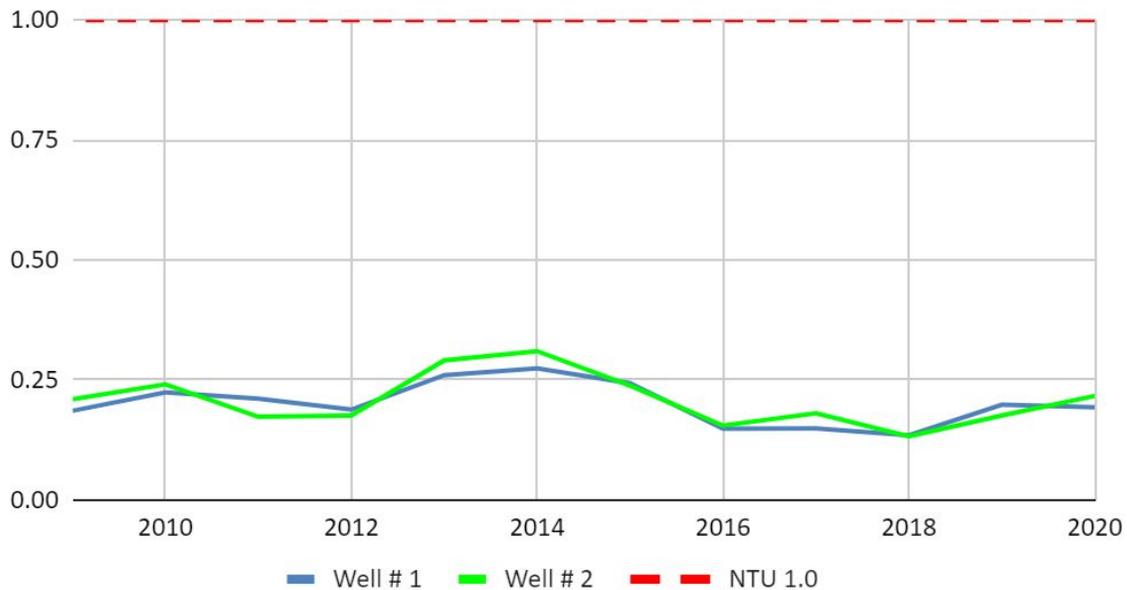
**Figure 7**

### Ripley Pumphouse - Historical Turbidity (NTU)

Well Source	10-Year Historical Average (2010 to 2019) (NTU)	2020 Average (NTU)	Comments
Ripley Well # 1	0.20	0.19	The raw turbidity has remained consistent based on the 10-year historical average. There is no concern at this time.
Ripley Well # 2	0.21	0.22	The raw turbidity has remained consistent based on the 10-year historical average. There is no concern at this time.
Ripley Well # 3	---	0.21	There is no historical data for Well # 3.
Ripley Well # 4	---	0.20	There is no historical data for Well # 4.

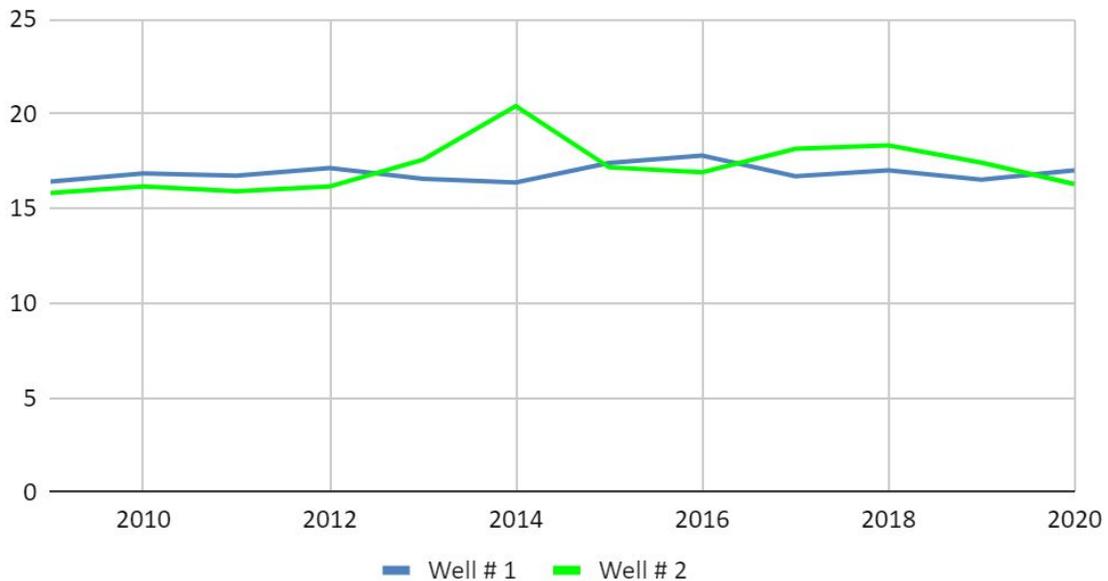
**Figure 8**

**Ripley Pumphouse - Historical Well Levels (m below grade)**

Well Source	10-Year Historical Average (2010 to 2019) (m)	2020 Average (m)	Comments
Ripley Well # 1	16.98 m below grade	16.53 m below grade	The well level has remained consistent based on the 10-year historical average. There is no concern at this time.
Ripley Well # 2	17.23 m below grade	17.42 m below grade	The well level has remained consistent based on the 10-year historical average. There is no concern at this time.
Ripley Well # 3	---	12.69 m below grade	There is no historical data for Well # 3.
Ripley Well # 4	---	13.14 m below grade	There is no historical data for Well # 4.

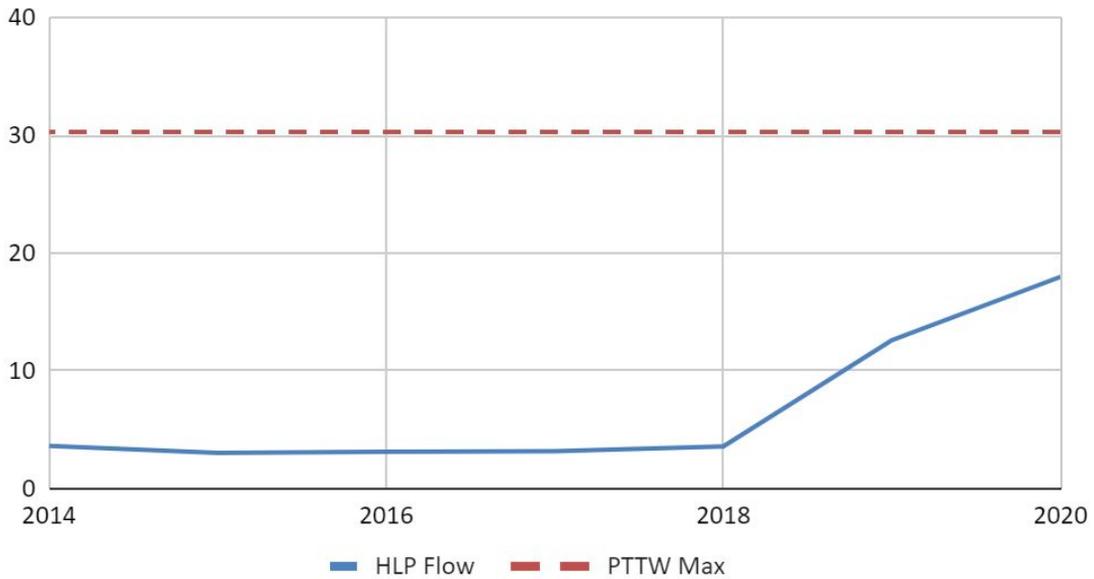
**Figure 9**

**Ripley Pumphouse - Historical Flows (L/s)**

Well Source	5-Year Historical Average (2015 to 2019)	2020 Average	Comments
Ripley Pumphouse (Well # 1 and # 2 combined)	Avg flow: 5.11 L/s Capacity: 33.56%	Avg flow: 17.98 L/s Capacity: 28.93%	Flows are consistent based on the 5-year historical average. The operation of the well cycling has been changed with the addition of the Elevated Tank and the average flows are reflective of this change. There are no concerns at this time.
Ripley Well # 3	---	Avg flow: 20.40 L/s Capacity: 1.69%	There is no historical data for Well # 3.
Ripley Well # 4	---	Avg flow: 21.25 L/s Capacity: 4.22%	There is no historical data for Well # 4.
